Program Review of the Implementation of Approximate Original Contour Regulations in Pennsylvania's Bituminous Surface Mining Program

Harrisburg Field Office

September 2010

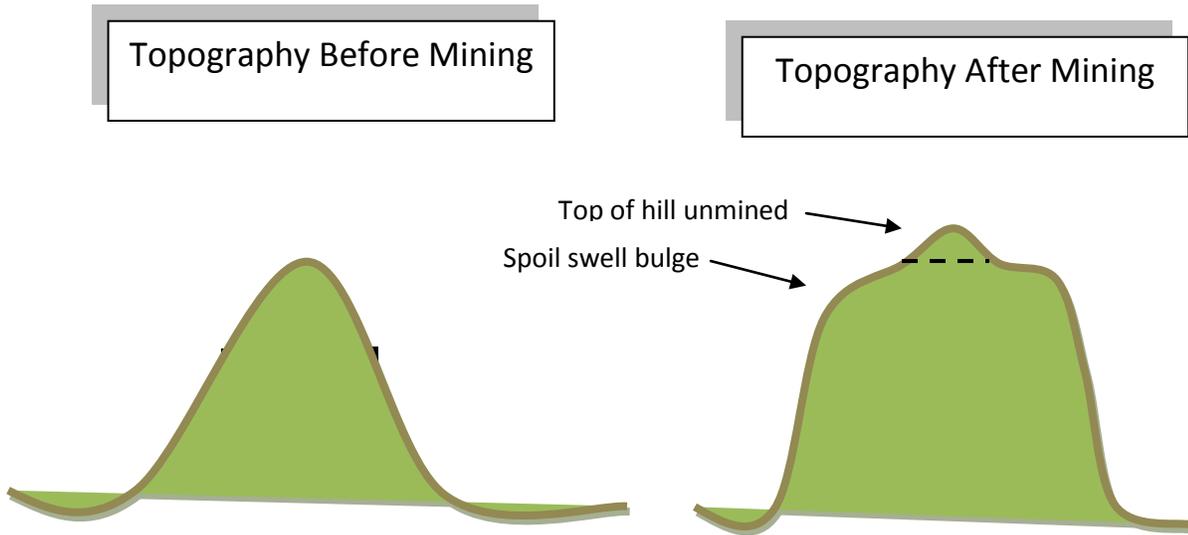
Figure 4: This simple illustration depicts the change in hill side morphology for some surface mines in Pennsylvania.

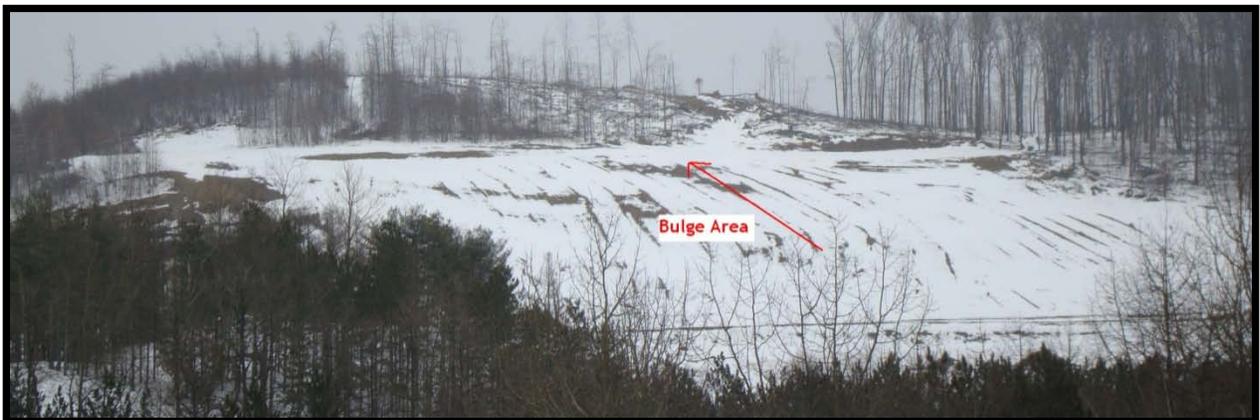
Photo 1: This photo of a recently backfilled contour strip mine shows a bulge in the middle of the hill side.

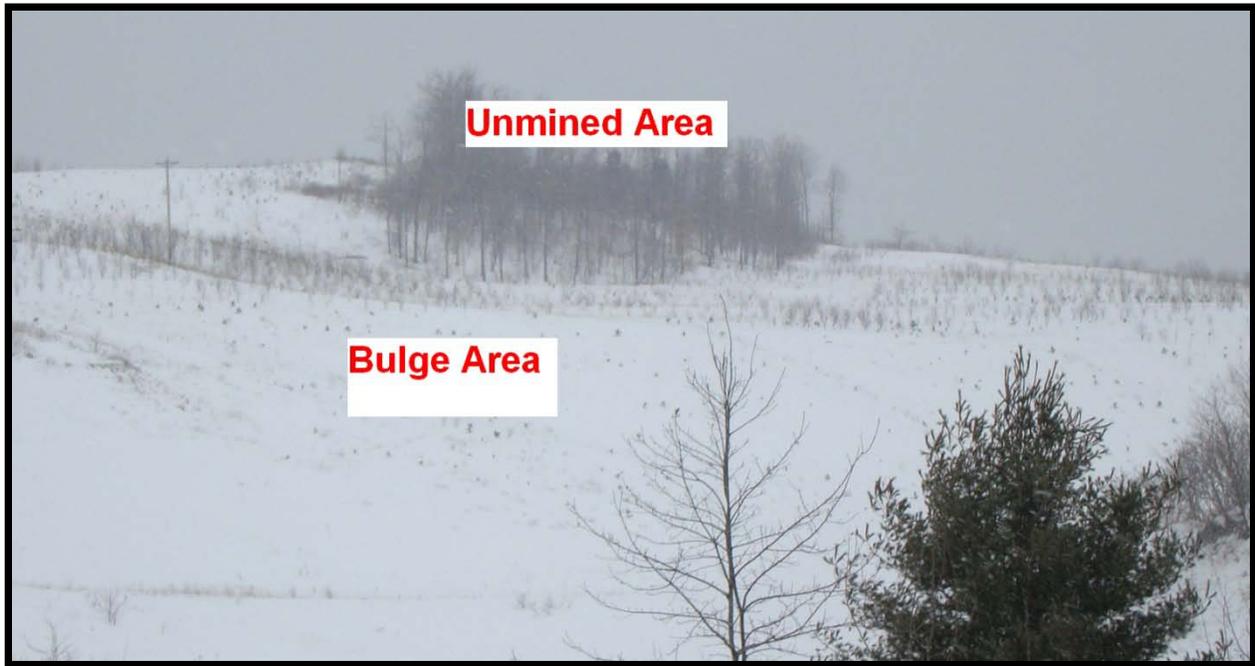
Photo 2: Photo of the MB Energy Brink operation reviewed during this study showing the bulge created by the spoil swell from the > 300 ft high wall. The obvious change in slope depicts the bulge area from the reclaimed area blended into the high wall.

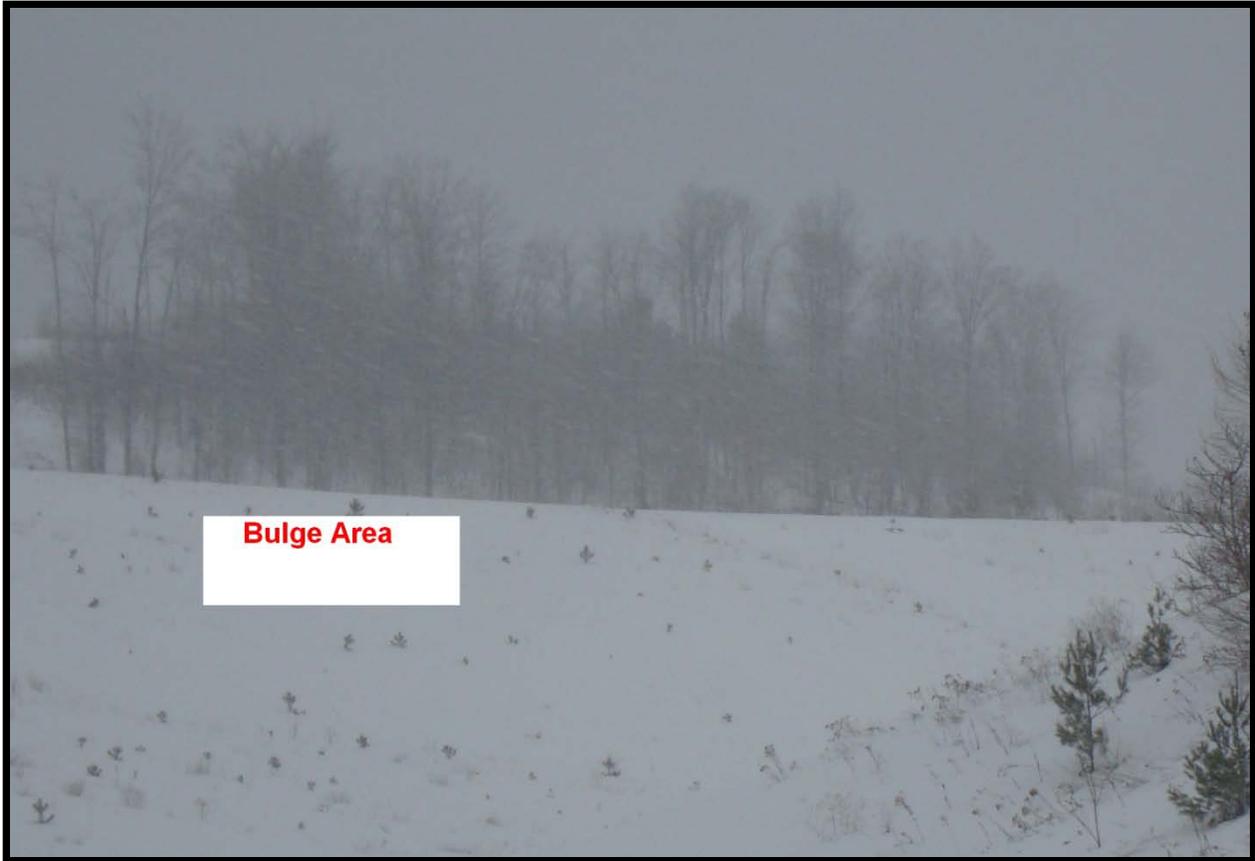
Photo 3: This is a close up photo of the bulge on the Brink operation. The change in slope created by the spoil swell is apparent.

Discussions with DEP staff show that the Pennsylvania program prefers to have the spoil swell “blended” into the reclamation, which results in some variation from the original elevation or morphology, rather than have the excess spoil be disposed of as an “excess spoil” fill in unmined areas or approve a variance from AOC. It is important to note that AOC is commonly achieved with the “spoil swell bulge” incorporated into reclaimed hill sides. The point of this discussion is to highlight one of the few AOC-related challenges in Pennsylvania; the hill side bulge is a relatively minor challenge at limited sites. This issue was one of the few AOC-related issues discussed by PADEP inspectors during this study. Inspectors minimize the shape of the bulge by ensuring operators keep grading more dirt from the spoil pile to the top of the high wall and bottom of the low wall until a relatively even blending/grading is achieved.

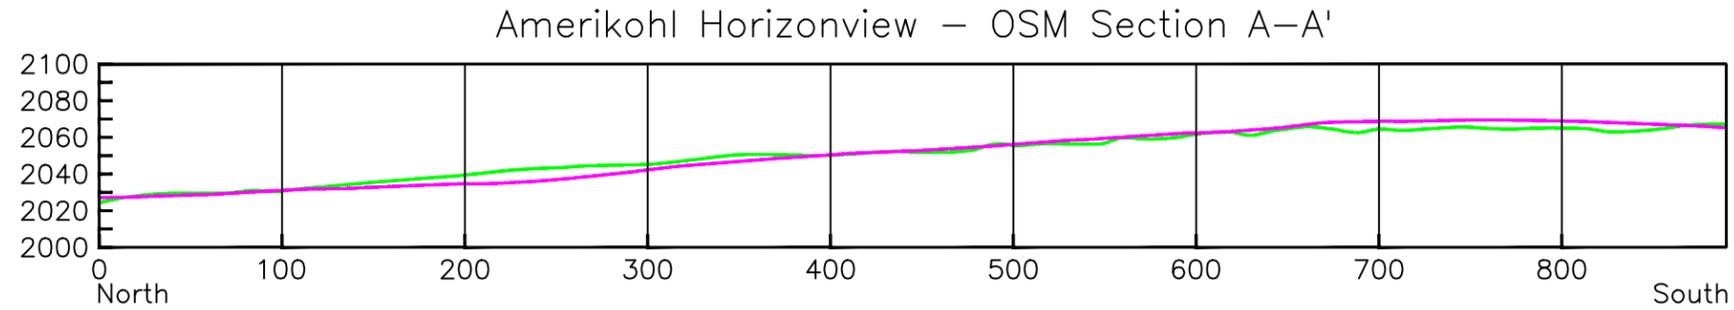
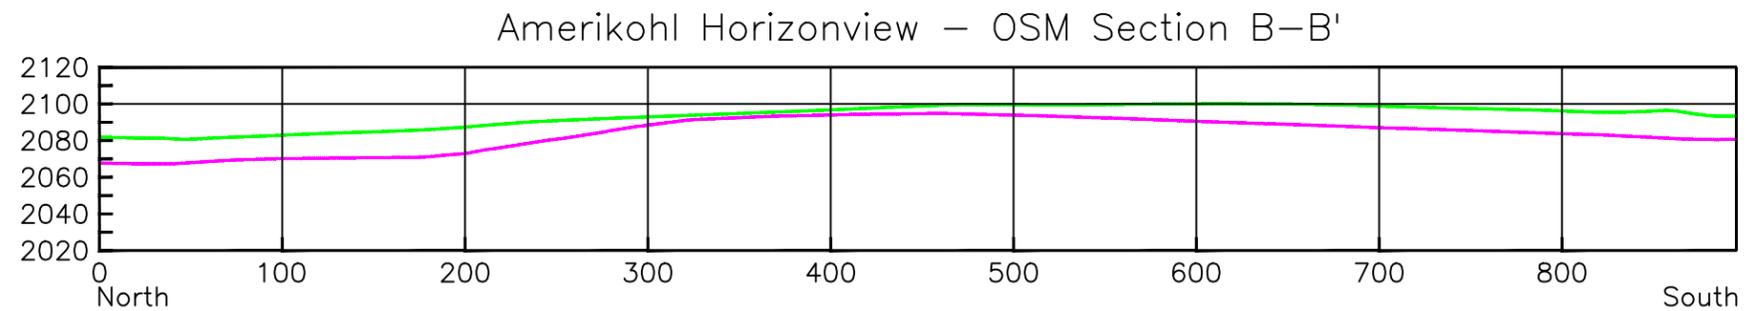
Figure 10

APPROXIMATE ORIGINAL CONTOUR PA 56060110 AMERIKOHL MINING HORIZON VIEW MINE
SECTIONS A-A' and B-B'
GPS CROSS SECTION FROM TOPO WITH FIELD GPS CROSS SECTION

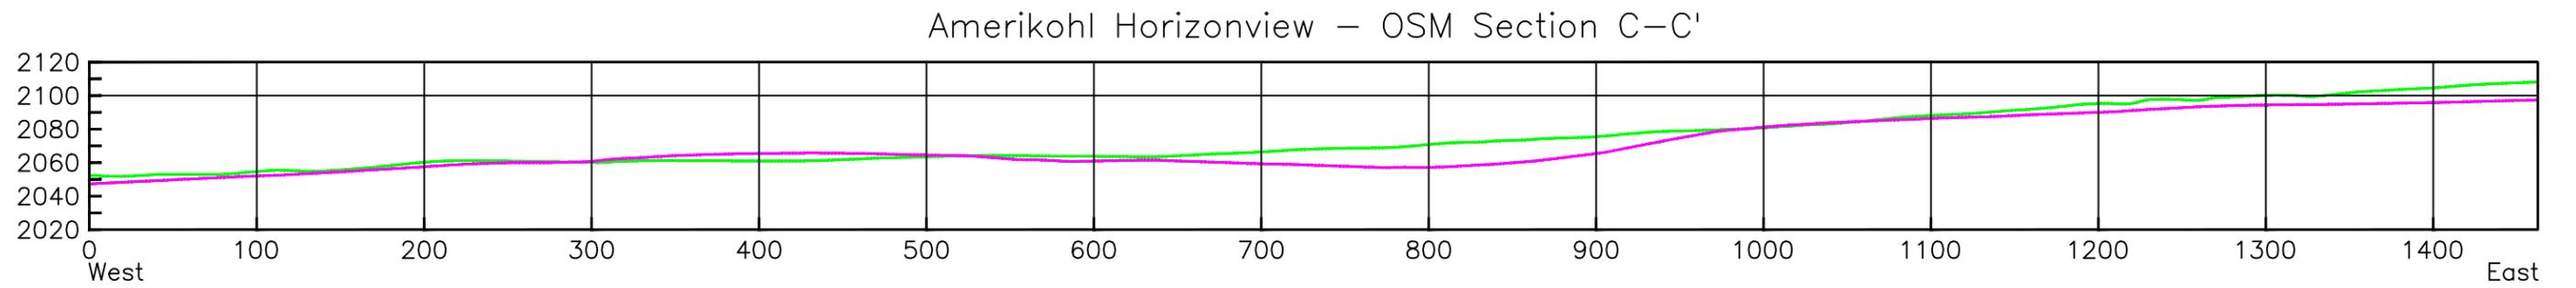
Figure 11

APPROXIMATE ORIGINAL CONTOUR
PA 56060110 AMERIKOHL MINING
HORIZON VIEW MINE
SECTION C-C'
GPS CROSS SECTION FROM TOPO WITH
FIELD GPS CROSS SECTION

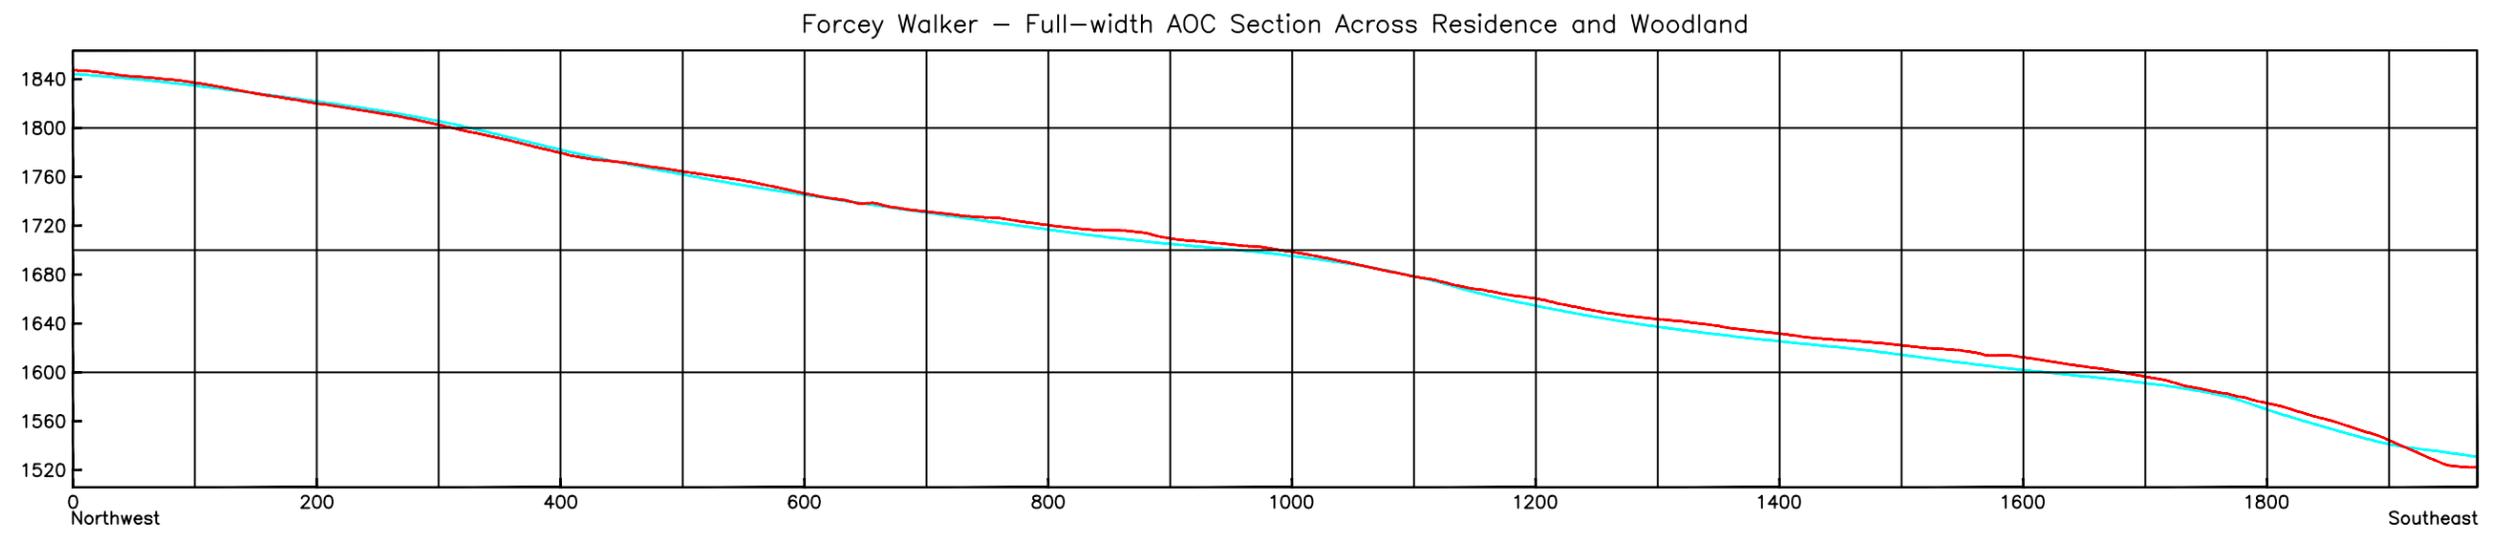
Figure 19

Results of PFL AOC Section. Location of x-section shown in Figure 17

APPROXIMATE ORIGINAL CONTOUR
PA FORCEY/WALKER
STEEP SLOPE AREA
FULL-WIDTH CROSS SECTION FROM PERMIT
REMOTE SENSING CROSS SECTION

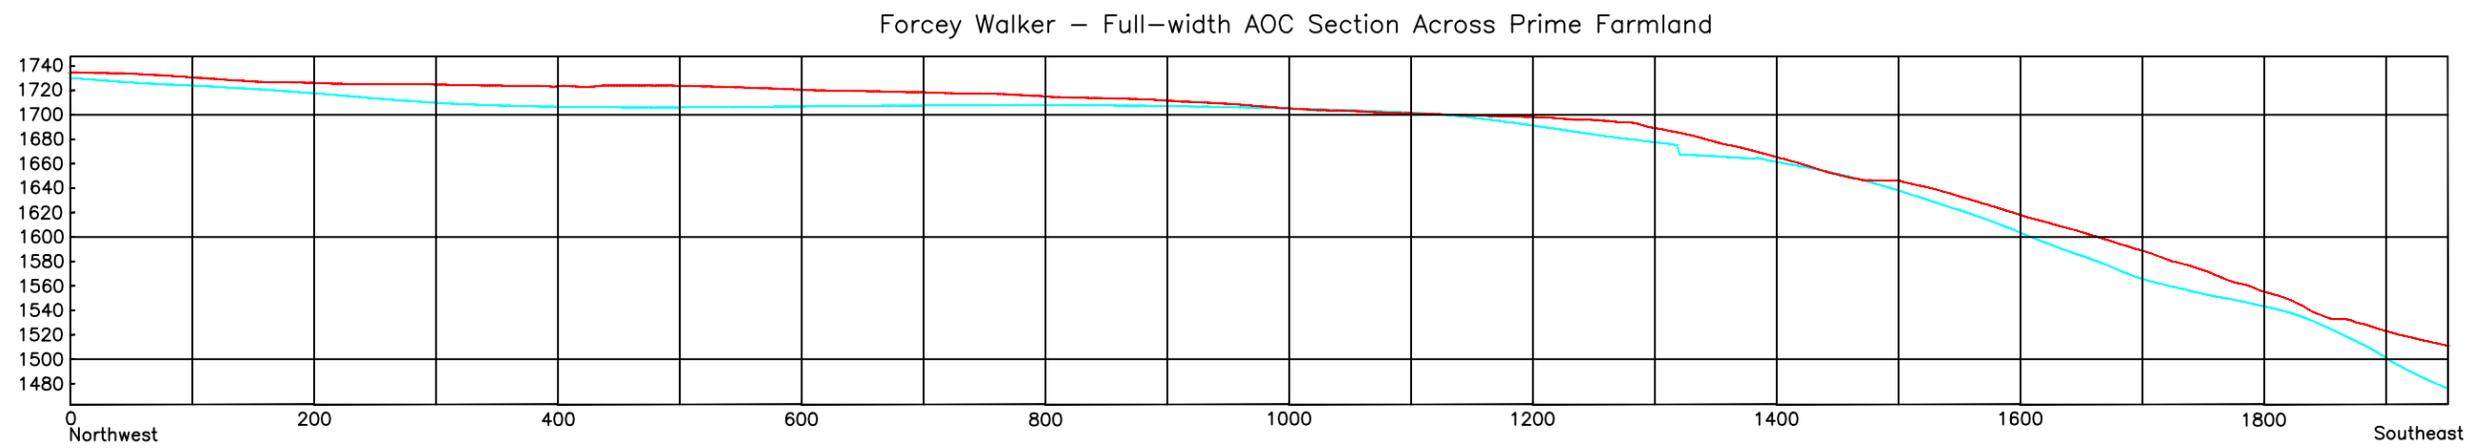
Figure 20

Location of Residential AOC x-section shown in Figure 17

APPROXIMATE ORIGINAL CONTOUR
PA FORCEY/WALKER
PRIME FARMLAND AREA
FULL-WIDTH CROSS SECTION FROM PERMIT
REMOTE SENSING CROSS SECTION

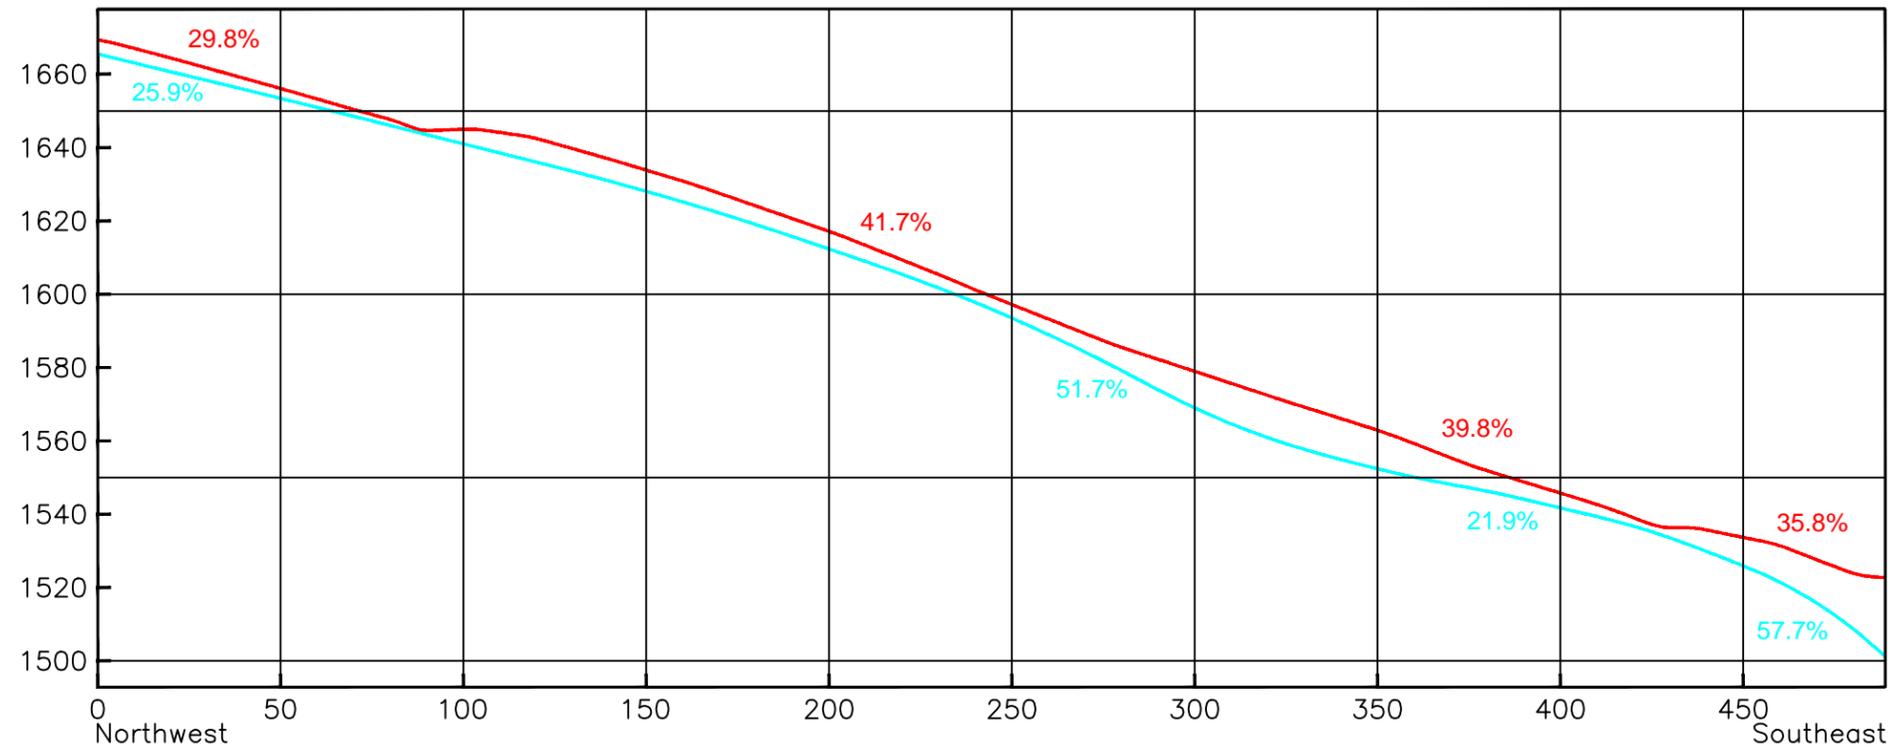
Figure 22

Forcey Walker – Steep Slope AOC Section

APPROXIMATE ORIGINAL CONTOUR
PA FORCEY/WALKER
STEEP SLOPE AREA
CROSS SECTION FROM PERMIT REMOTE SENSING CROSS SECTION

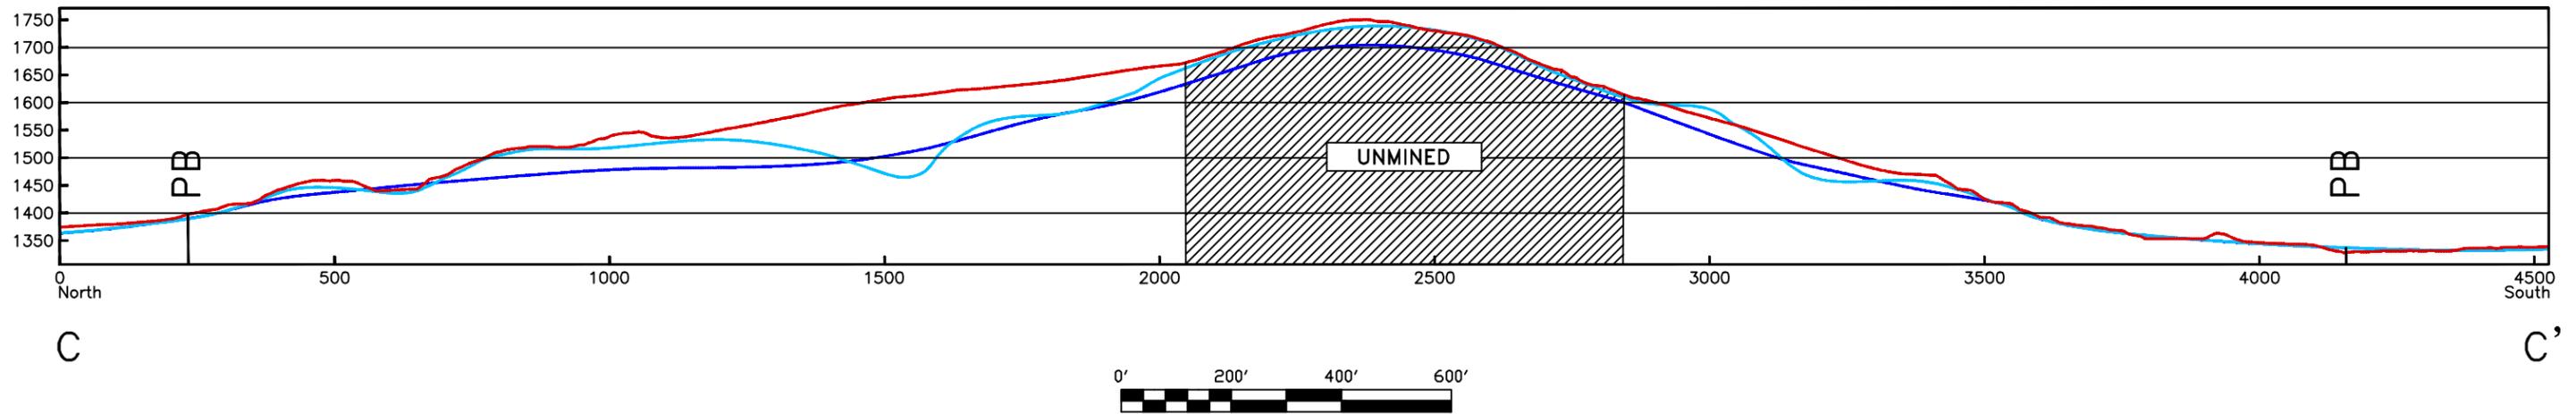
Figure 34

APPROXIMATE ORIGINAL CONTOUR
PA M.B. ENERGY, INC. BRINK #5
CROSS SECTION C-C'
OSM CROSS SECTION
WITH PRE AND POST MINING DATA

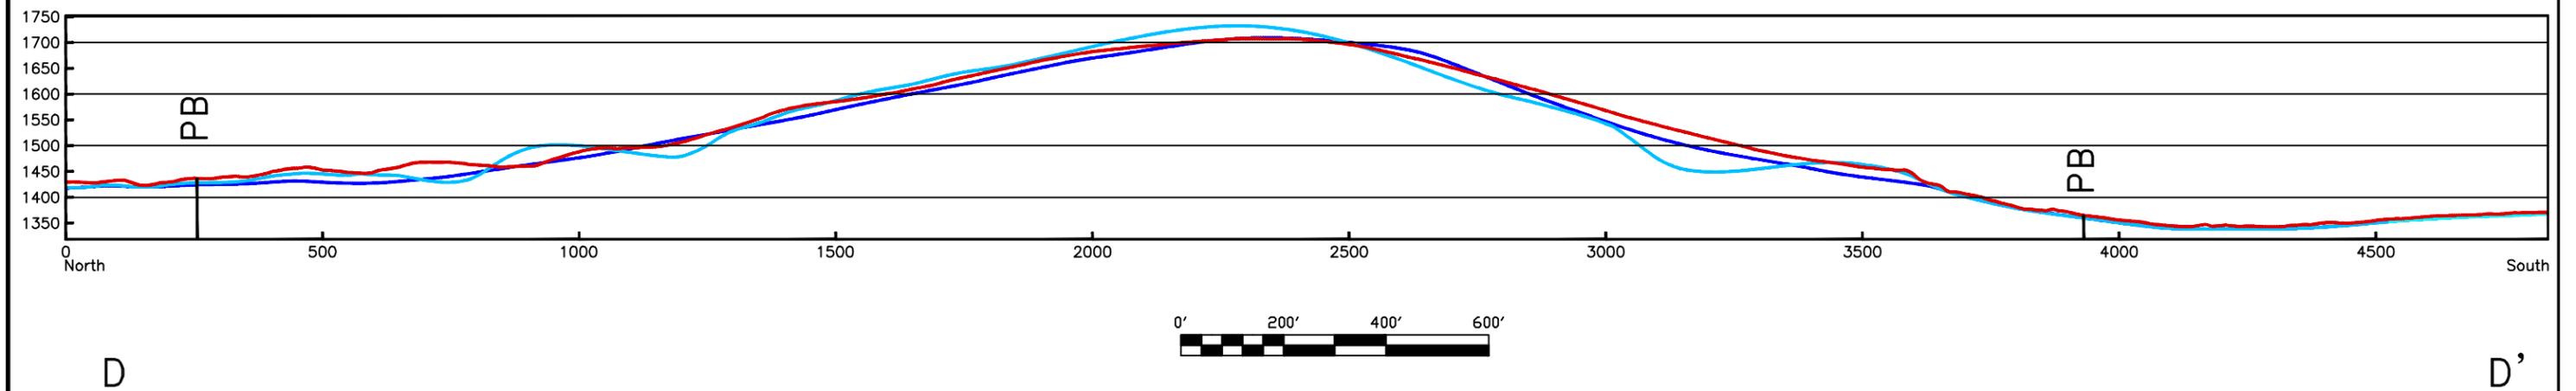
Figure 35

APPROXIMATE ORIGINAL CONTOUR
PA M.B. ENERGY, INC. BRINK #5
CROSS SECTION D-D'
OSM CROSS SECTION
WITH PRE AND POST MINING DATA

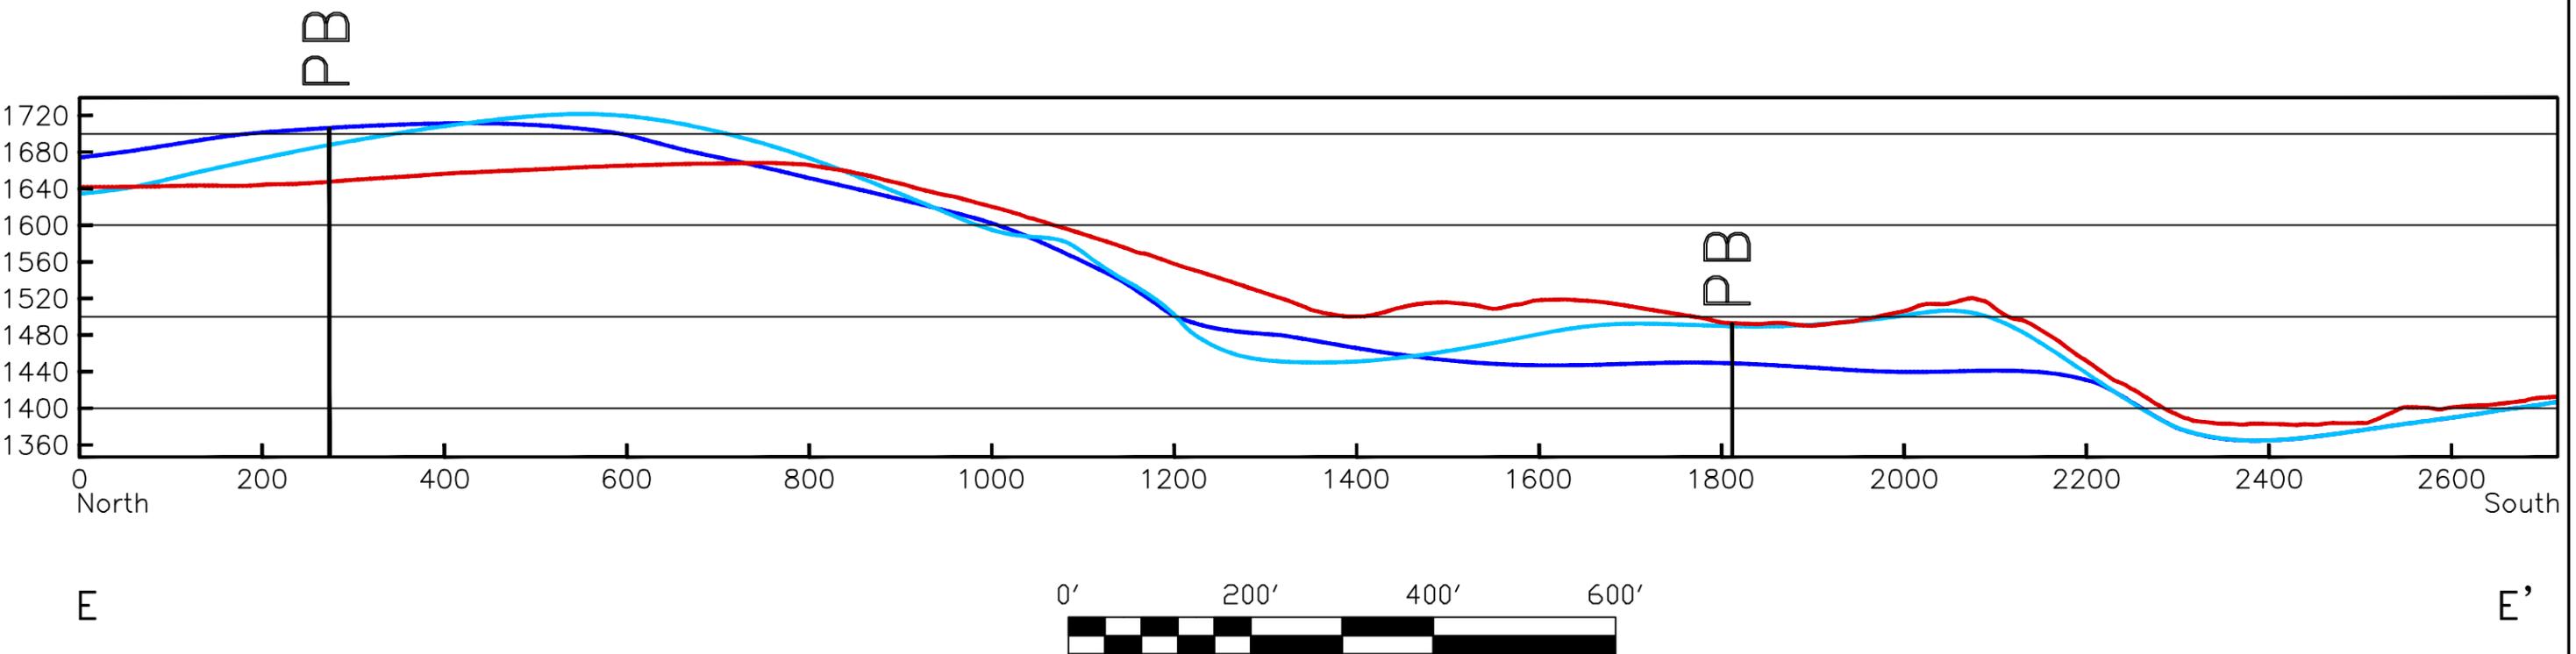
Figure 36

APPROXIMATE ORIGINAL CONTOUR
PA M.B. ENERGY, INC. BRINK #5
CROSS SECTION E-E'
OSM CROSS SECTION
WITH PRE AND POST MINING DATA

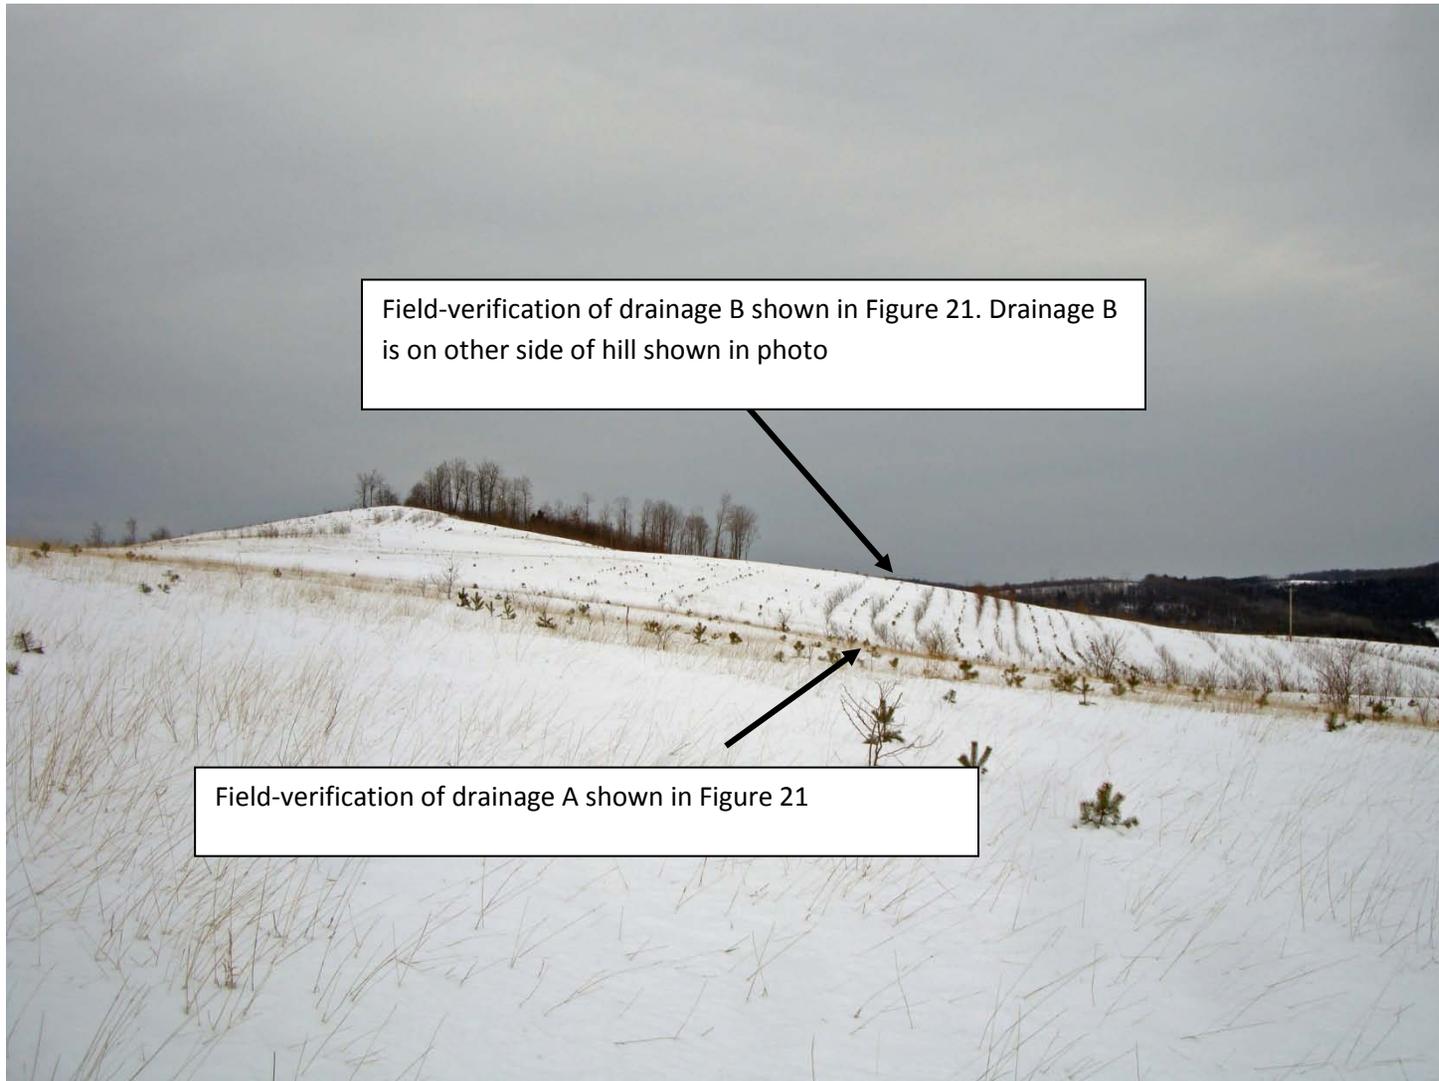
Photo 14

Field-verification of drainage B shown in Figure 21. Drainage B is on other side of hill shown in photo

Field-verification of drainage A shown in Figure 21

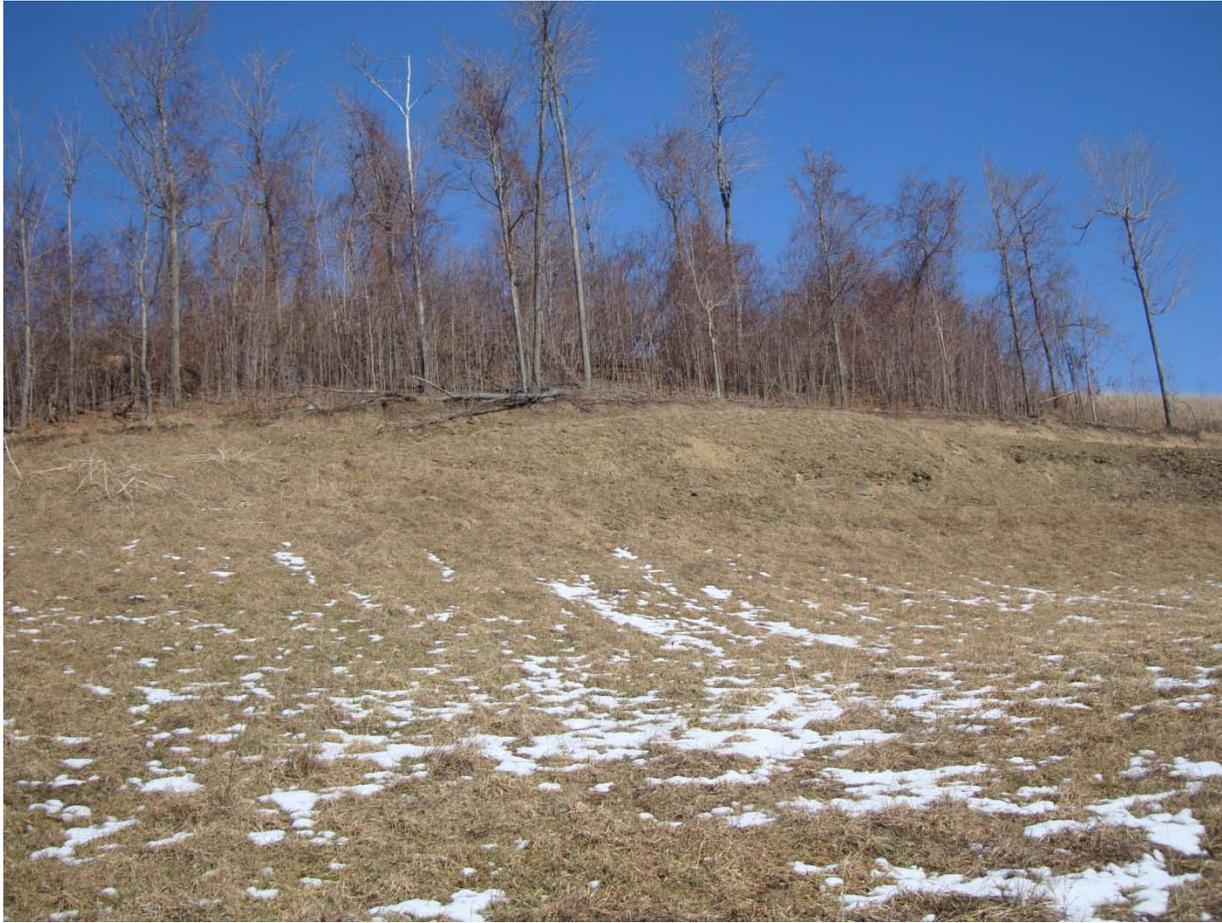
Photo 15

Photo showing the blending of the reclaimed land into the unmined land

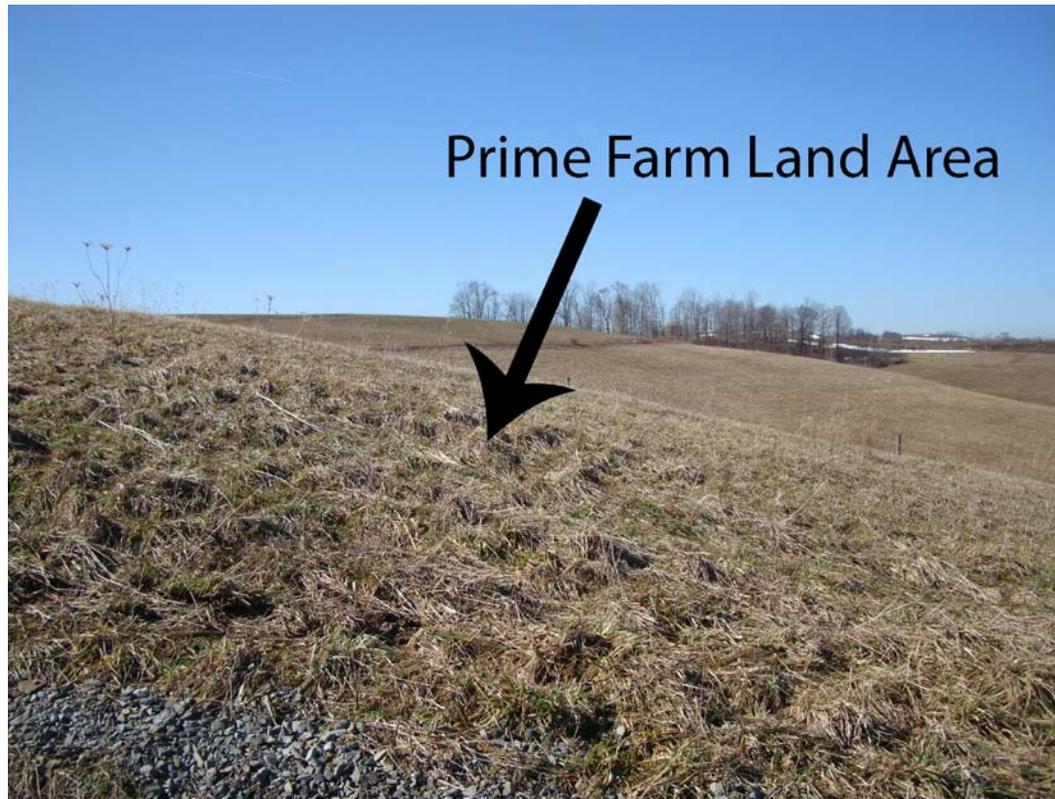
Photo 16

Photo showing the reclamation of the prime farm lands.

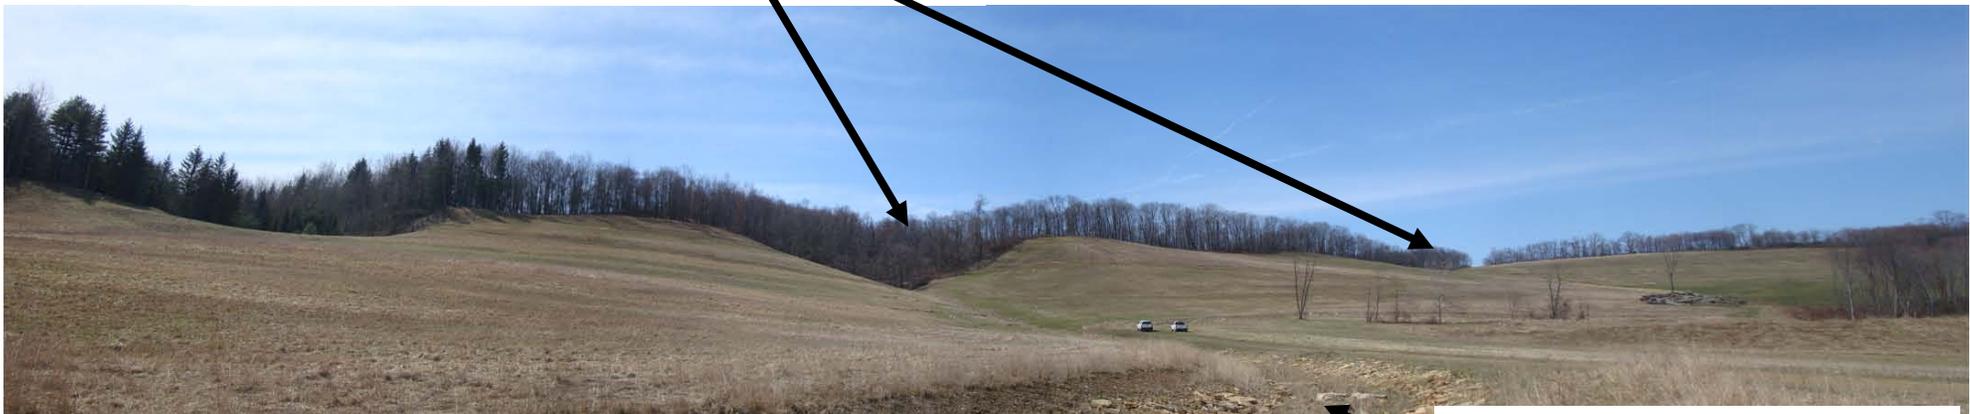
Photo 17

Reconstructed Intermittent stream
drainages

Intermittent stream
reconstruction

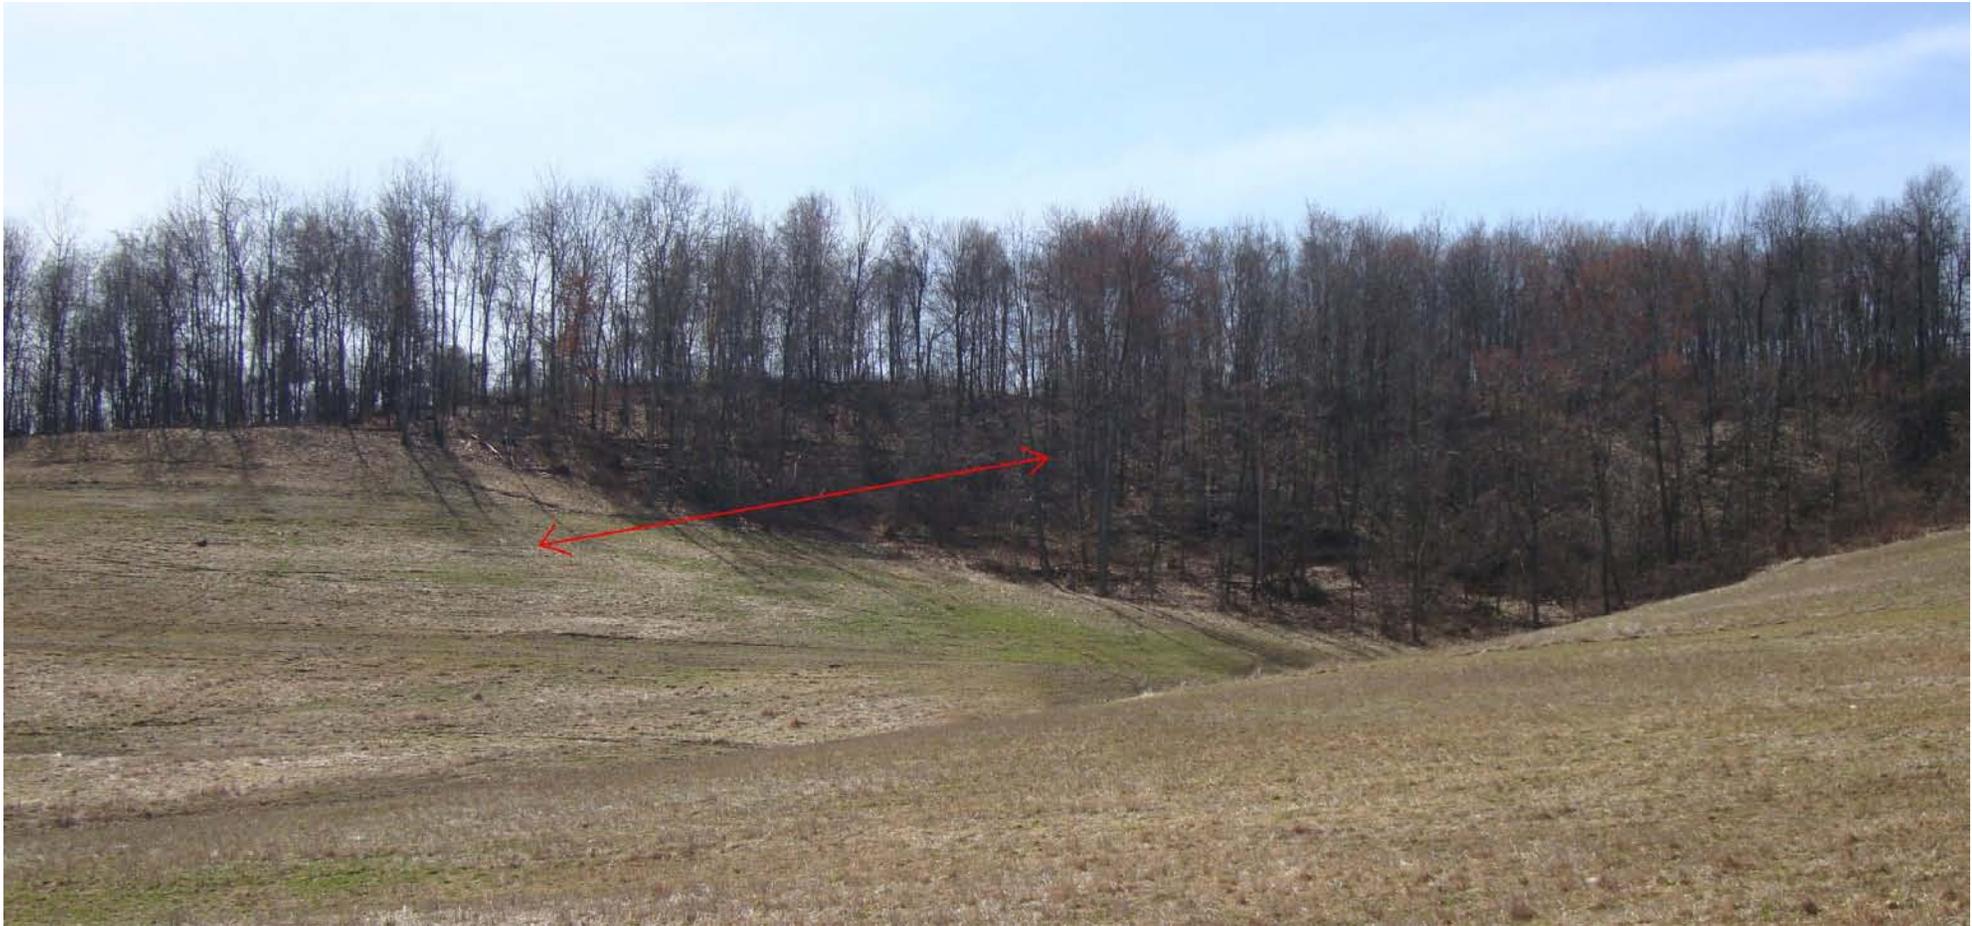
Photo 18

Photo showing how the reclaimed hillside blends into the surrounding topography
