Excess Spoil Minimization and Fill Stability

Peter Michael¹ and Mike Superfesky²

EXCESS SPOIL MINIMIZATION AND FILL STABILITY

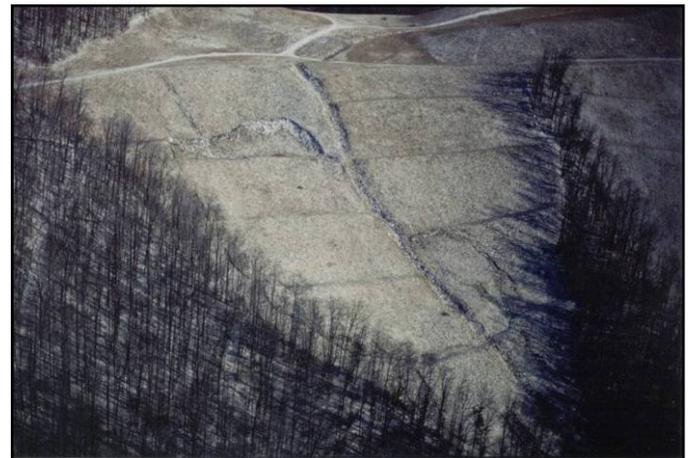
- For fills resting on steeper foundation slopes, the most critical failure surface was non-circular and was located at shallow depth in the colluvium parallel to the spoil-colluvium interface;
- The presence of a weak layer underlying the structure had a significant impact on the stability safety factor, causing a decrease from 1.81 (for rock-like foundation material) to 1.14 (for colluvium with a 24-degree friction angle); and
- For both non-circular and circular failure surfaces, the depth of colluvium below the fill (starting at two feet) did not affect the stability safety factor.

Figure 10. Translational Land Slips on a Durable Rock Fill.

In conclusion, the study emphasized that the identification of soil-like material in the foundation of a proposed excess spoil fill—and the use of accurate foundation shear strength properties—is essential for a realistic valley fill stability analysis. Absence of soil-like properties in the analysis should only coincide with the permit applicant’s documented intent to remove the soil from the fill footprint prior to excess spoil placement.

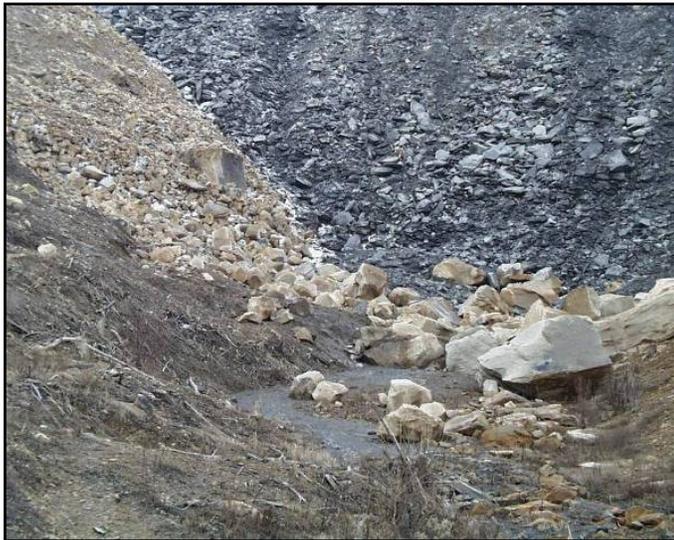
Figure 11. Comparative Effectiveness of Gravity Segregation between Sandstone and Shale Particles at Toe of Durable Rock Fill Under Construction.

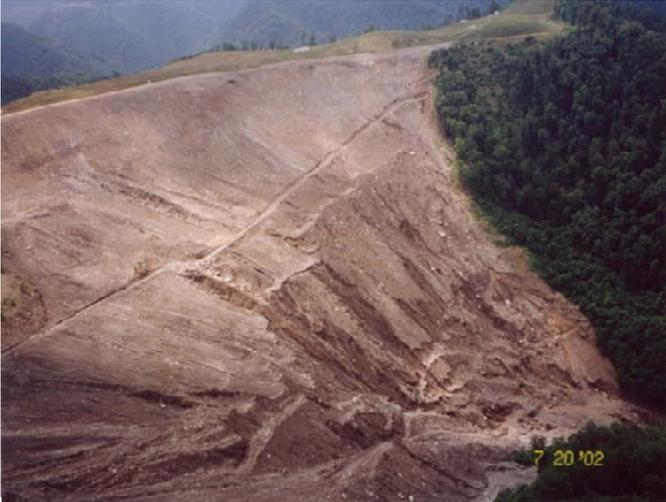
Some of the most dramatic cases of fill-associated erosion, wash-out sedimentation, and localized flooding took place during the last five years West Virginia (Figures 12 and 13). These events followed high intensity rainfall and occurred in small watersheds containing unreclaimed or partly unreclaimed valley fills. Temporary surface drainage structures were not adequate to handle the high discharge flow. Consequently large volumes of water cascaded over the fill outslpces; causing sloughing and erosion of un-compacted spoil, breaching of sediment ponds, and downstream flooding. The most severe instance occurred at Lyburn, in Logan County WV on July 18, 2002 when heavy rains occurred while the face of the fill was being regraded to final configuration.

Figure 12. Erosion and Sloughing on Fill Face from Uncontrolled Storm Runoff. Photographed by WVDEP.

OSM investigations of these major washout events indicated that future impacts from heavy precipitation can be minimized by: (1) timely and phased reclamation; (2) proper installation and maintenance of surface drainage; (3) proper location of the fills; (4) minimization of additional disturbance of the surrounding area; (5) building in extra sediment and flood storage facilities; and (6) following proper fill certification procedures. However, it is important to note that at least most of these measures should also be used to minimize more gradual erosion over a fill face over an extended time period. Ironically, those less severe cases may be more damaging to the long-term mass stability of a fill, since they receive less public attention and consequently may benefit less from remediation.

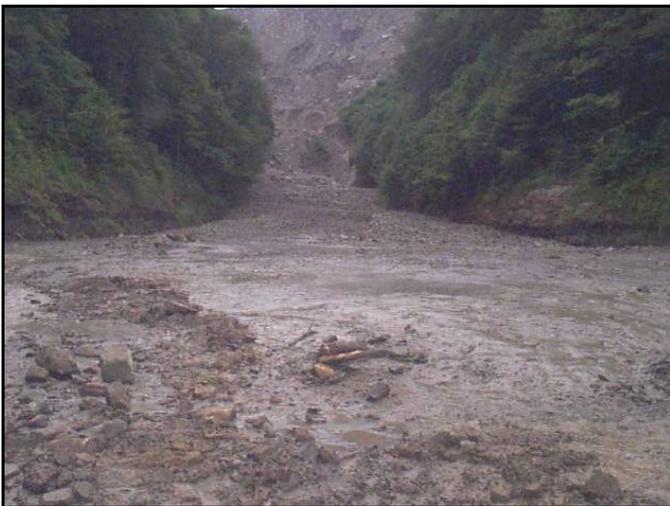
Figure 13. Post-Storm Mudflow and Outwash from Unreclaimed Durable Rock Fill with Inadequate Surface Drainage Control.

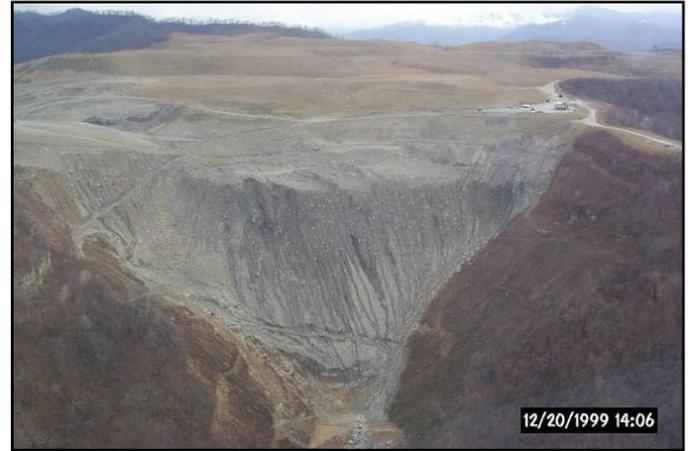
The EIS stability study noted that some durable rock fills had been abandoned for long periods of time following partial construction. It found eight cases of unreclaimed durable rock fills where end-dumping or regrading-and-seeding work had not occurred for a year or more (Figure 14).

Figure 14. Durable Rock Fill Lacking Contemporaneous Reclamation.

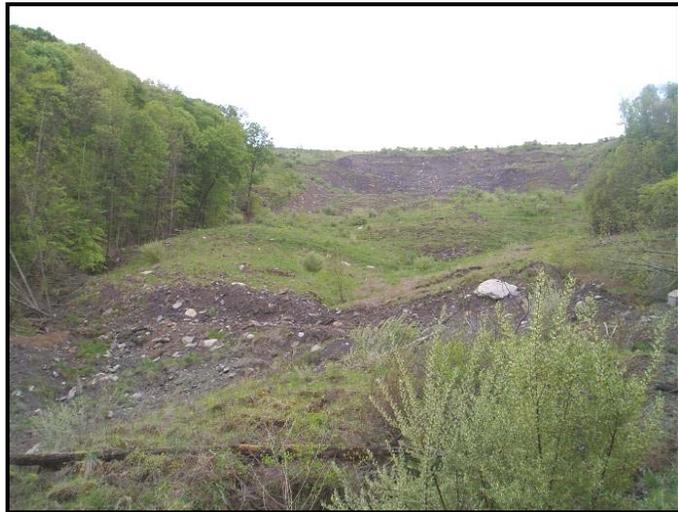
Figure 15. General View of Landslide on Durable Rock Fill, Looking Upslope from Toe.

Not counting tension cracks in otherwise intact portions of the fill face, the landslide affected approximately 90 to 95 percent of the structure. The crown-to-toe length was approximately 1,160 ft.; the

maximum width between side scarps, about 600 ft.; and the vertical drop and lateral transport distances were approximately 200 and 260 ft., respectively. In addition to the 200 ft. deep head scarp, the slide morphology also included a smaller scarp close to the landslide toe.

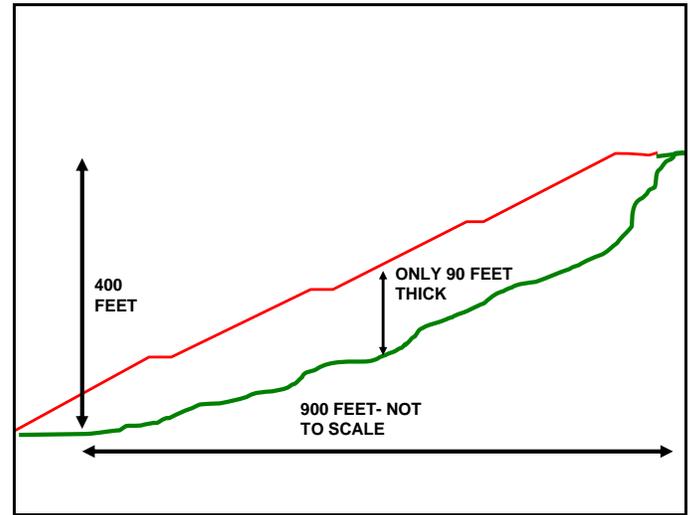
Figure 16. Schematic Cross Section of Fill 1 Prior to Failure.

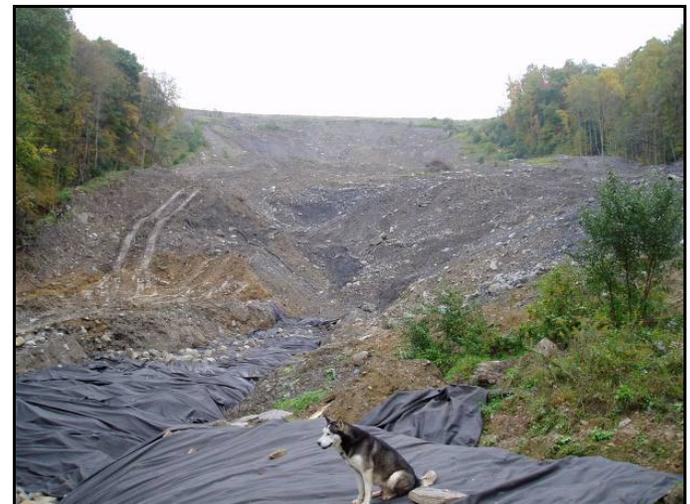
The spoil materials exposed in the landslide scarps were poorly sorted, exhibiting a roughly even volumetric distribution of clay-to-gravel grain sizes (Figure 17). Assuming that the relative amount of gravels and boulders in the observable spoil was roughly indicative of the amount of durable rock present, an OSM investigator estimated to percent durable rock by volume to be somewhere between 30 and 40 percent. There was no evidence of gravity segregation of particle size in the exposures of the spoil.

Figure 17. Particle Size Distribution at the Toe of Fill 1. The photograph was taken by KYDNR during remediation in October 2006.

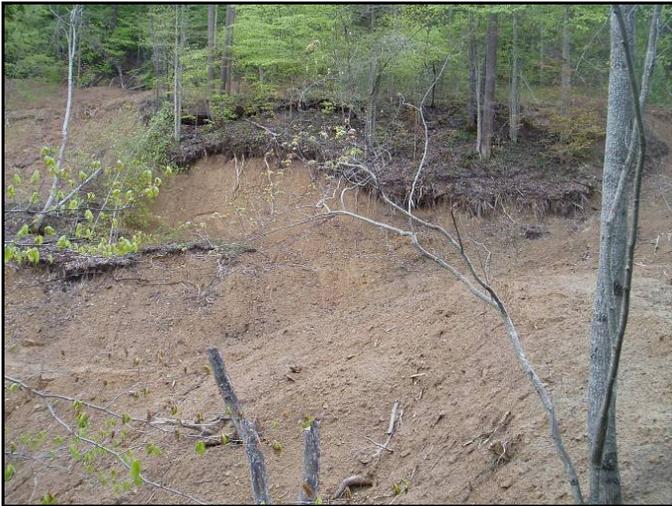
Evidence of another potential factor behind the failure was found just beyond the toe of the slide: a thick sequence of colluvium and deeply weathered bedrock, exposed by the construction of a new settlement pond and haulage road, may be indicative of weak foundation conditions beneath the fill (Figure 18).

Figure 18. Colluvium and Weathered Bedrock Near Toe of Fill 1.

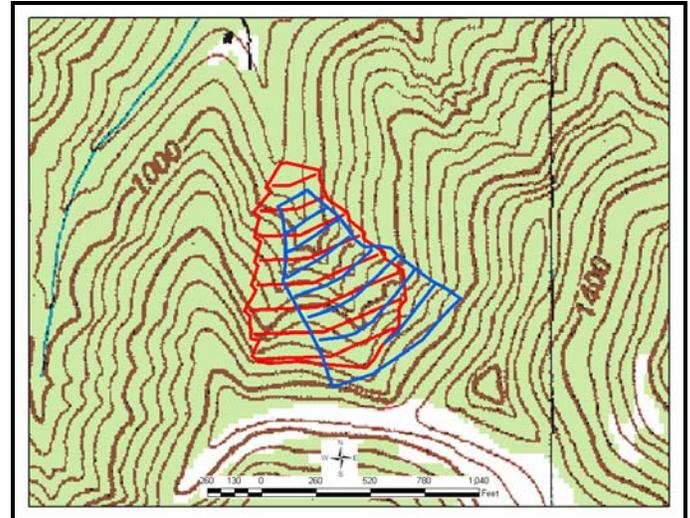
Figure 19. Shift in Fill 1 Location from As-Designed (Red) to As-Built (Blue).
