Coal Mine Impoundment Safety

D. E. Stump Jr. PE
Office of Surface Mining
Appalachian Region,
Pittsburgh, PA

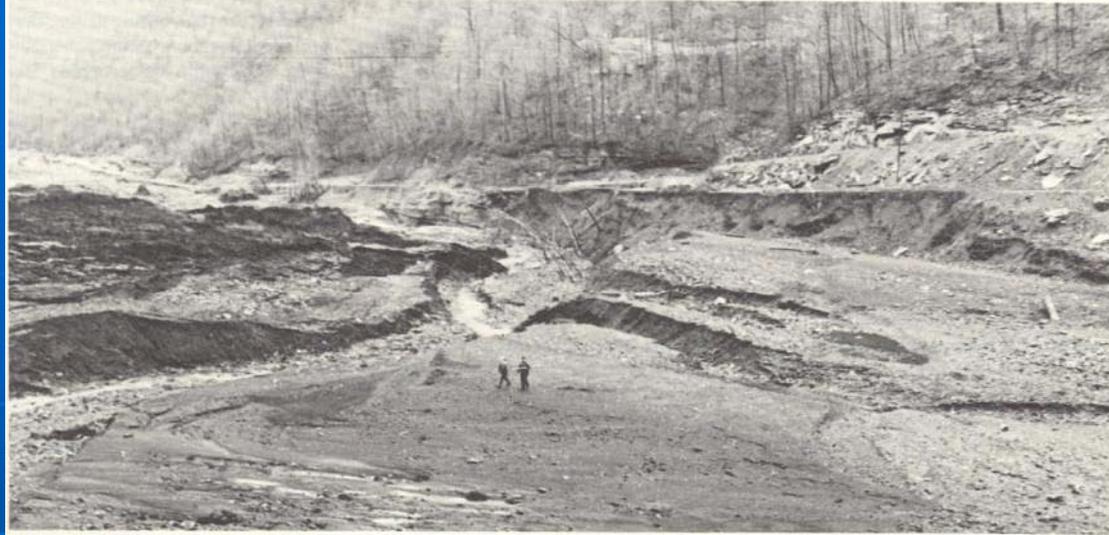
Citizen Commissioners inspect . . .

. . . the bed of Dam # 3 and remnants of its right abutment bordering the mine haul road.

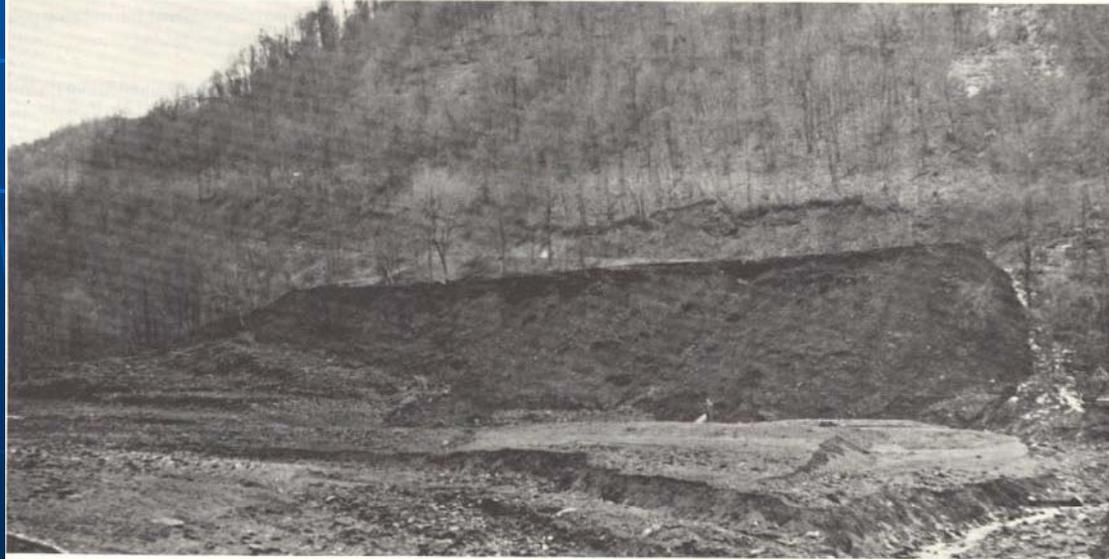
. . . the opposite abutment, noting the vertical disappearance of the entire length of Dam # 3.

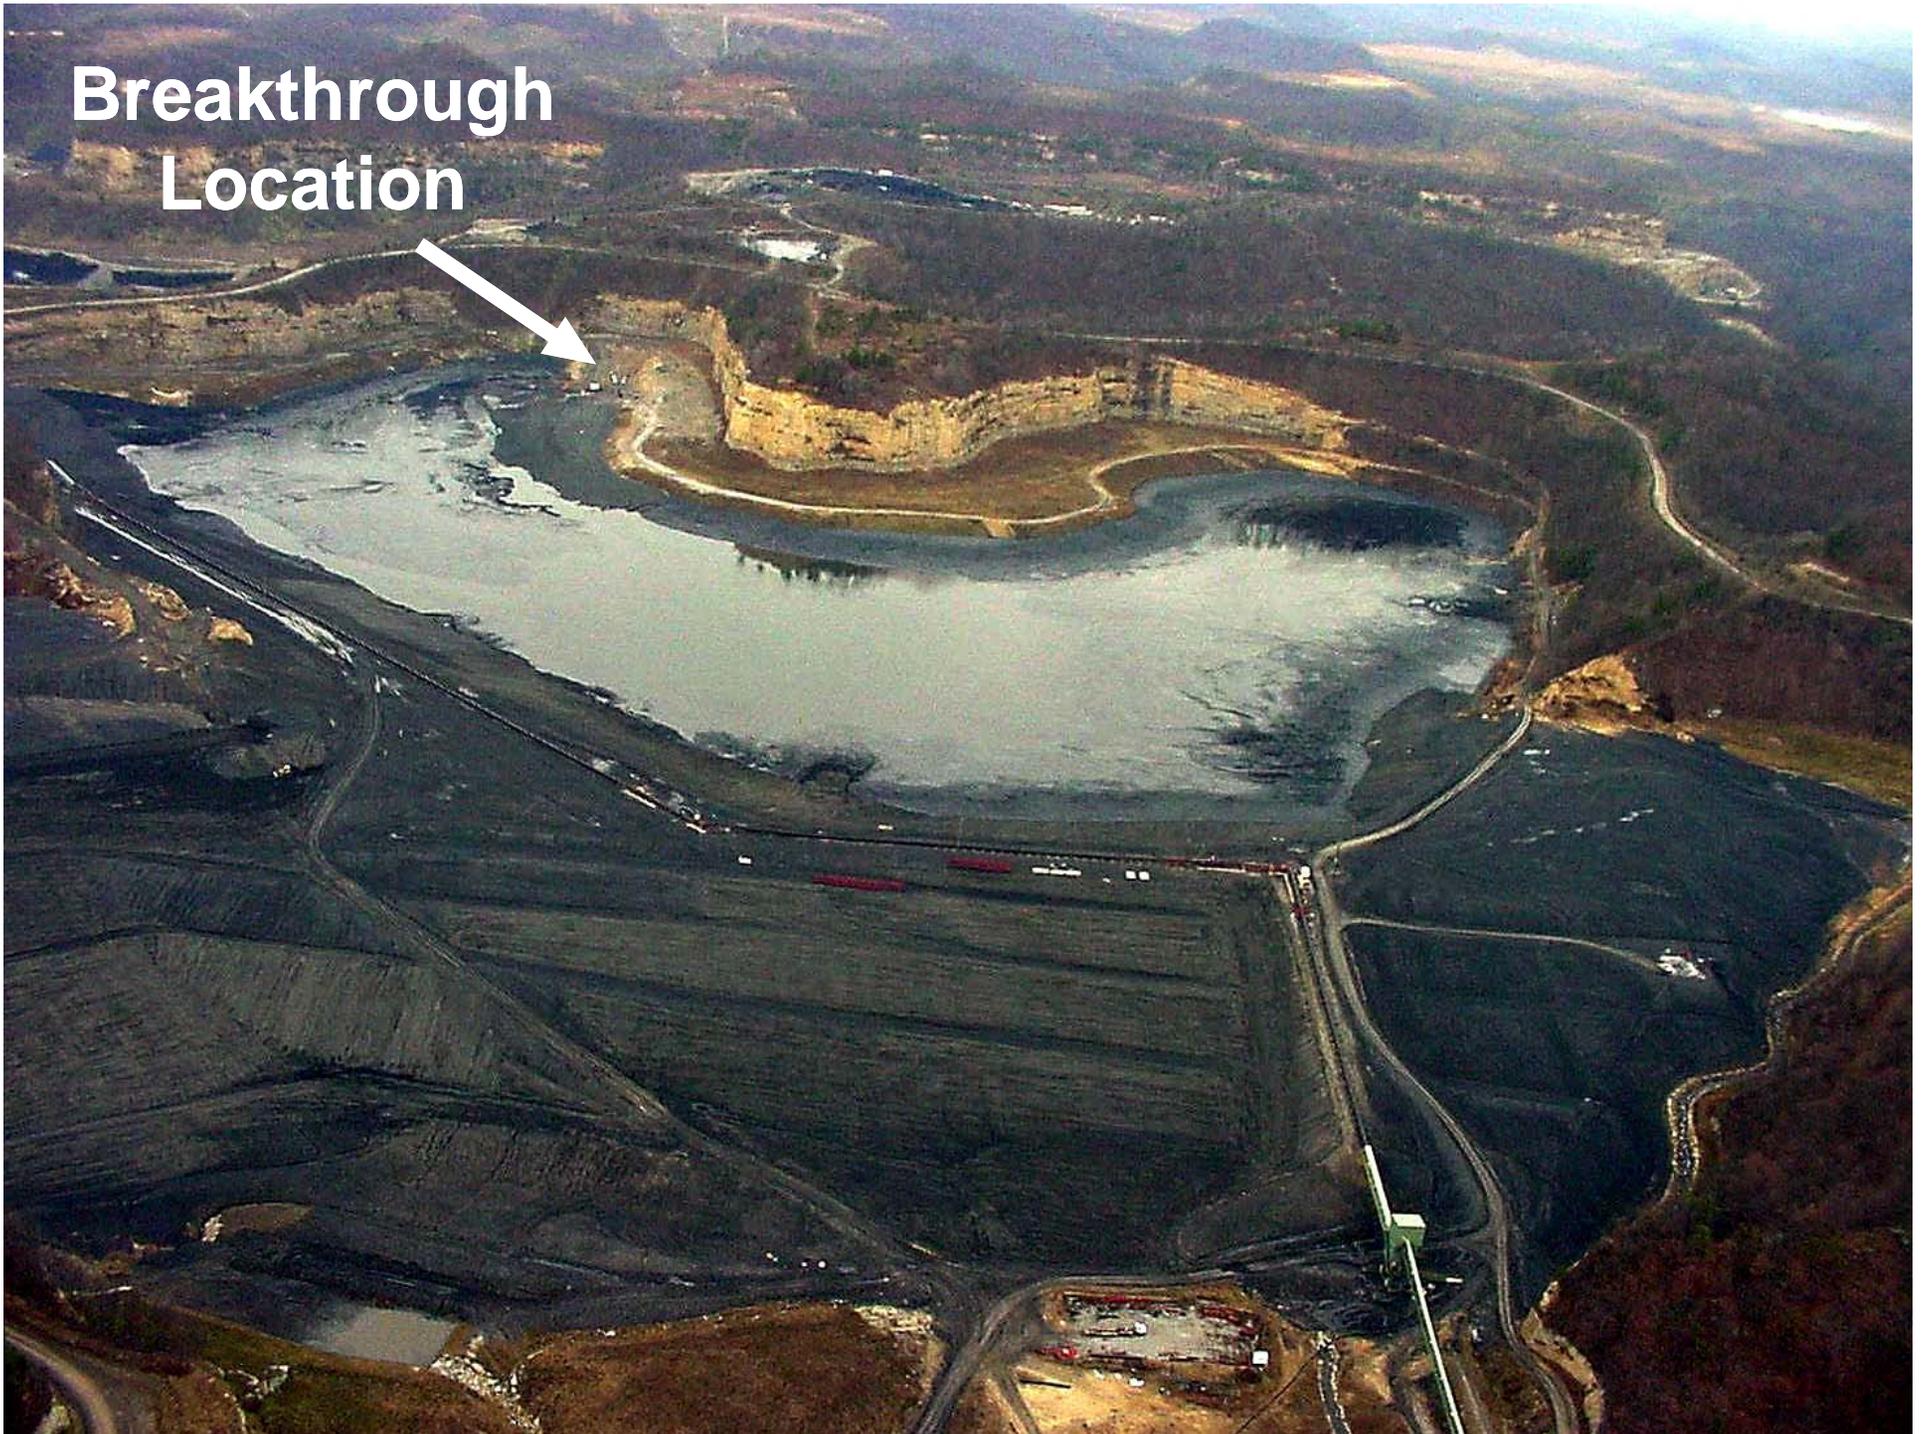
**Breakthrough
Location**

The embankment did not fail

The coal waste slurry flowed
through underground mine
workings

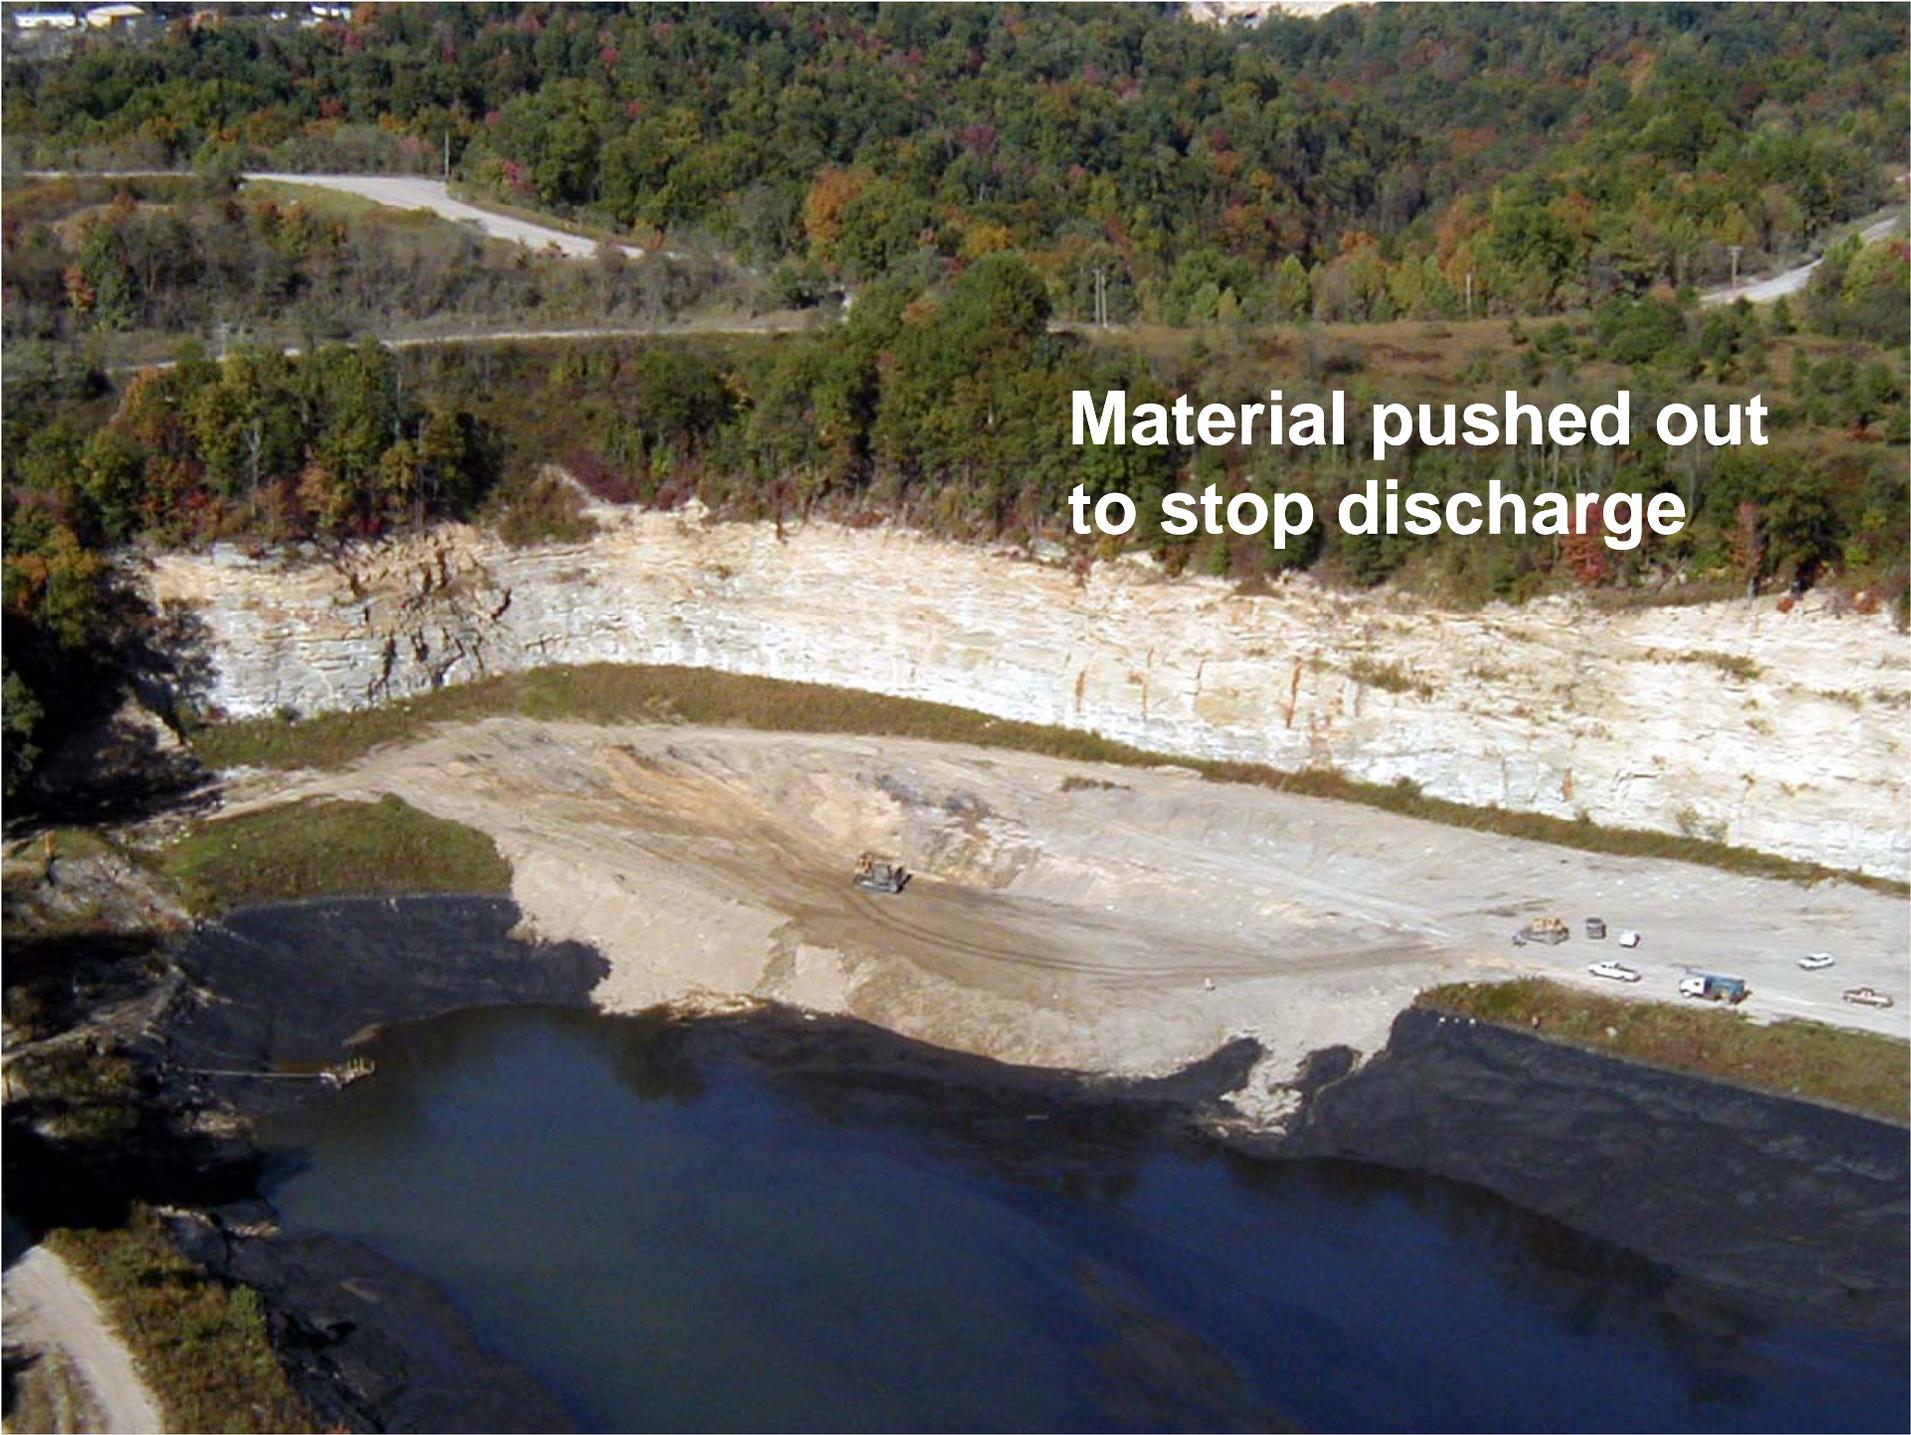
**Material pushed out
to stop discharge**

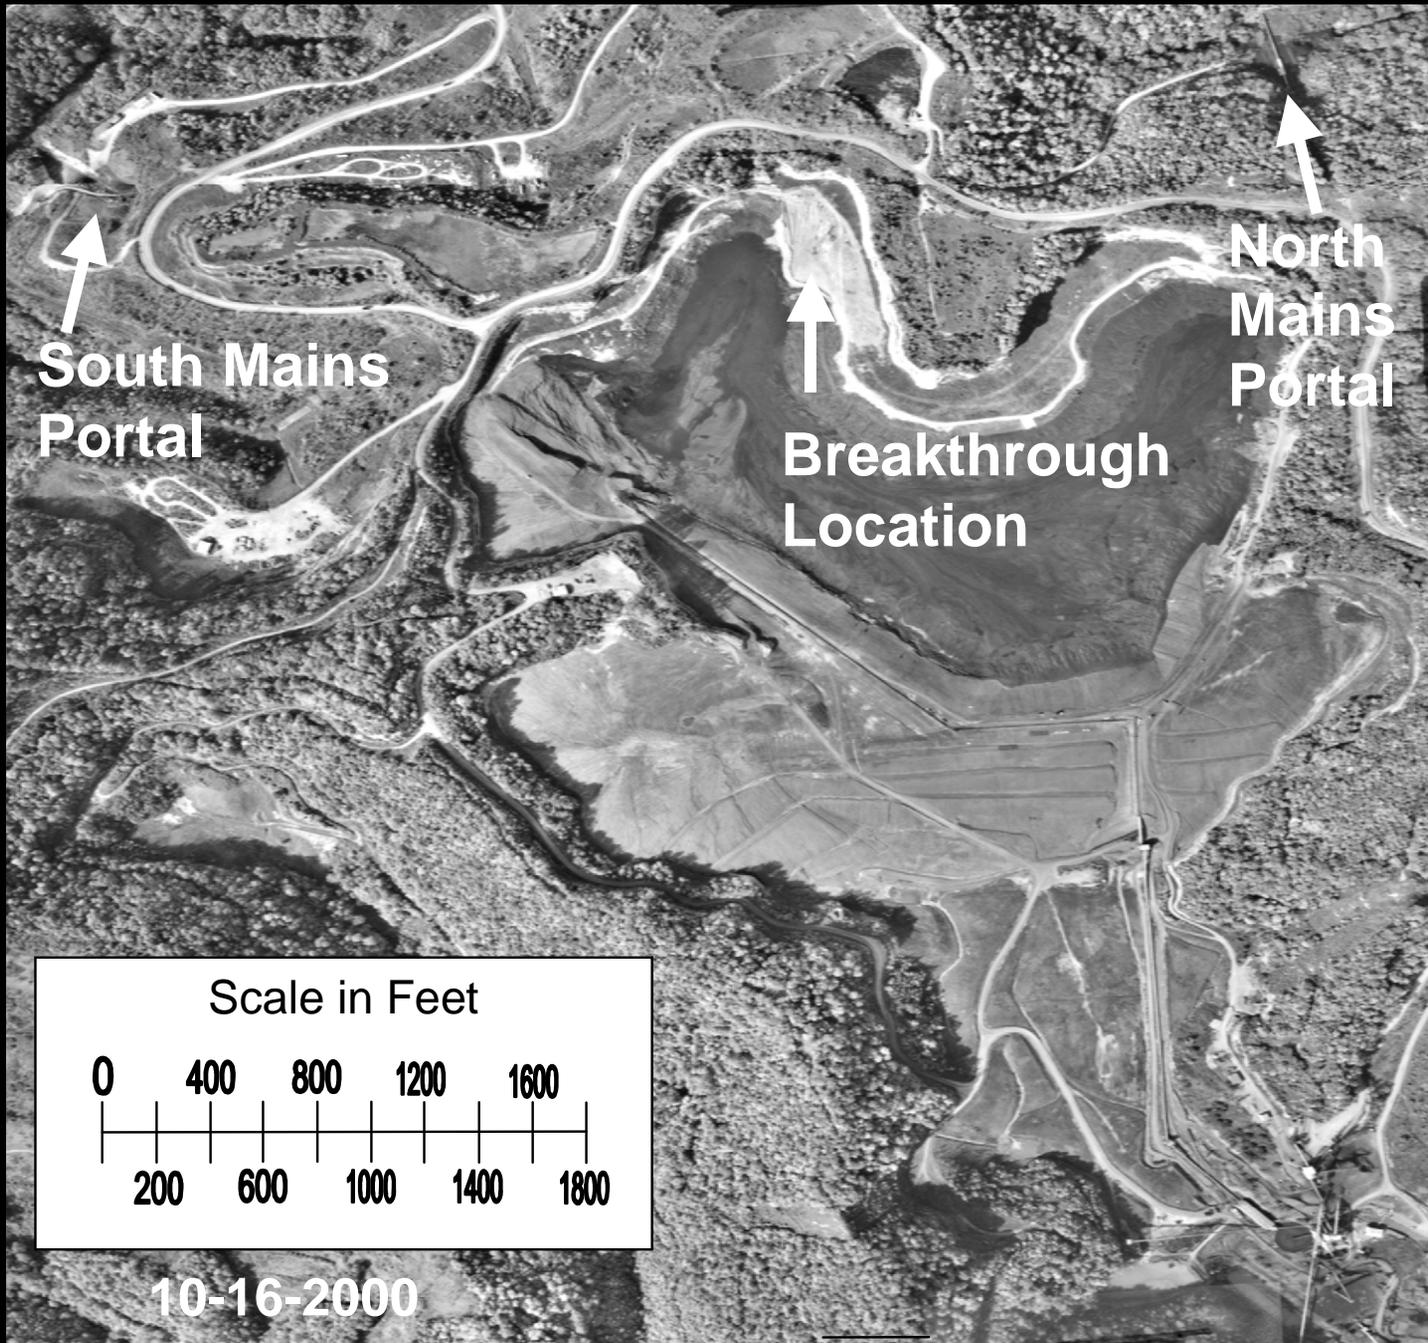
**South Mains
Portal**

**Breakthrough
Location**

**North
Mains
Portal**
