Remediation of a Failed Primary Spillway Device at a High Hazard Classification Impoundment

George R. Gunn
Reclamation Specialist
Knoxville Field Office
Office of Surface Mining

The *other* impoundment is: “the freshwater lake”, and is associated with one of the preparation plants and is the subject of this discussion.

January 22, 2009

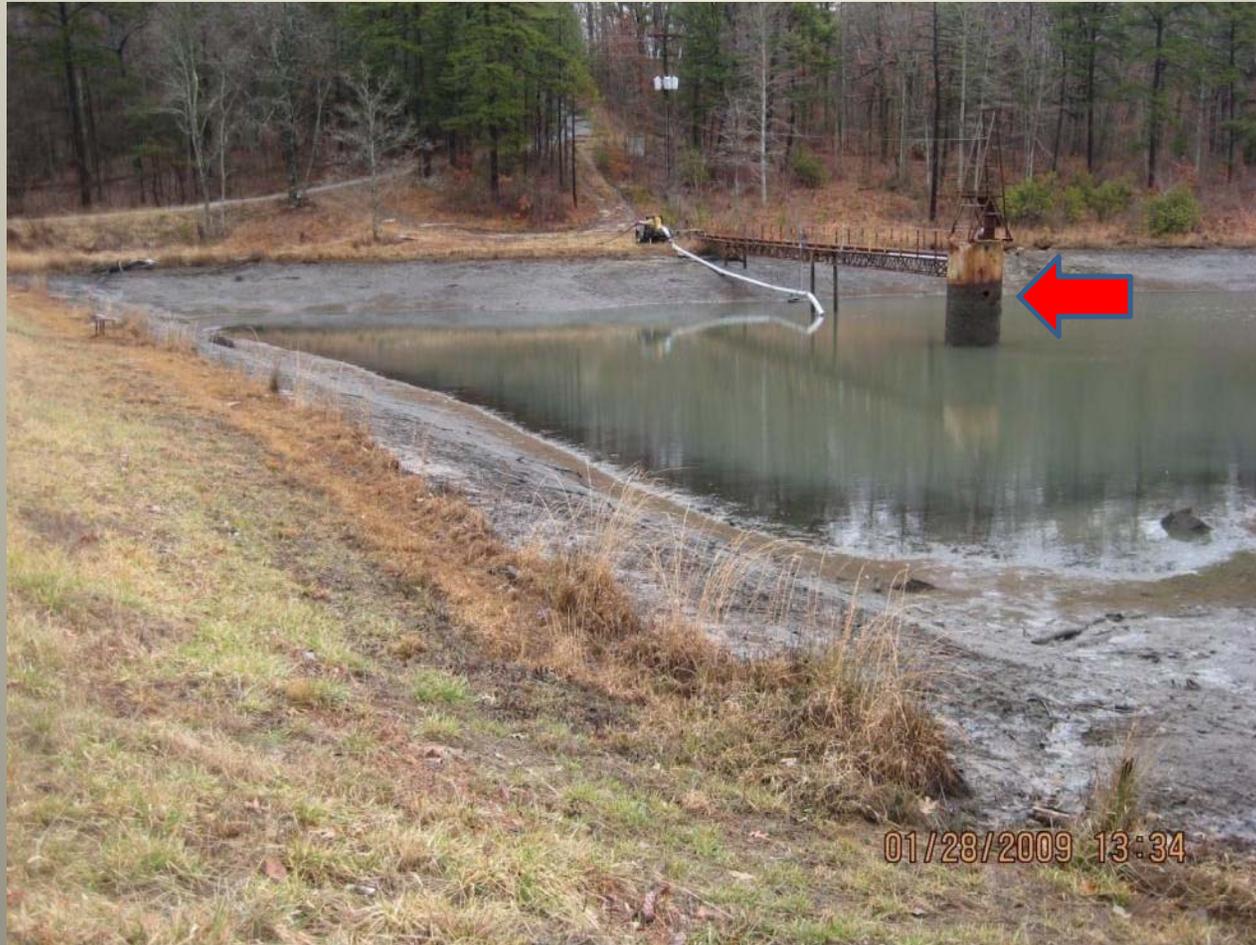
The decant riser is housed in this tank like structure.

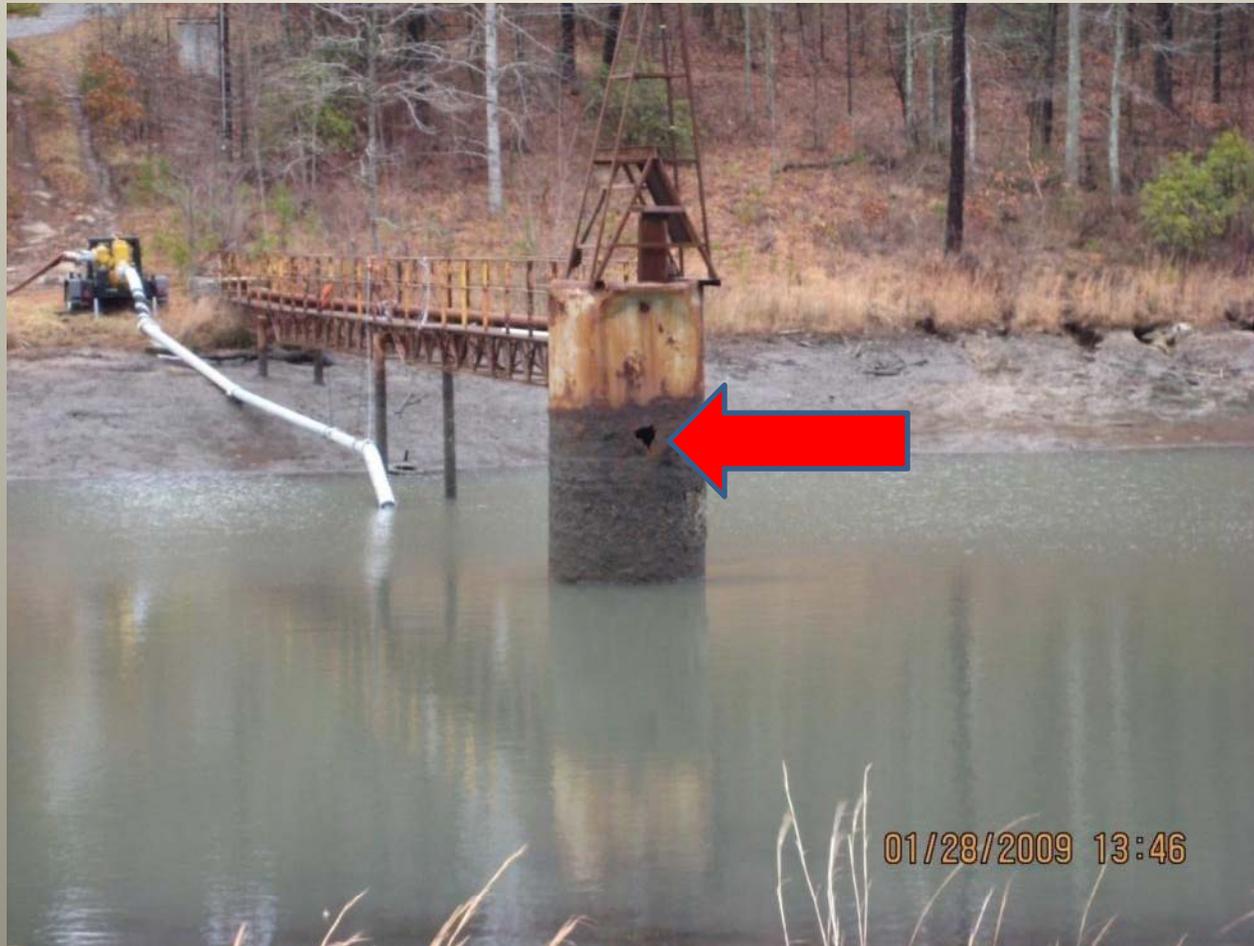
Close up of the tank like structure showing structural deterioration.

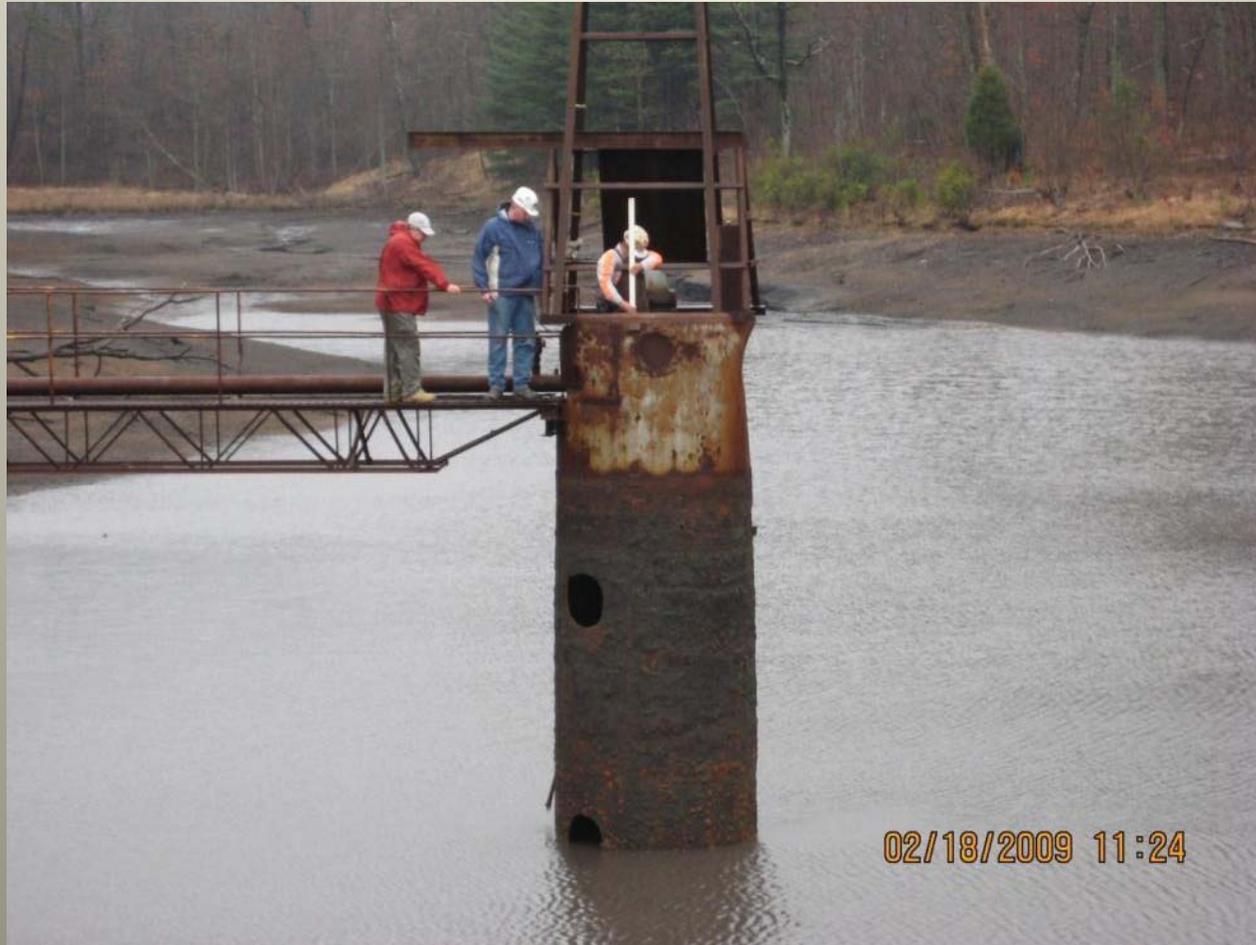
Another view of the tank like structure

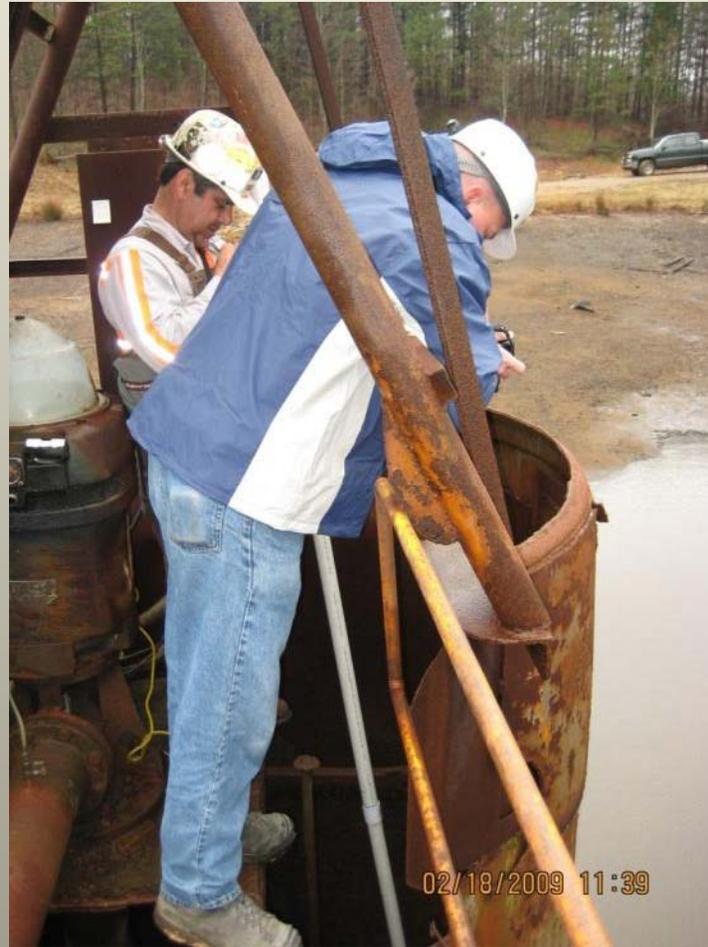
Another view of the tank like structure

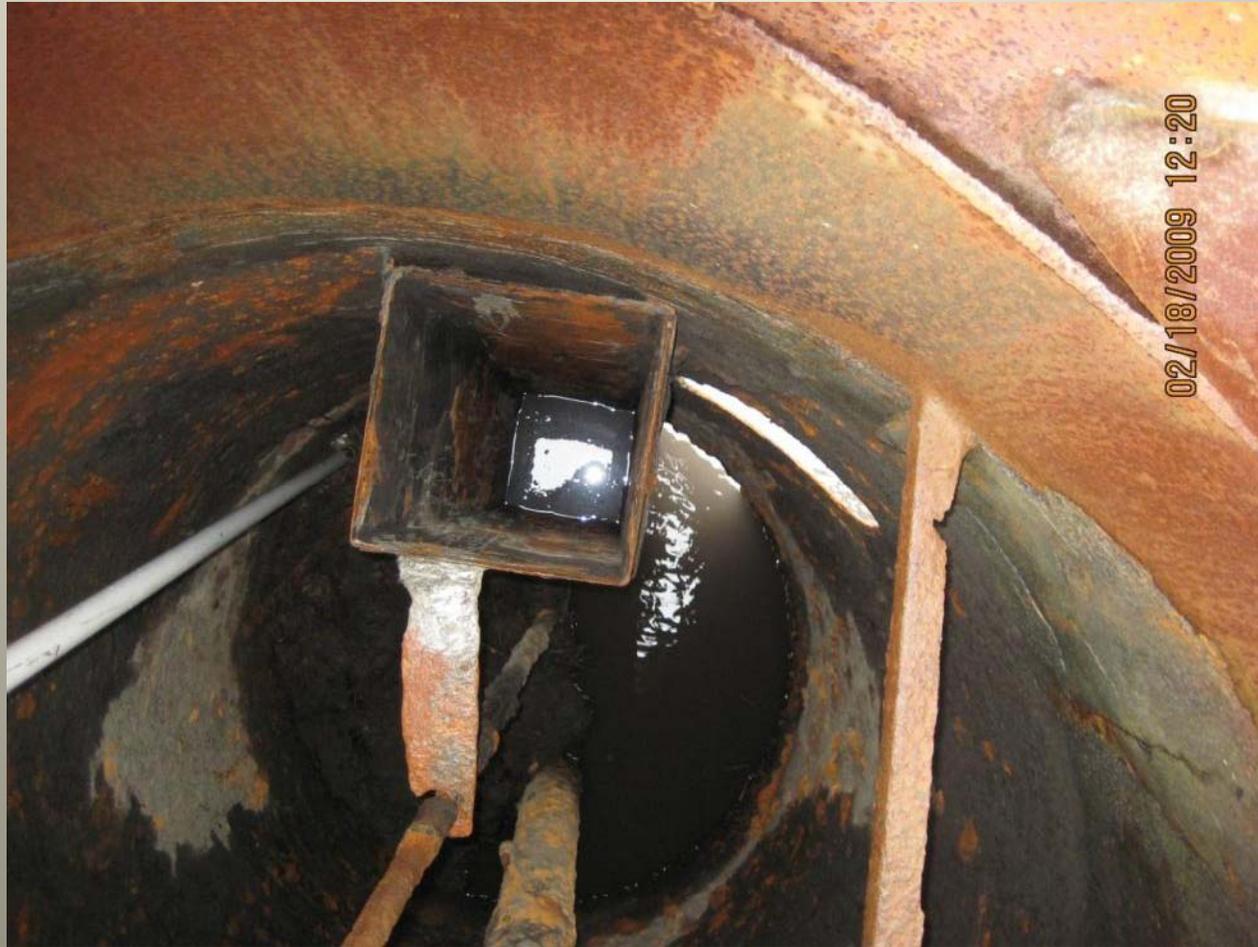
- The operator notified OSM that there was an issue of concern with the Freshwater Lake.
- The lake was de-watering through the principal spillway device in a manner without “*control*”.
- It was determined the principal spillway “decant riser” had malfunctioned below the water line.

View of decant riser from the top of the tank like structure

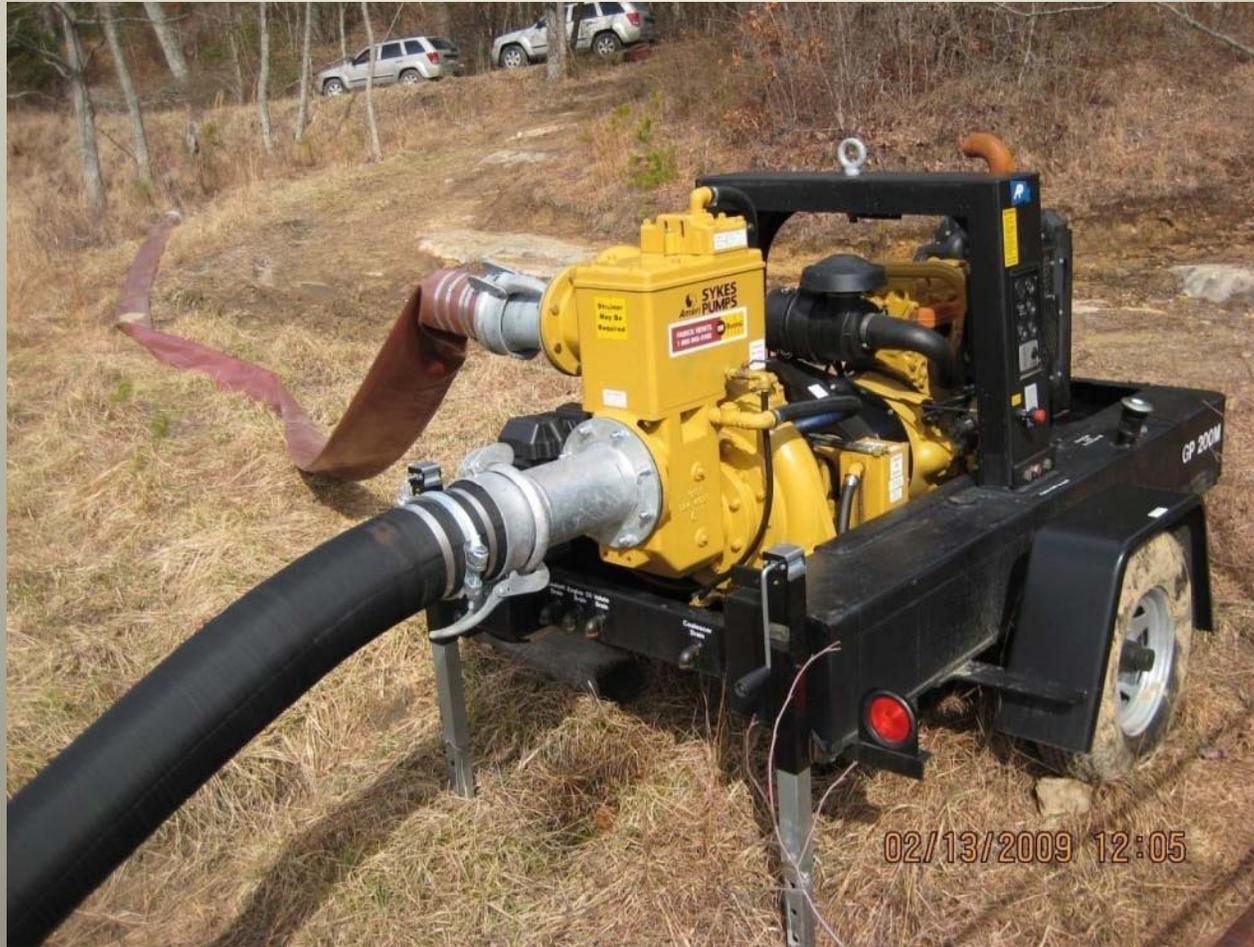
Draw down stabilization

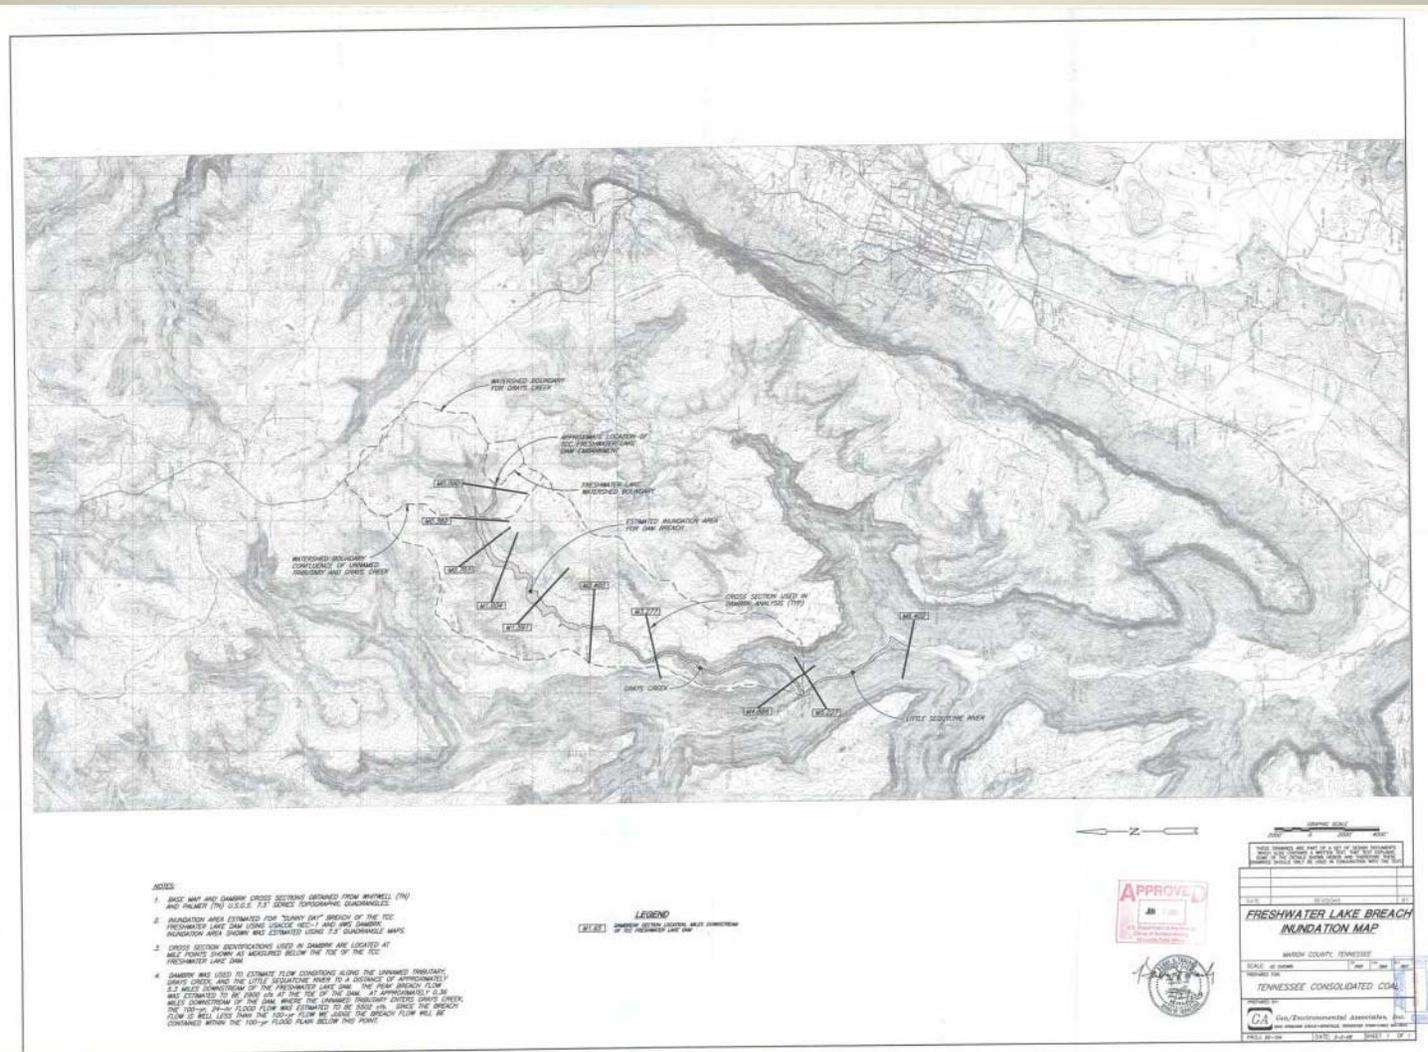
flood inundation study

- Showed there were no dwellings in the inundation zone in the event of dam failure.

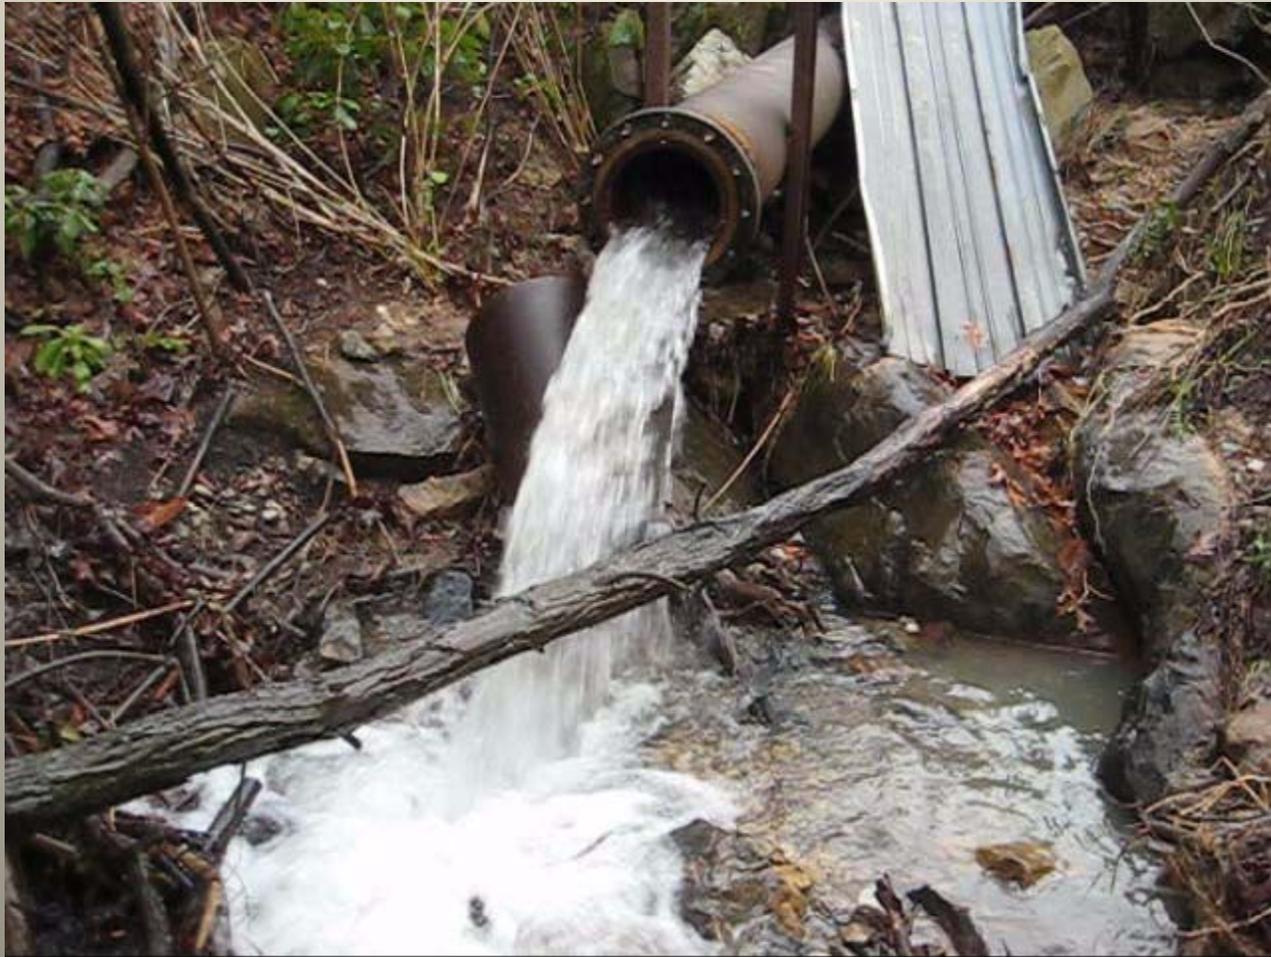
Discharge from principal spillway through failed decant riser

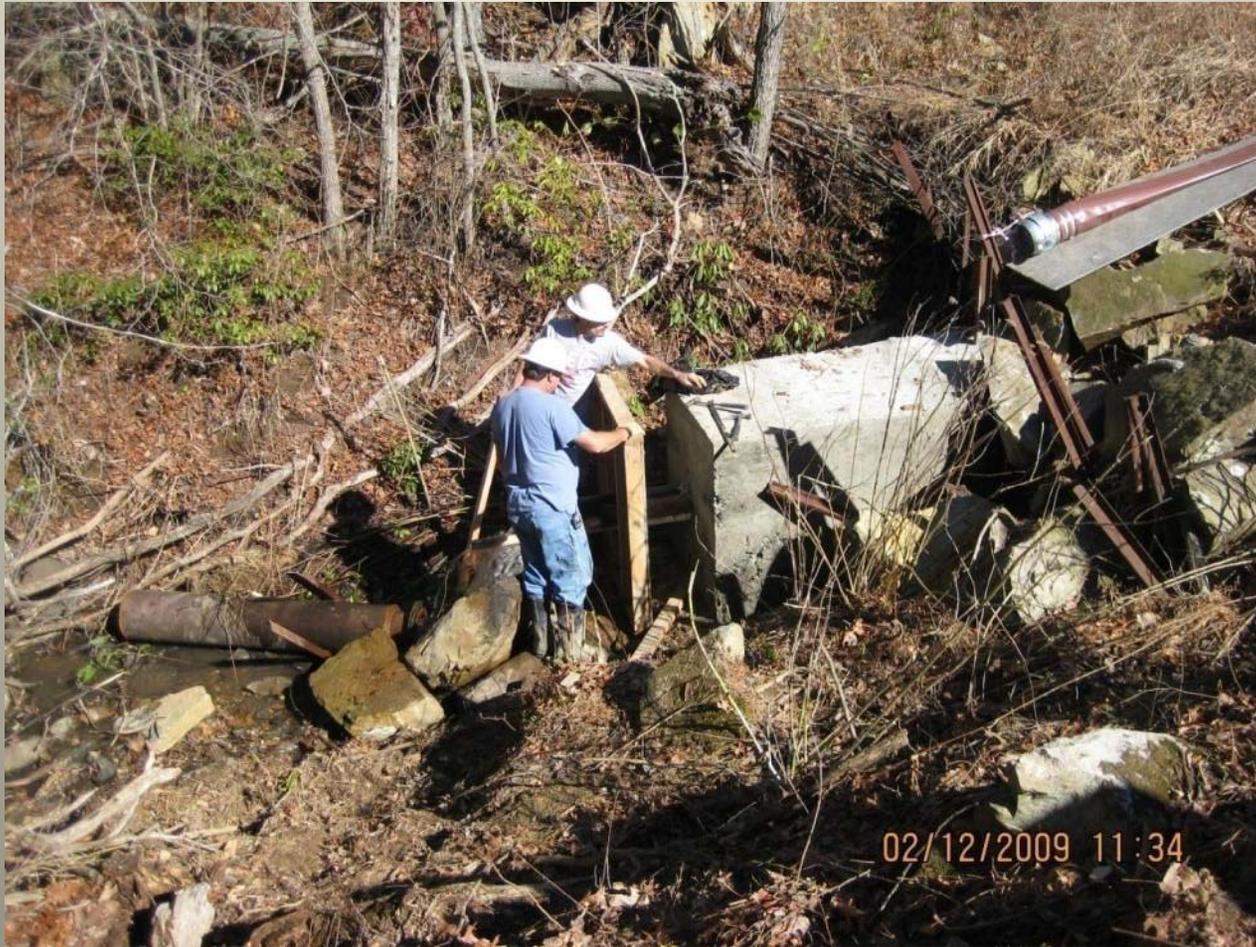
Principal Spillway Grout Injection: Preparing the bulkhead

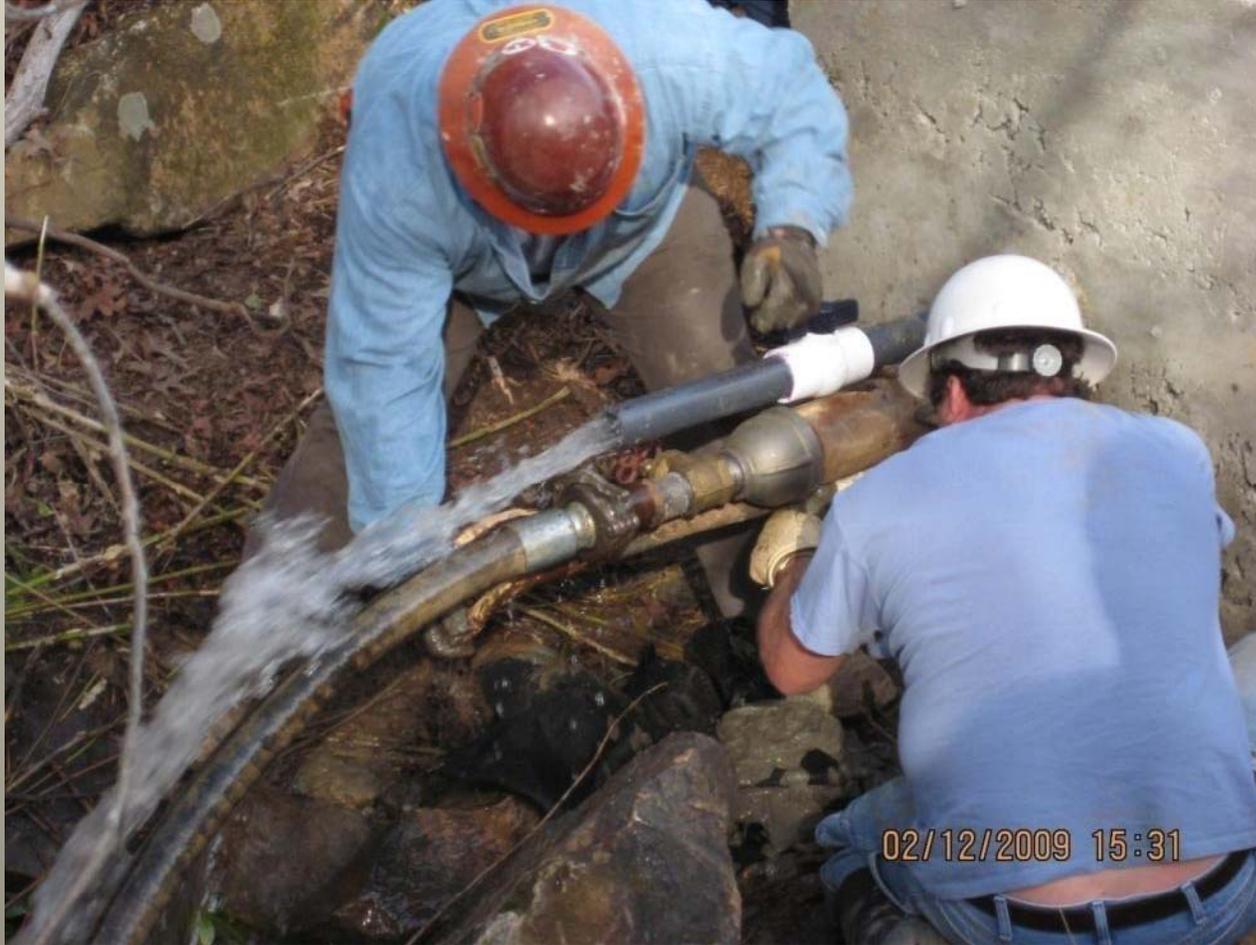
Injecting the grout

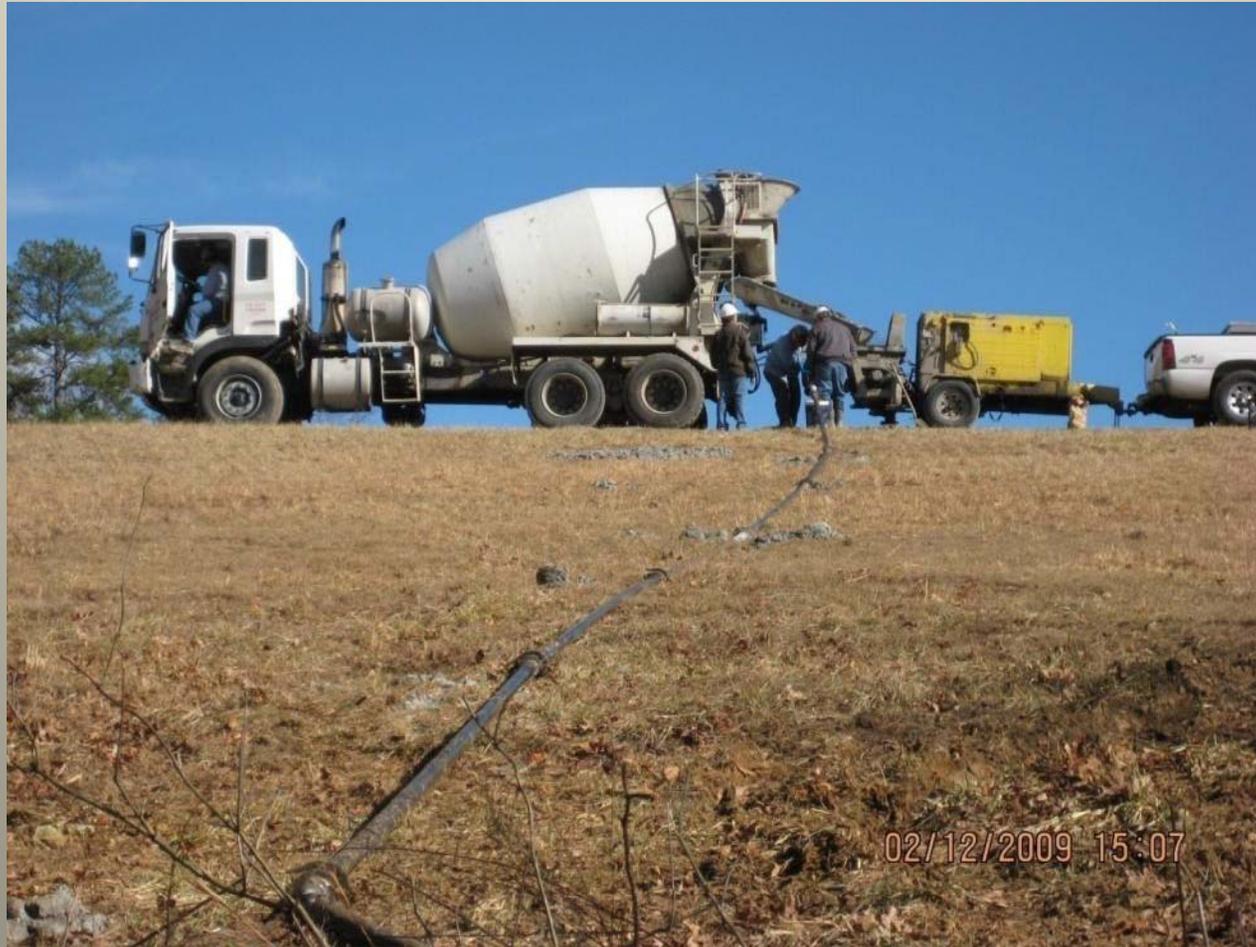
Injecting the grout

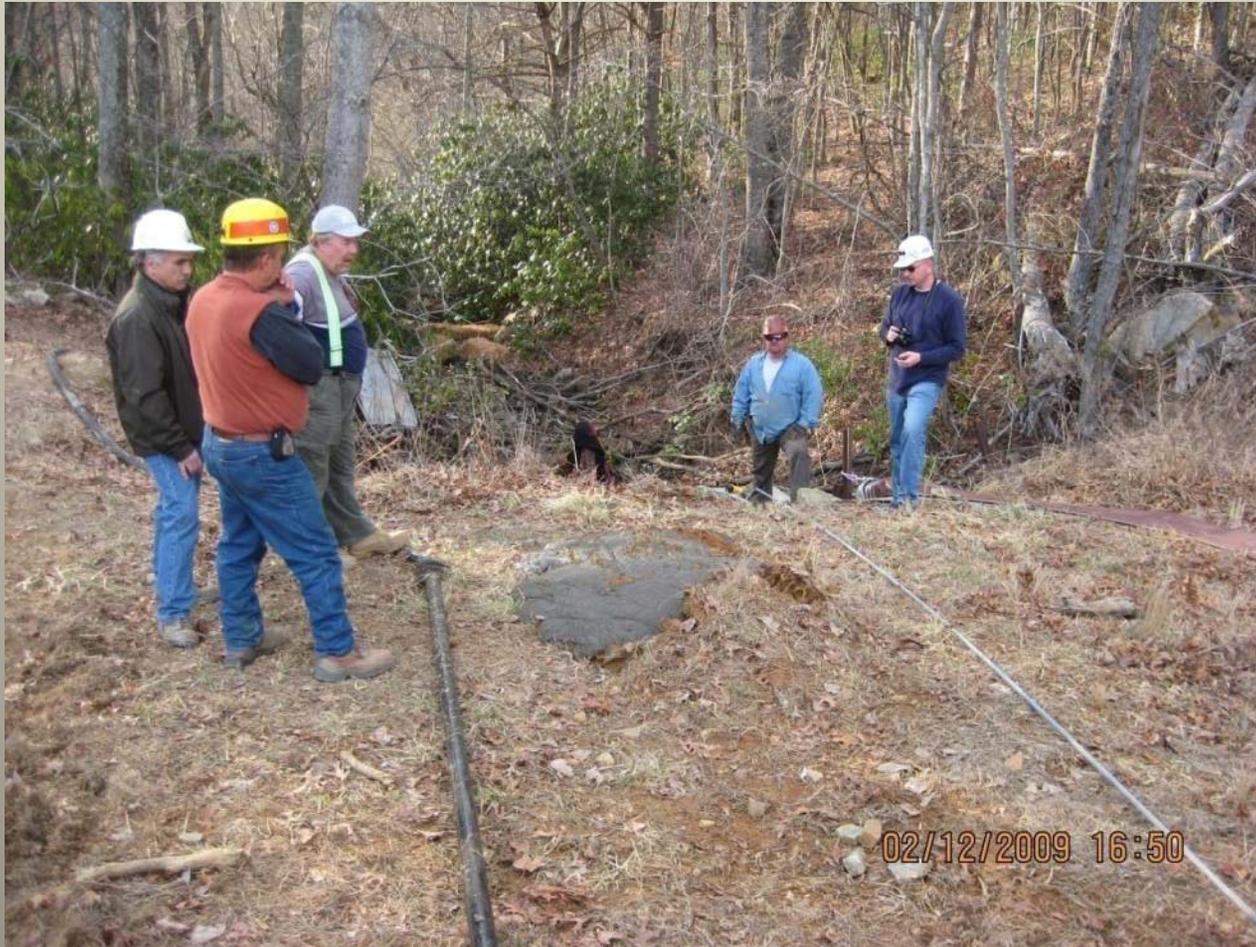
Grout Eruption at Toe of Dam

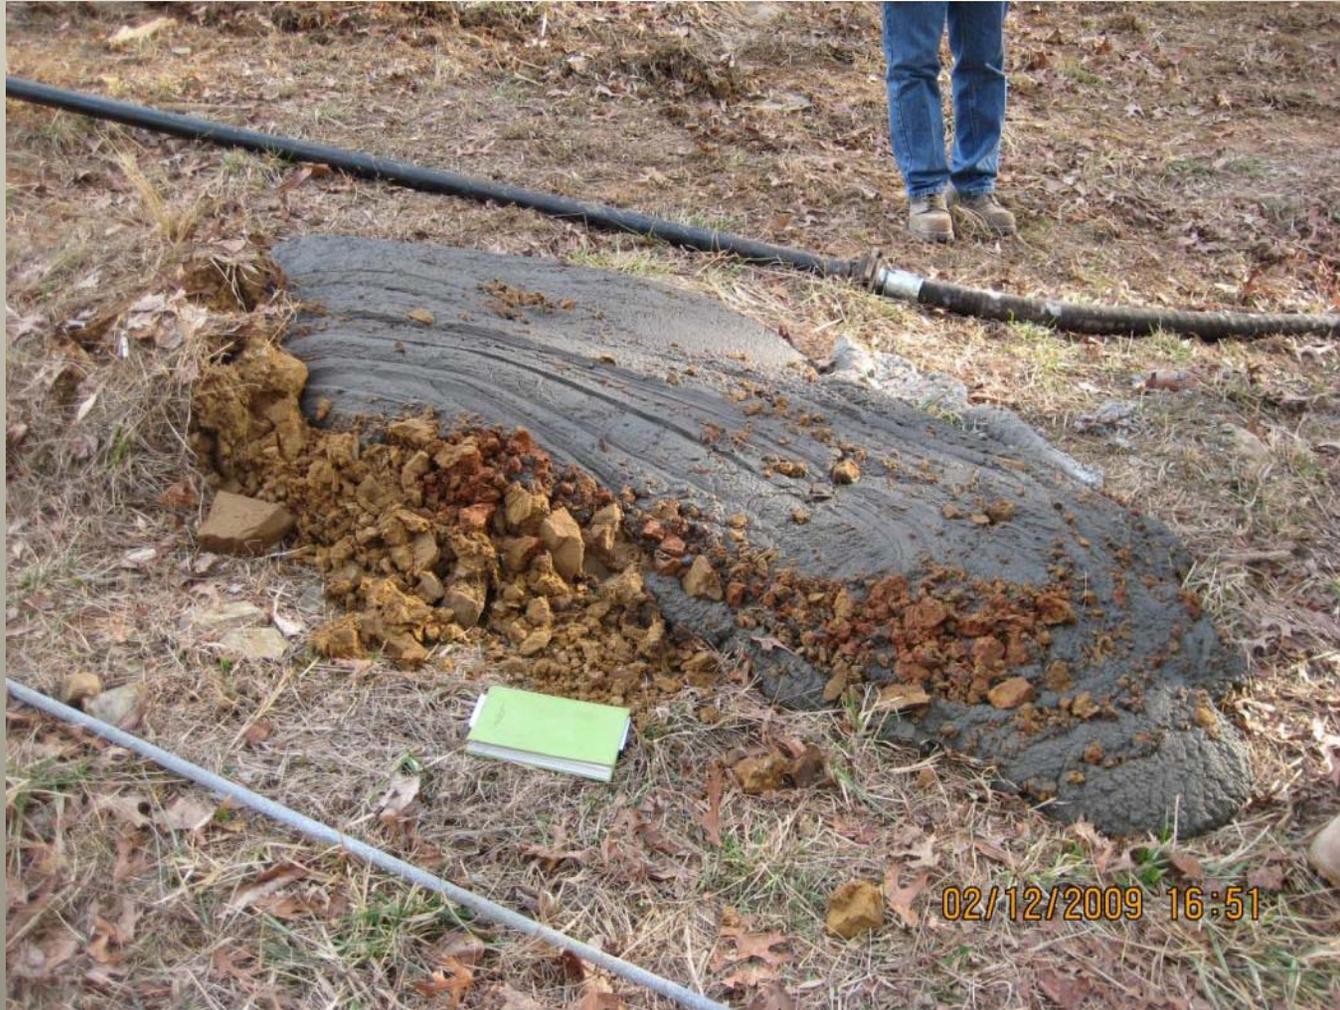
Grout Eruption at Toe of Dam

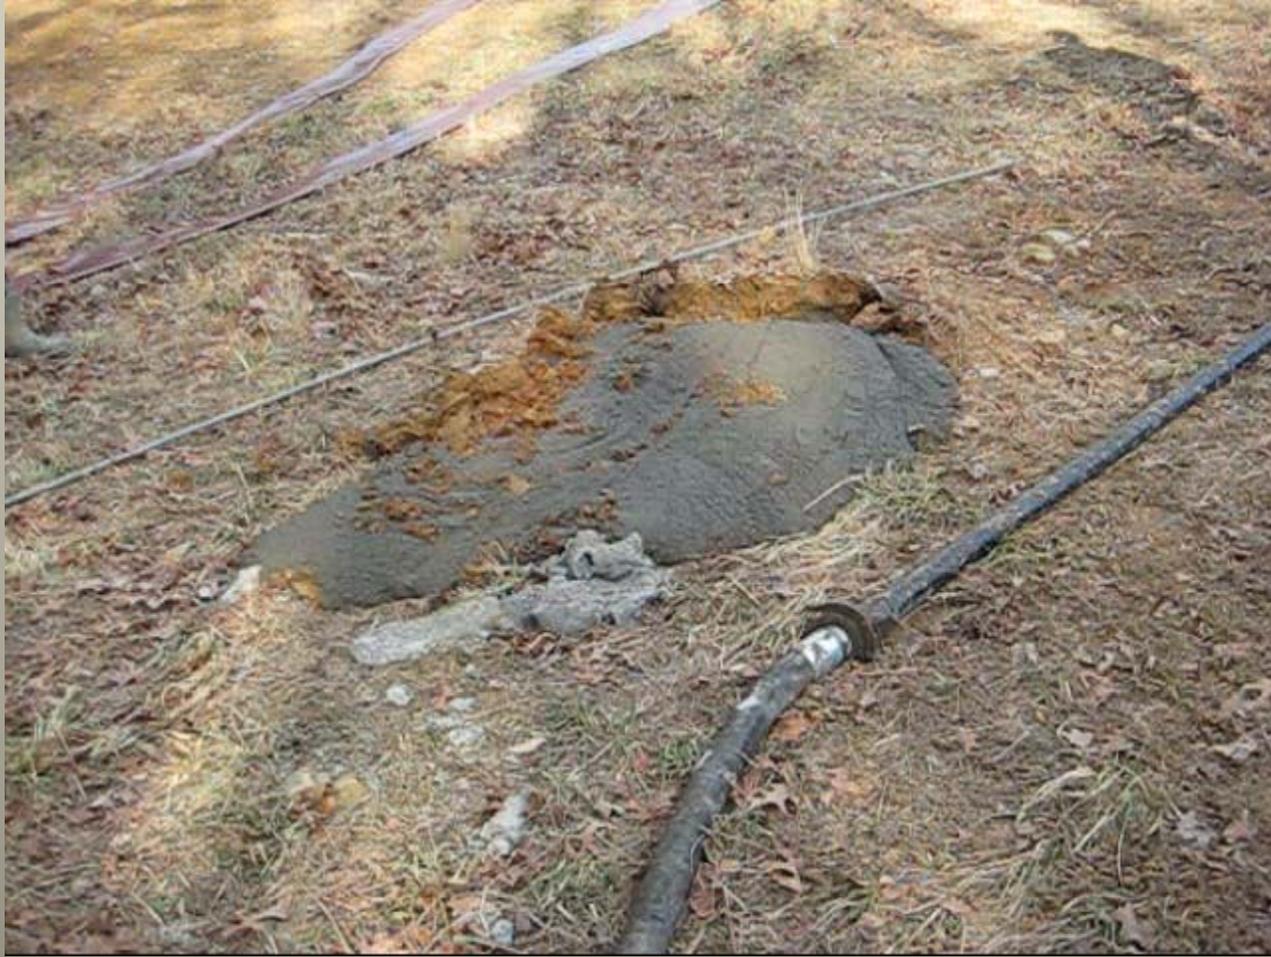
Grout Eruption at Toe of Dam

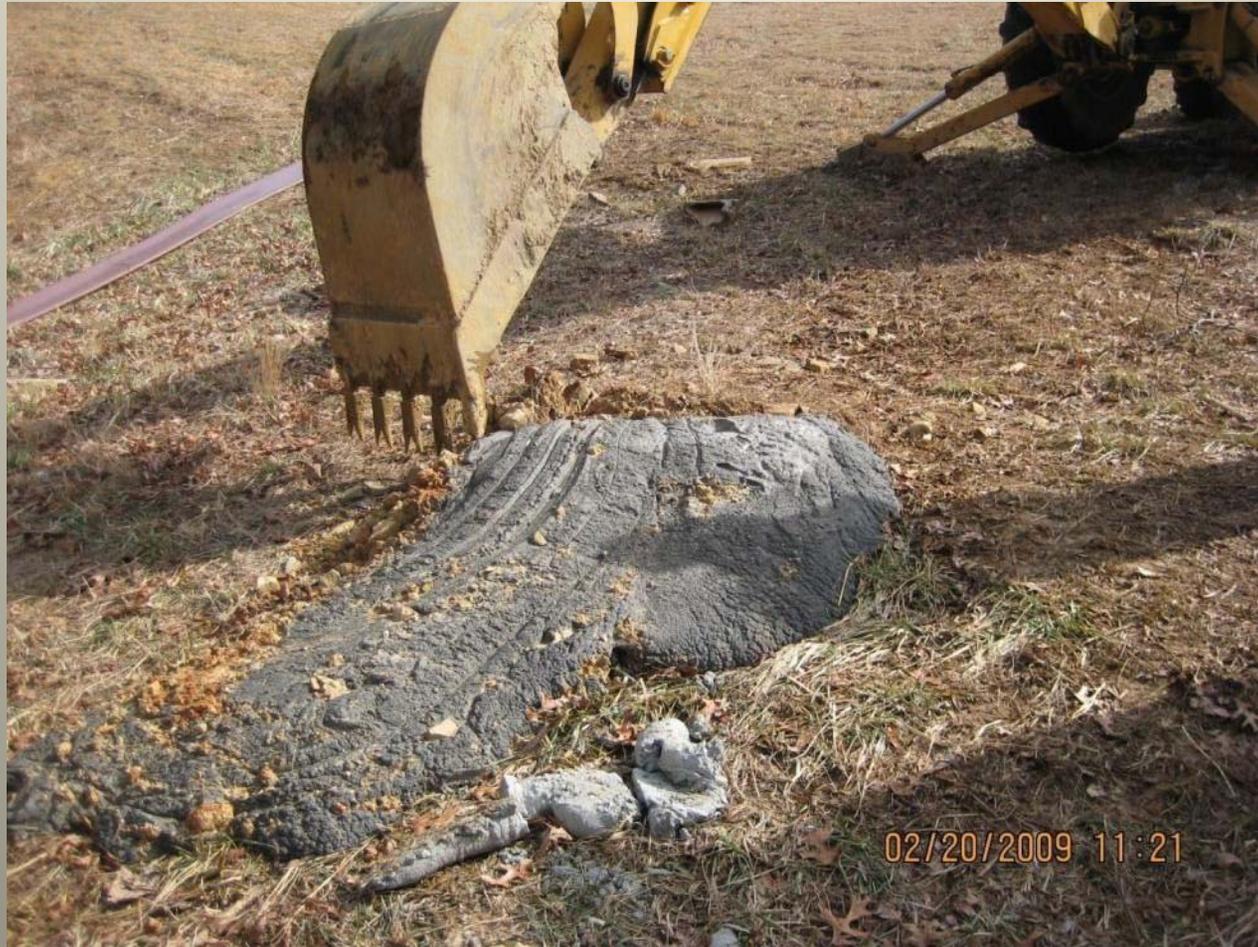
Eruption Exploration

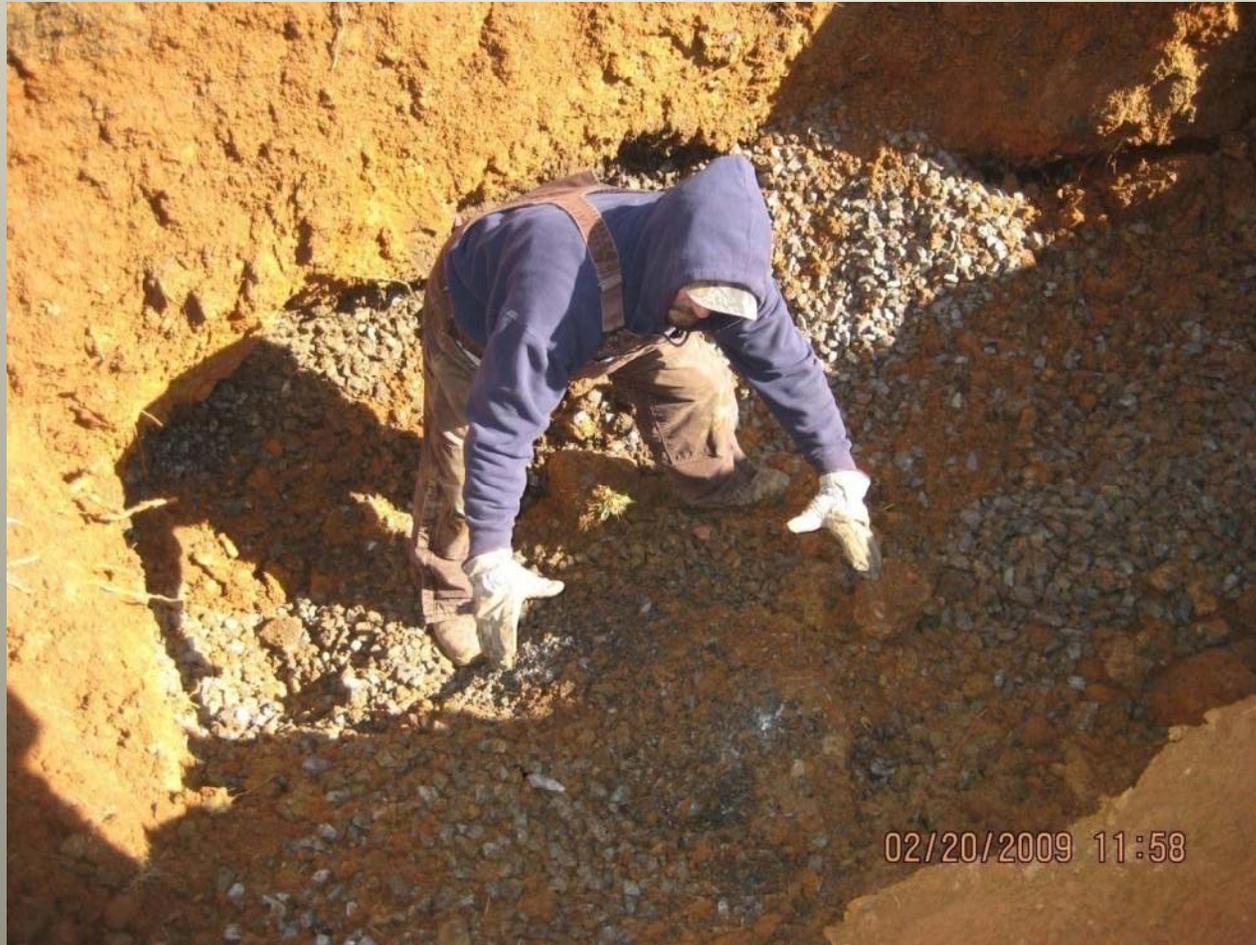
Eruption Exploration

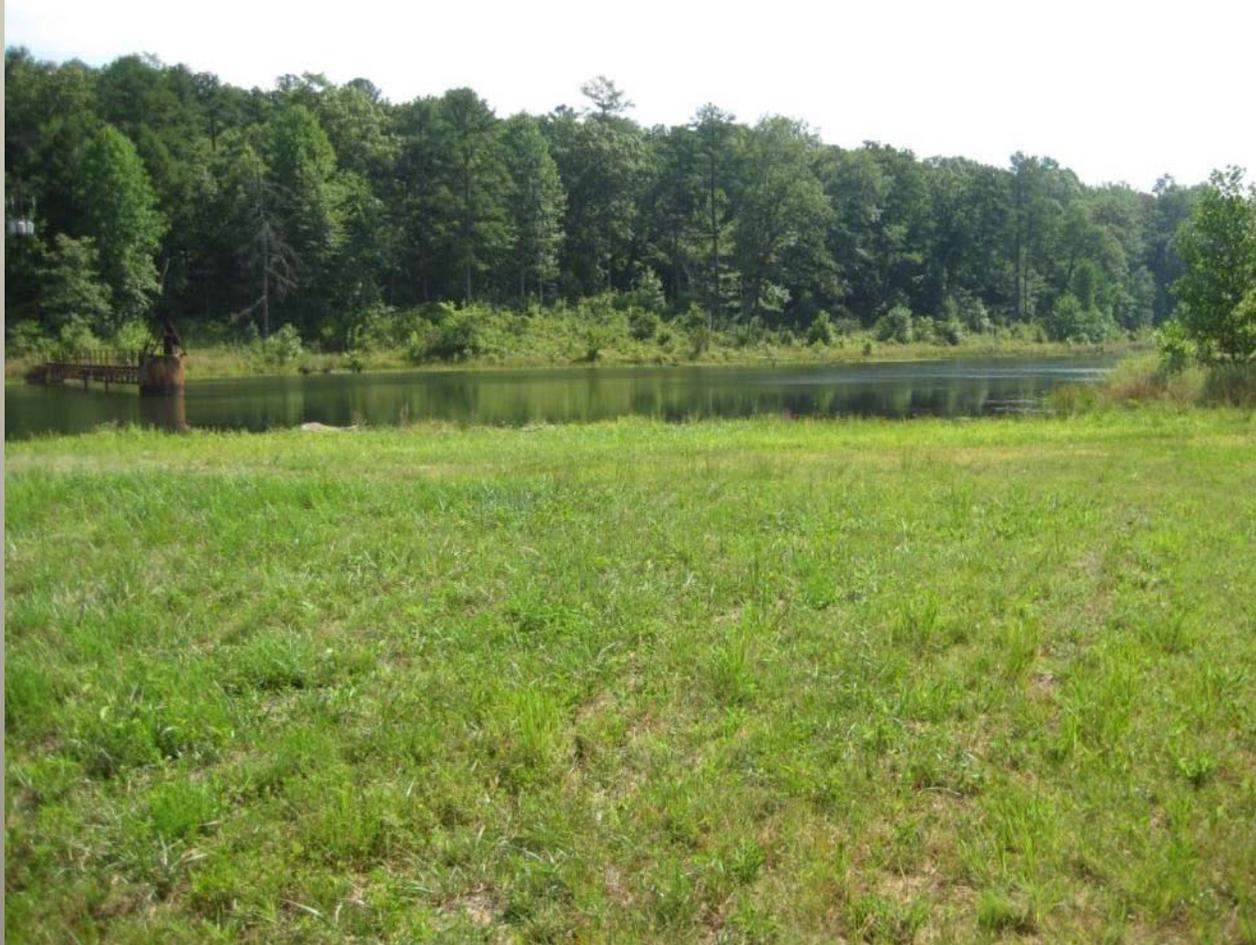
Principal Spillway Reconstruction

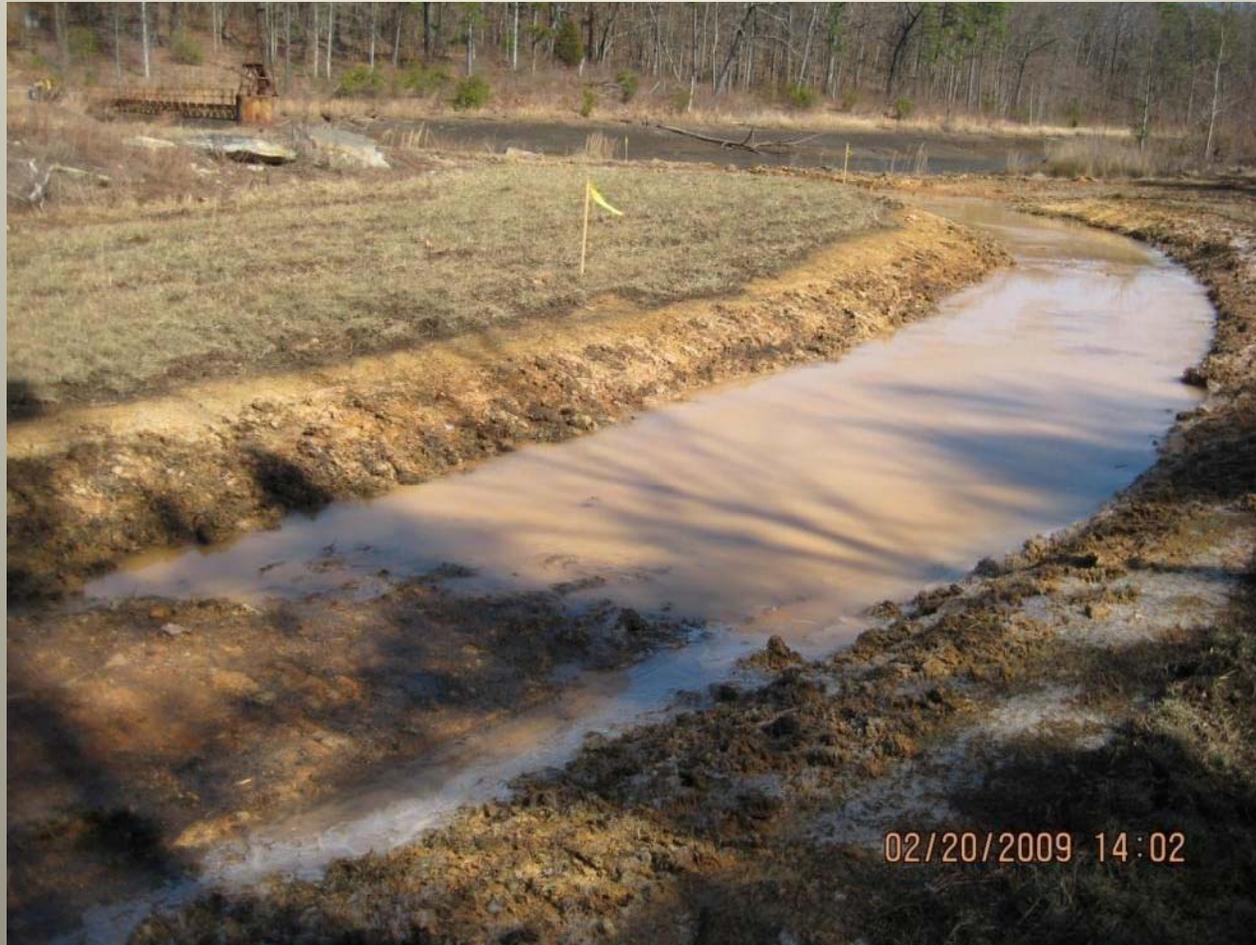
Principal Spillway Reconstructed
