OUTCROP BARRIER DESIGN GUIDELINES FOR APPALACHIAN COAL MINES

Prepared for
U.S. Department of the Interior
Bureau of Mines

by
Dames & Moore
Park Ridge, Illinois

Final Report
Contract JO 395069

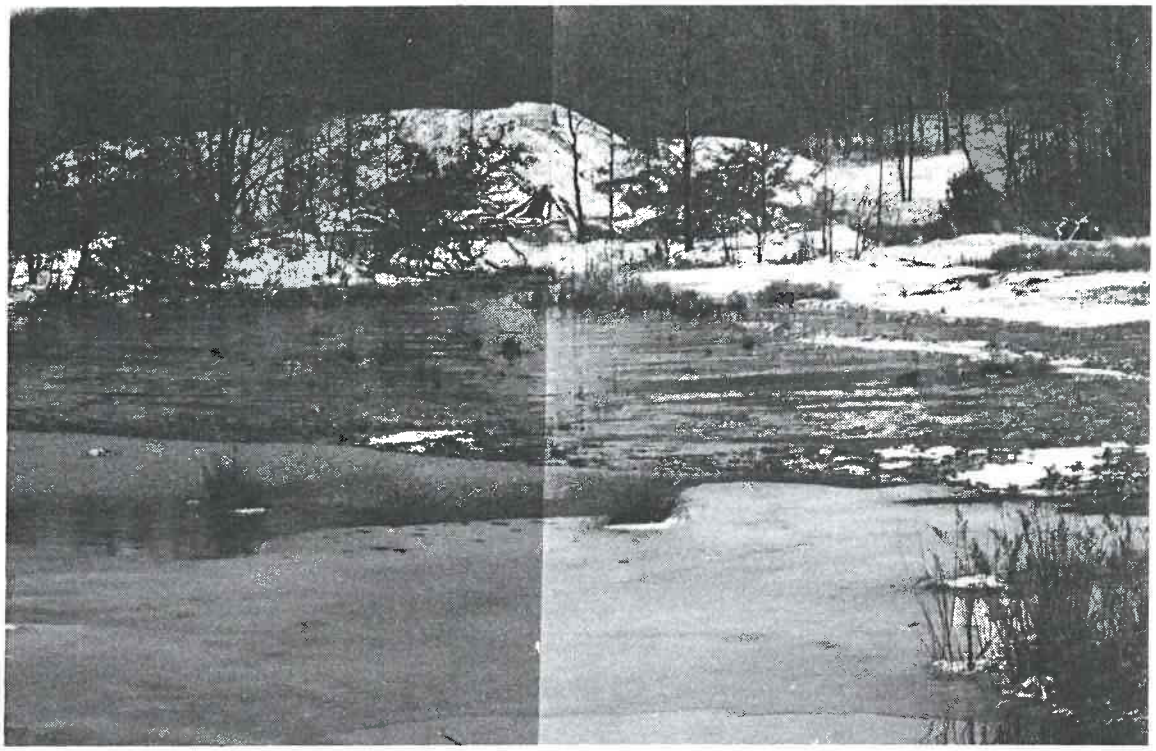
Inspection of Mine 1A on the opposite side of Seaton Creek, indicated that the discharge from portal 1 is running along highway 504. Figure 8 illustrates this discharge. Sample no. 3 was obtained from this flow. Observation well 1A, which is located behind the seal in portal 1 was also inspected. Water was present in the hole the day of the visit. The last recorded DER measurement indicated 16 feet of water in the observation well. No other discharge or seepage was found at this mine.

FIGURE 7 SITE NO.1 DRAINAGE
BASIN BETWEEN MINE 1A AND MINE 1B

FIGURE 8 DISCHARGE
FROM MINE 1A AT SITE NO.1

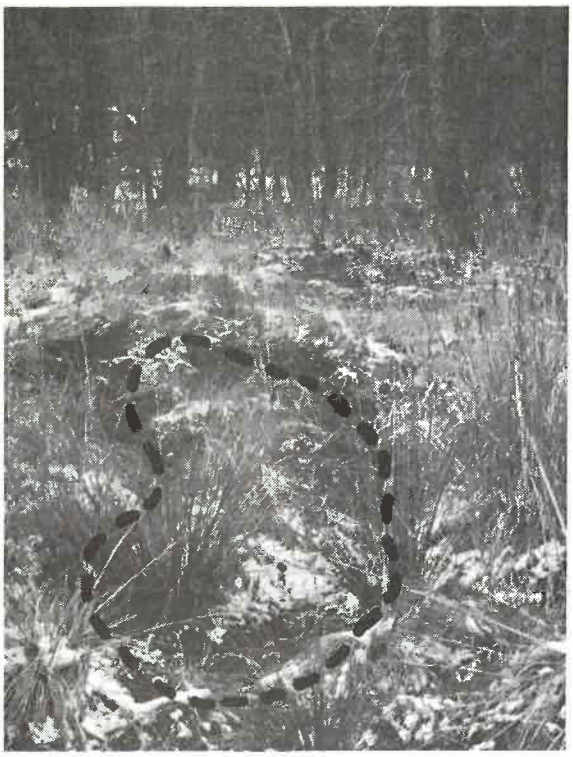
The present condition of Site No. 2 was determined during a site investigation performed on March 11, 1980. The site was lightly covered with snow that was beginning to melt. The inspection only covered the area indicated on Figure 9. Upon arriving at the site, the pad where the seals were installed was inspected. An area directly above a seal was accumulating water. Figure 10 presents a view behind the seal and an area where water is seeping out of the mine pool. This may be caused

FIGURE 10 SEEPAGE
THROUGH OVERBURDEN BEHIND
HYDRAULIC SEAL AT SITE NO. 2

FIGURE 11 DISCHARGE
THROUGH PORTAL AT SITE NO. 2

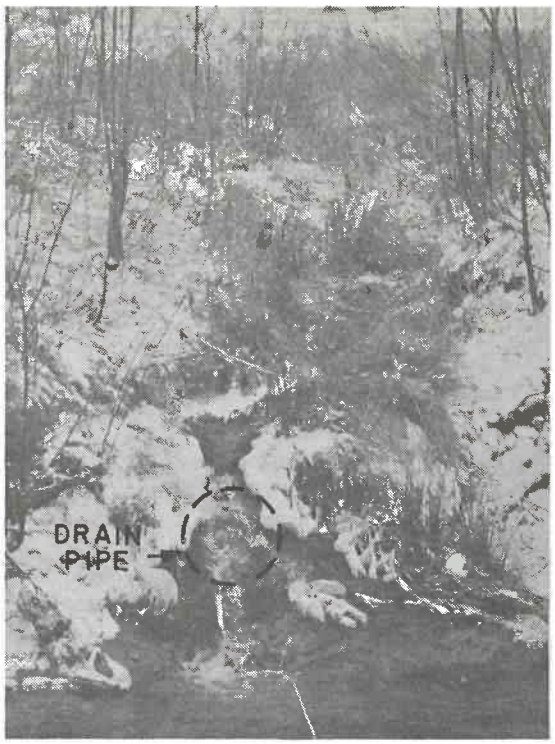
FIGURE 21 FRENCH DRAIN DISCHARGE INTO RATTLESNAKE CREEK AT SITE NO. 5

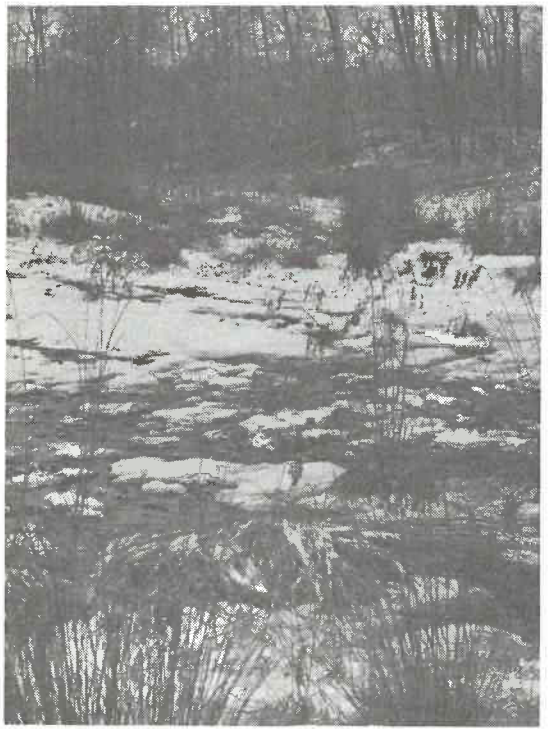
FIGURE 22 DEPRESSION WITH SEEPAGE AT SITE NO. 5

pool as the other sites studied. It is interesting to note that the lowest pH is found in the depression that is at the same elevation as the bottom of the coal seam. High iron levels are also found here. The only sulfate analysis available is for the French Drain discharge. The drain is not an abatement measure, but rather a means of diverting surface water from the spoil piles and drying the area so that vegetation could become established. 950 mg/l of sulfates are shown for this discharge which averages 50 gallons per minute.

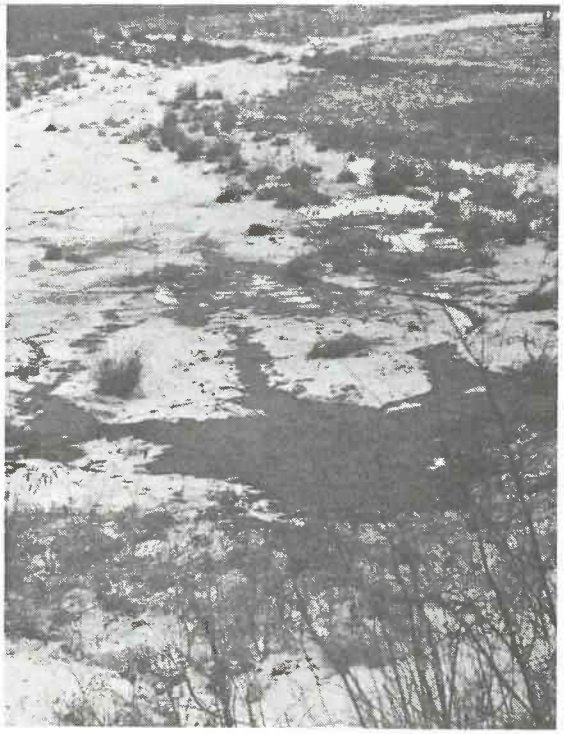
FIGURE 23 SEEPAGE AREA IN FRONT OF SEALED PORTAL AT SITE NO. 5 VIEWED FROM ABOVE THE SEAL

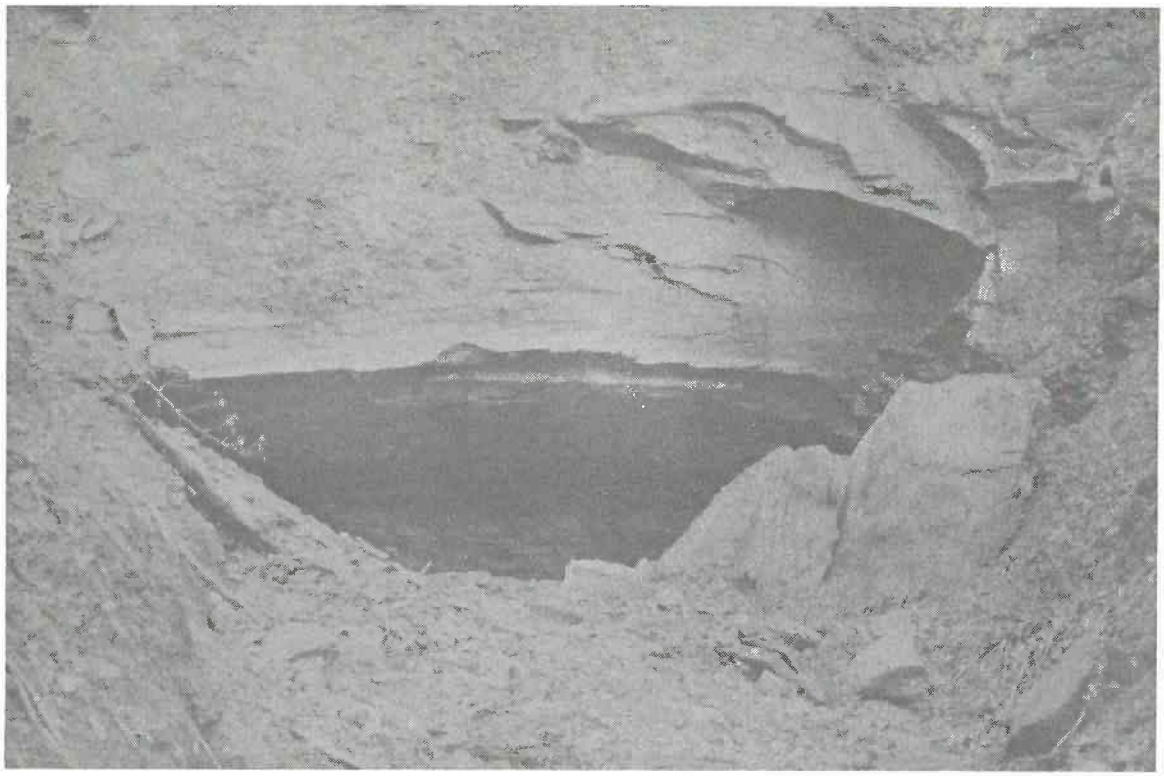
FIGURE 26 LOCATION OF BLOWOUT AT SITE NO. 6

The closure attempt at Site No. 6 was not designed to inundate the mine workings, but shows that this type of mine may be a potential hazard. The structural low point of the mine is along the west outcrop and was undisturbed by mine entries. The hydrostatic head that resulted in a blowout cannot be determined due to large quantities of precipitation prior to the burst, however, it has been estimated that 50 feet of head was likely . The barrier pillar remained stable with only a 15 to 20 feet width supporting the head. The overburden, however, was so weakened by fracturing and rock falls, that a blowout occurred through it.

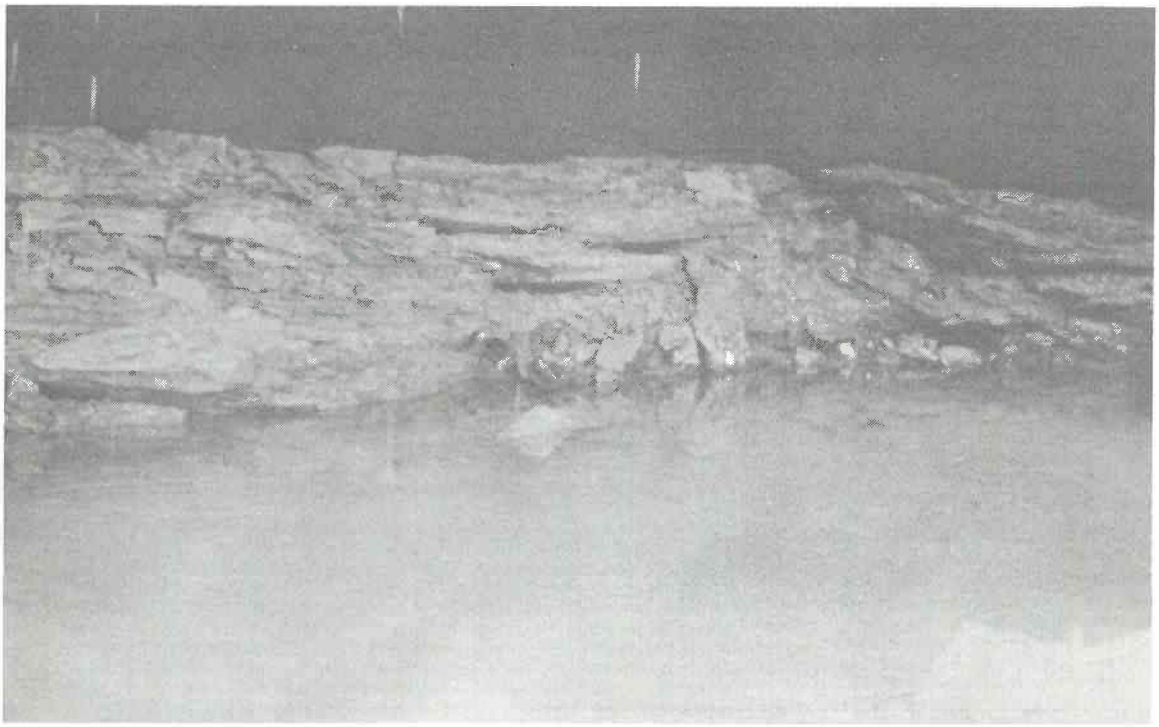
Several water quality samples were obtained. The first was taken in the mine pool shown in Figure 27. There is some ground-water influence as shown by the drops of water falling into the pool. The water analysis from this location showed a pH of 3.25, and 6.6 mg/l of total iron. Another sample was taken at a location outside of the mine pool where the discharge starts flowing down the hill (see Figure 28). The pH is unchanged, however, total iron and suspended solids are noticeably higher. Two additional samples were also obtained along the drainage path as it proceeded down the hillside (Figure 29). No significant change in pH was noted, however, iron levels at this point are approaching the OSM effluent limitations. Figure 25 illustrates the location of the blowout and the sampling points for the site.

FIGURE 27 MINE POOL AT SITE NO. 6
