Report of Investigations 9267

Hillseam Geology and Roof Instability Near Outcrop in Eastern Kentucky Drift Mines

By Gary P. Sames and Noel N. Moebs

BUREAU OF MINES
T S Ary, Director

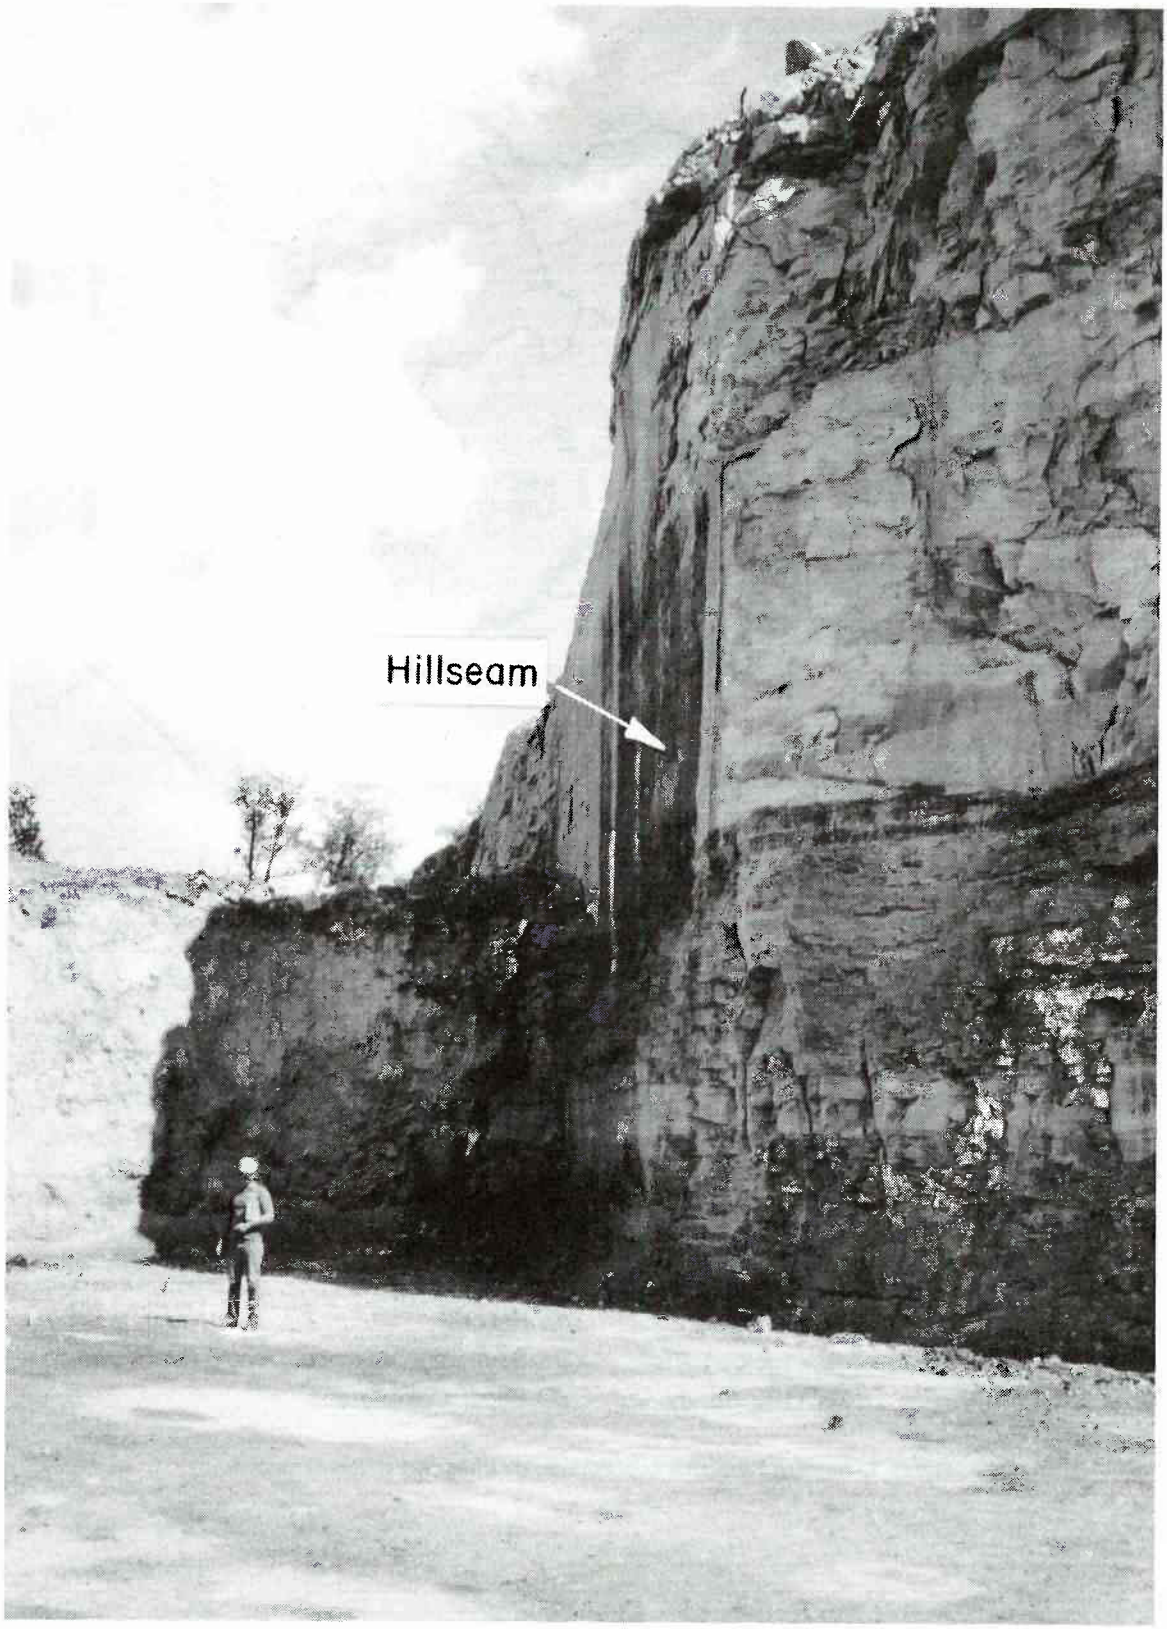
In addition to hillseam-related roof falls in underground coal mines, strip mine highwall stability is, to a large degree, adversely affected by the presence of hillseams. Figure 2 shows a nearly vertical strip mine highwall formed by one of several large, parallel hillseams. While hillseams may facilitate highwall removal, they can also be extremely hazardous, forming undetected, freestanding slabs or wedges of rock that can topple forward or slump into the excavation without warning.

Figure 2.–Hillseam in strip mine highwall.

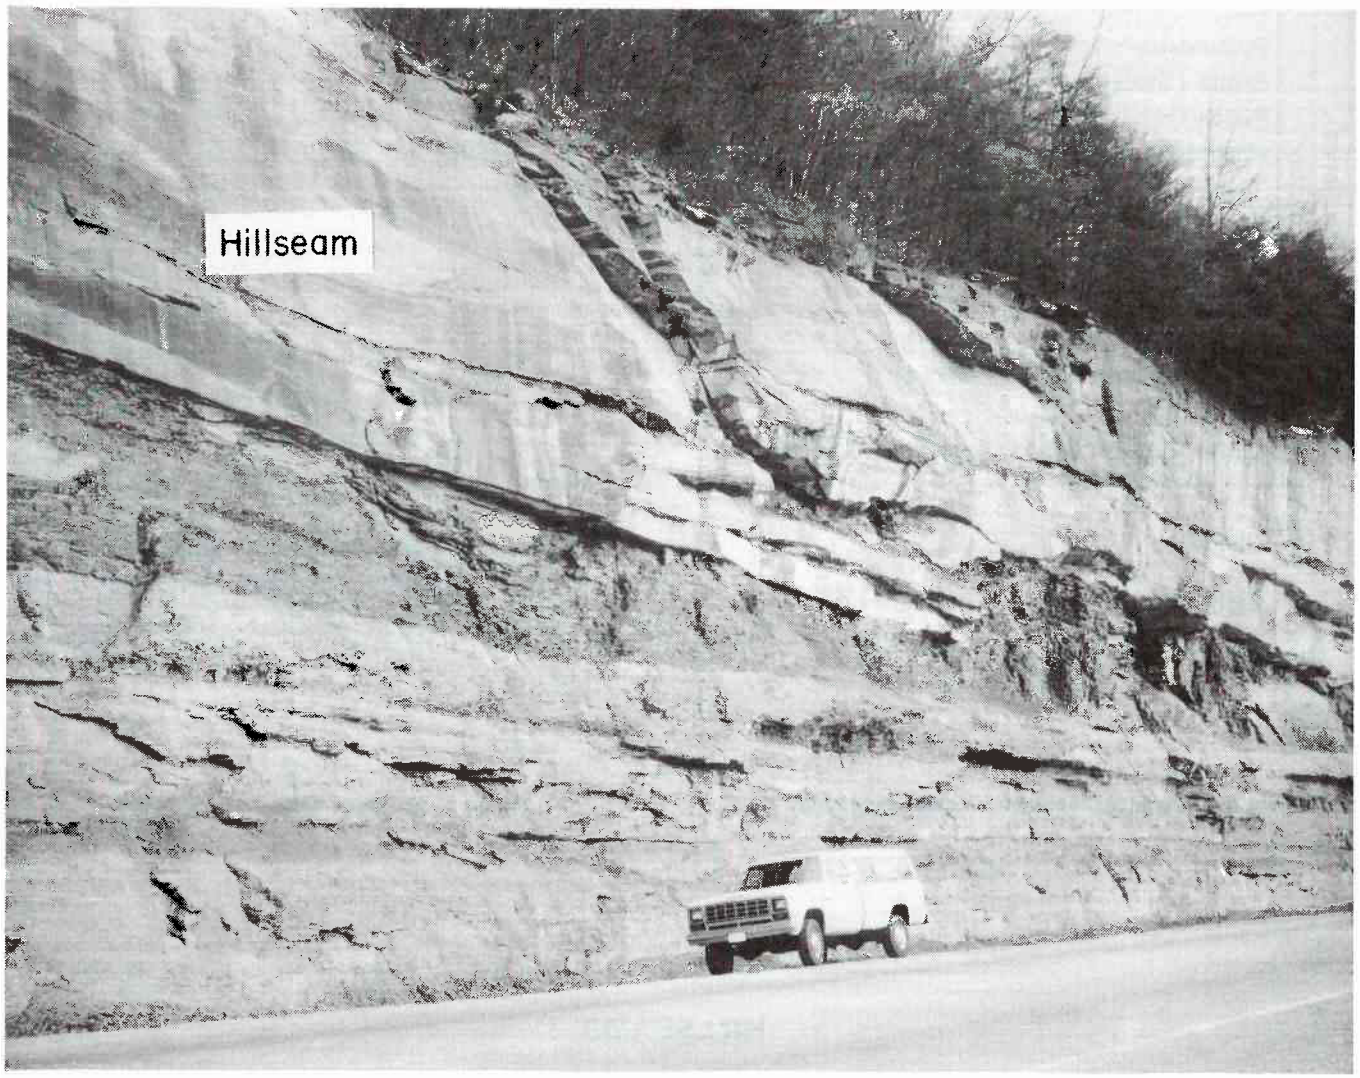
Hillseams also constitute a hazard in deep roadcuts that parallel surface contours. While deep-seated rockslides are rare (*7*) they typically involve excavated slopes in which large wedges of rock, separated from the valley walls by near vertical stress relief joints (hillseams), slide or hinge over into the excavation. Figure 3 shows such a situation in which a large wedge of rock, separated from the wall of a roadcut by a hillseam, is unsupported and may slide or topple towards the pavement without warning.

Figure 3.–Hillseam in wall of roadcut.

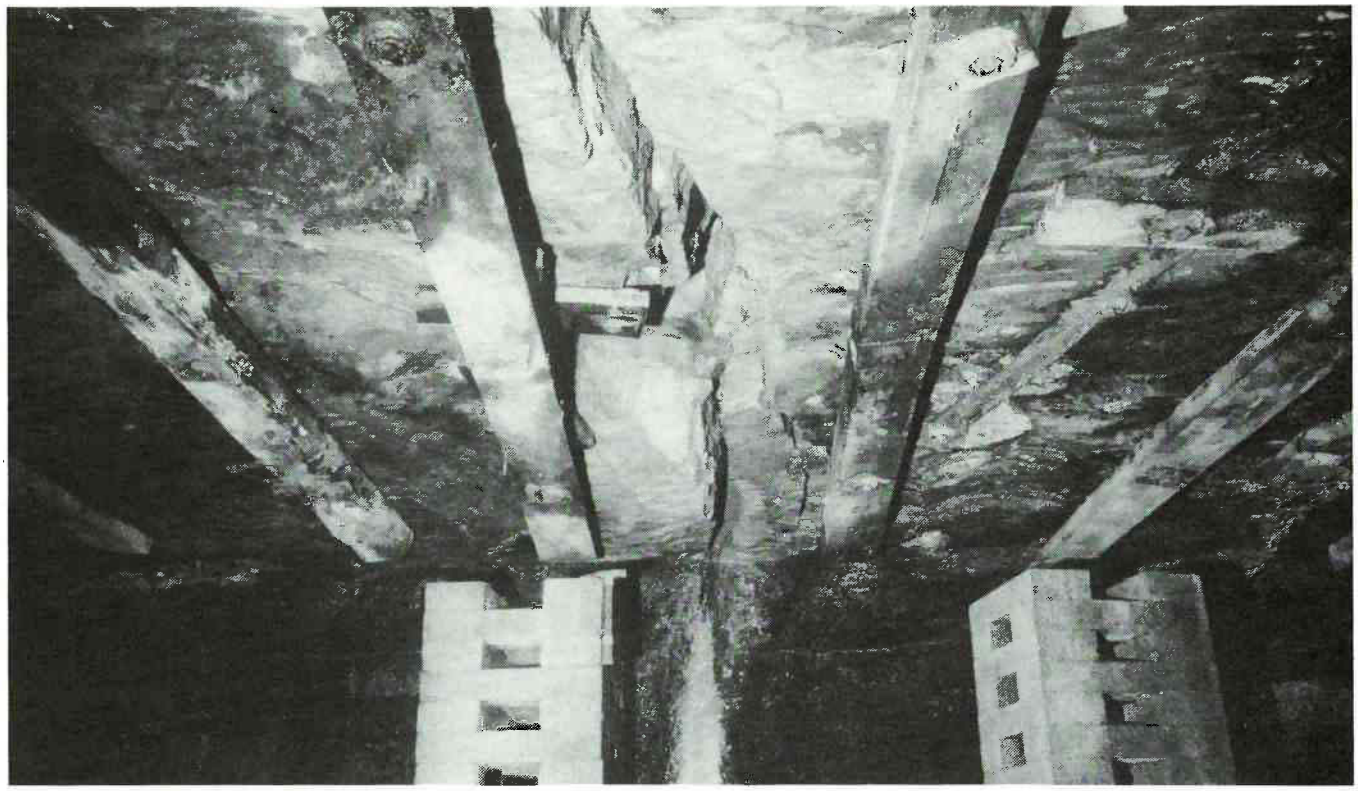
Figure 7.–Rib stained by ground water channeled by hillseam.

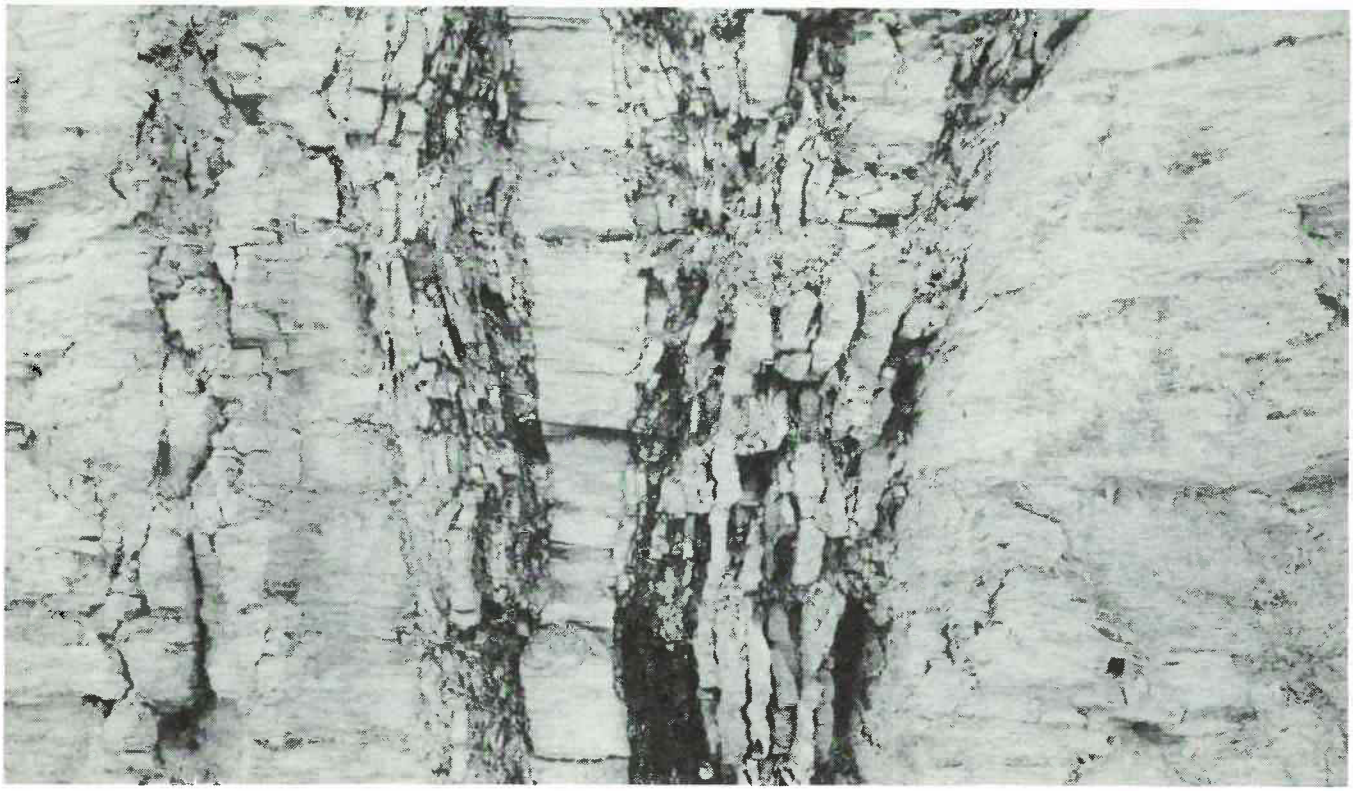
Figure 8.–Details of hillseam structure.

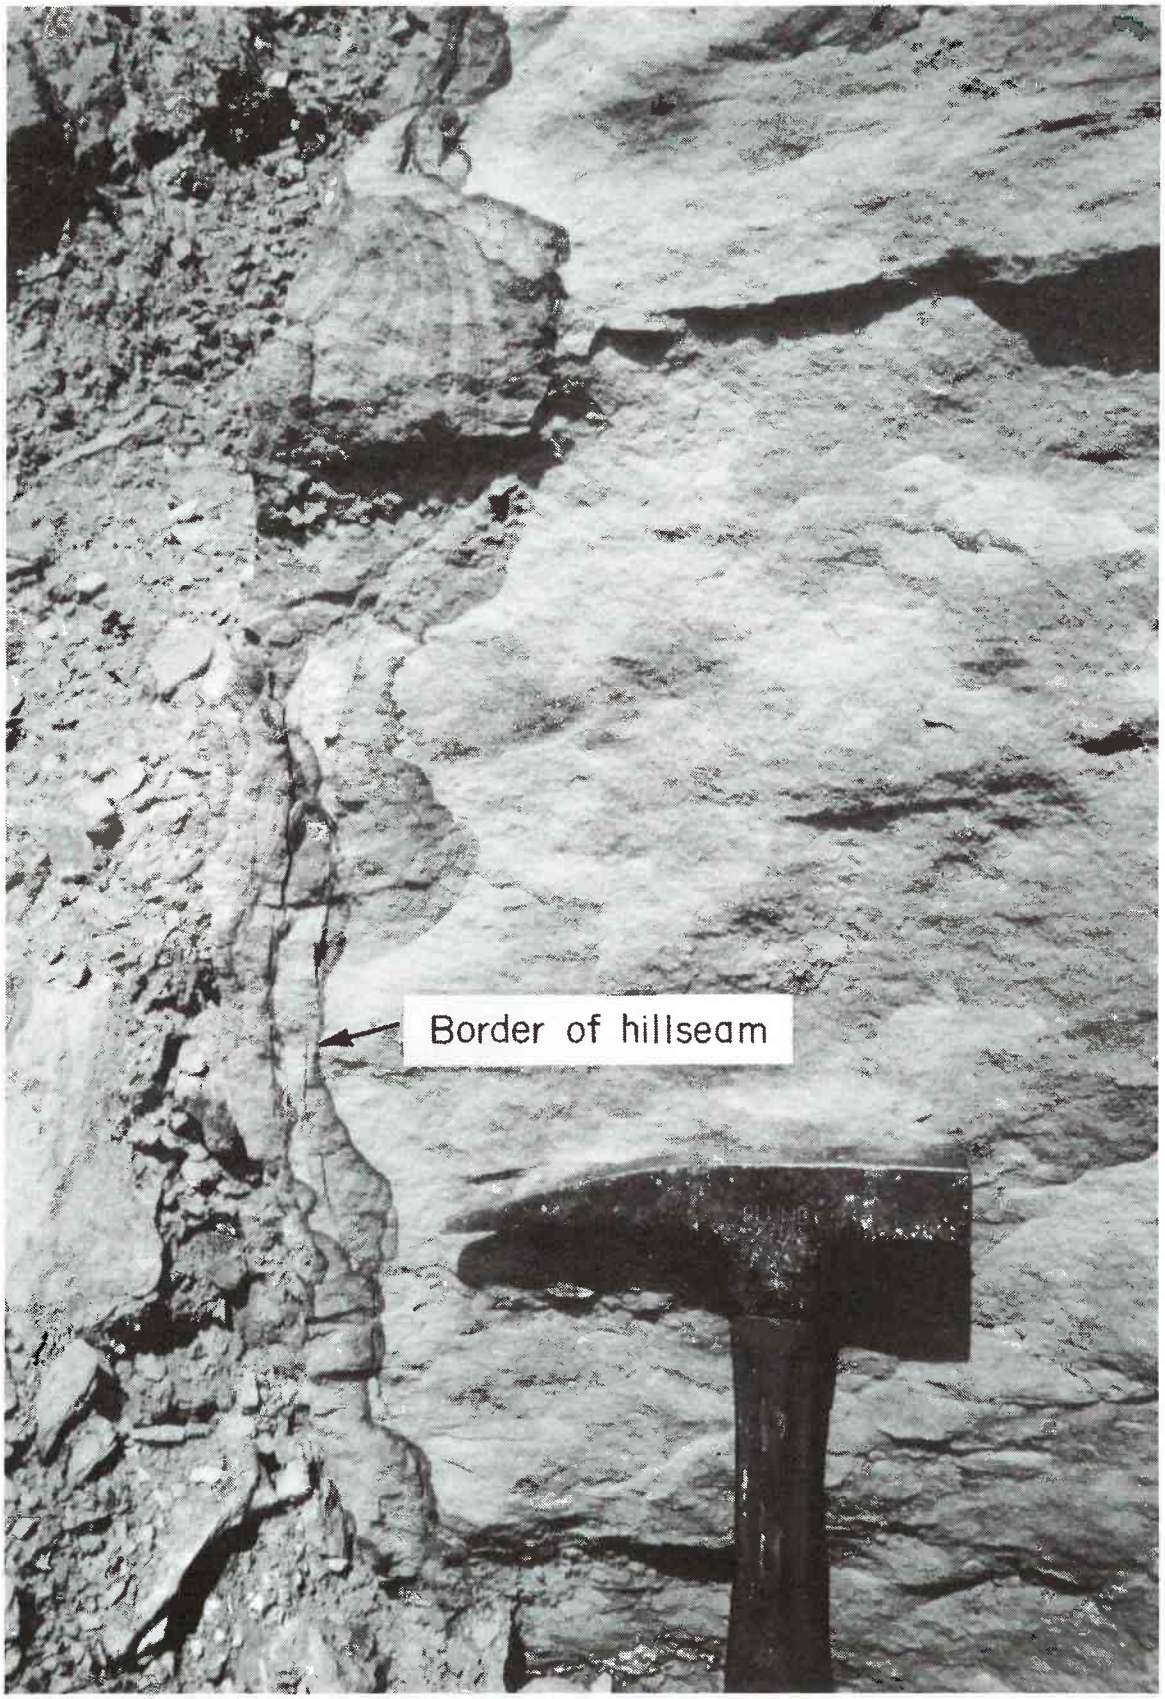
Figure 9.–Incipient parallel weathering in hillseam formation.

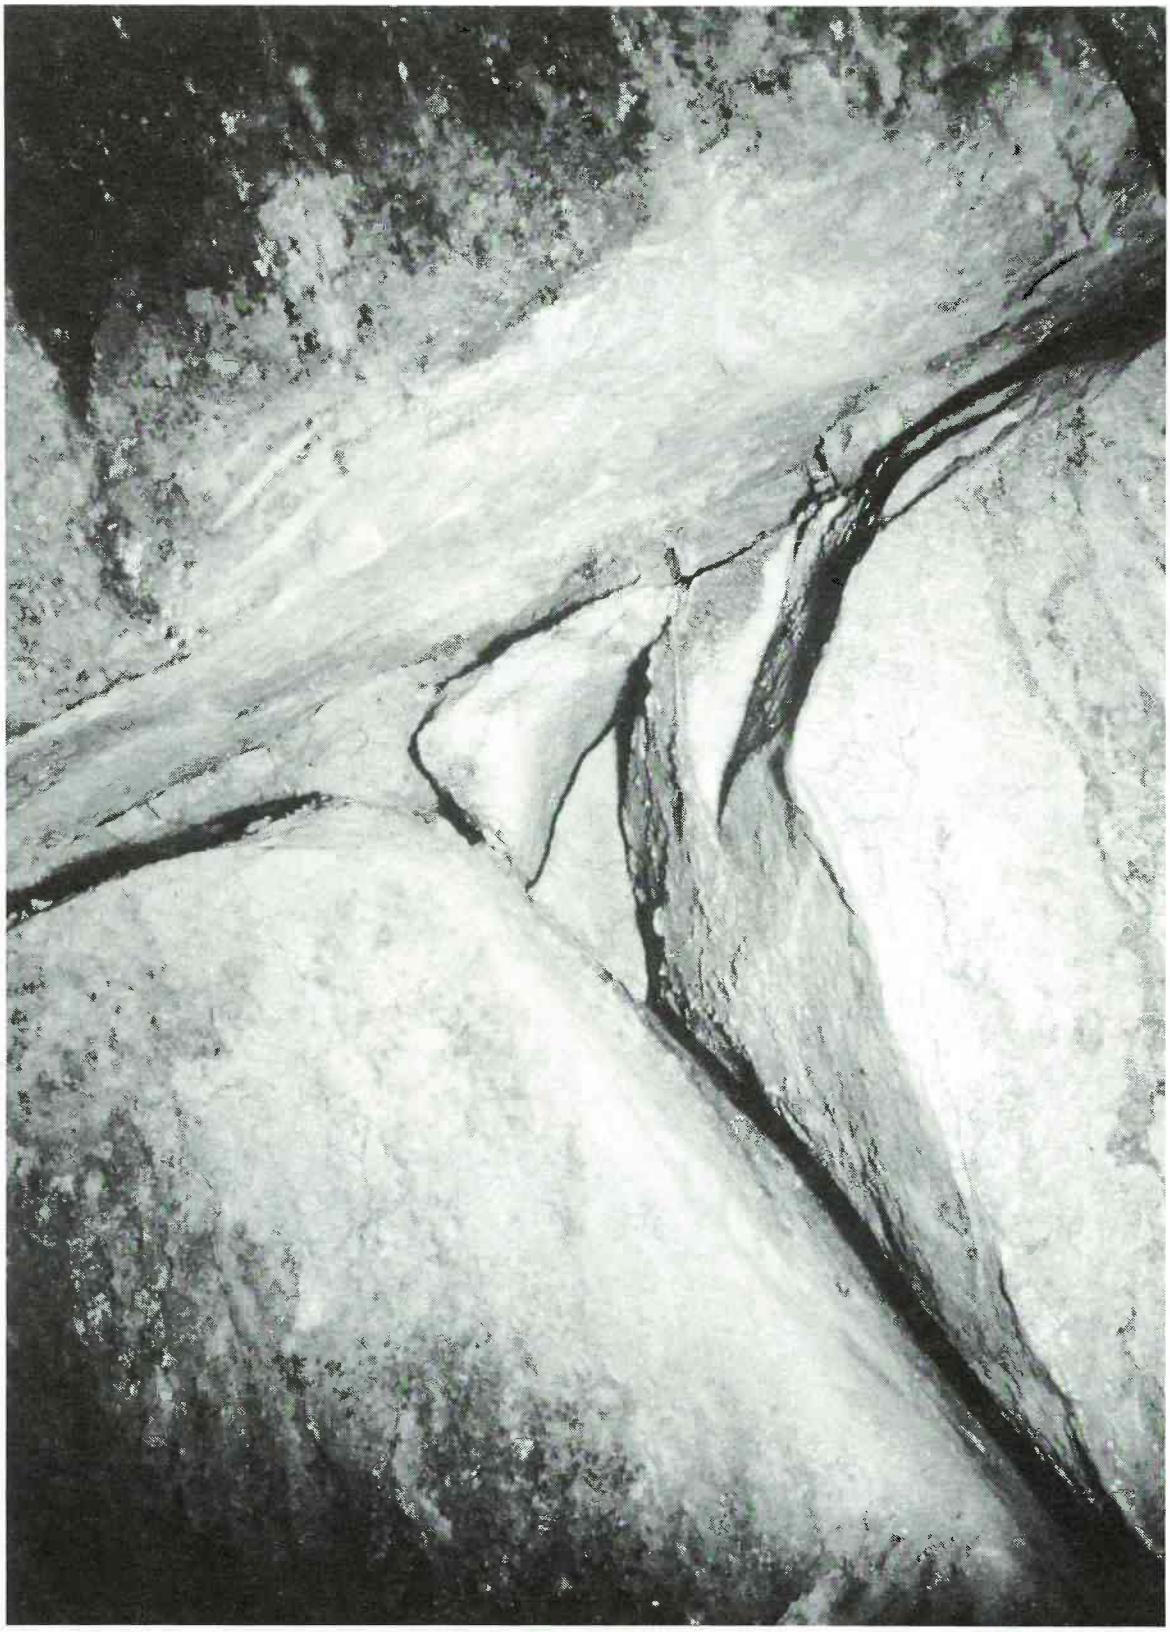
Figure 10.–Intersection of hillseams in mine roof.

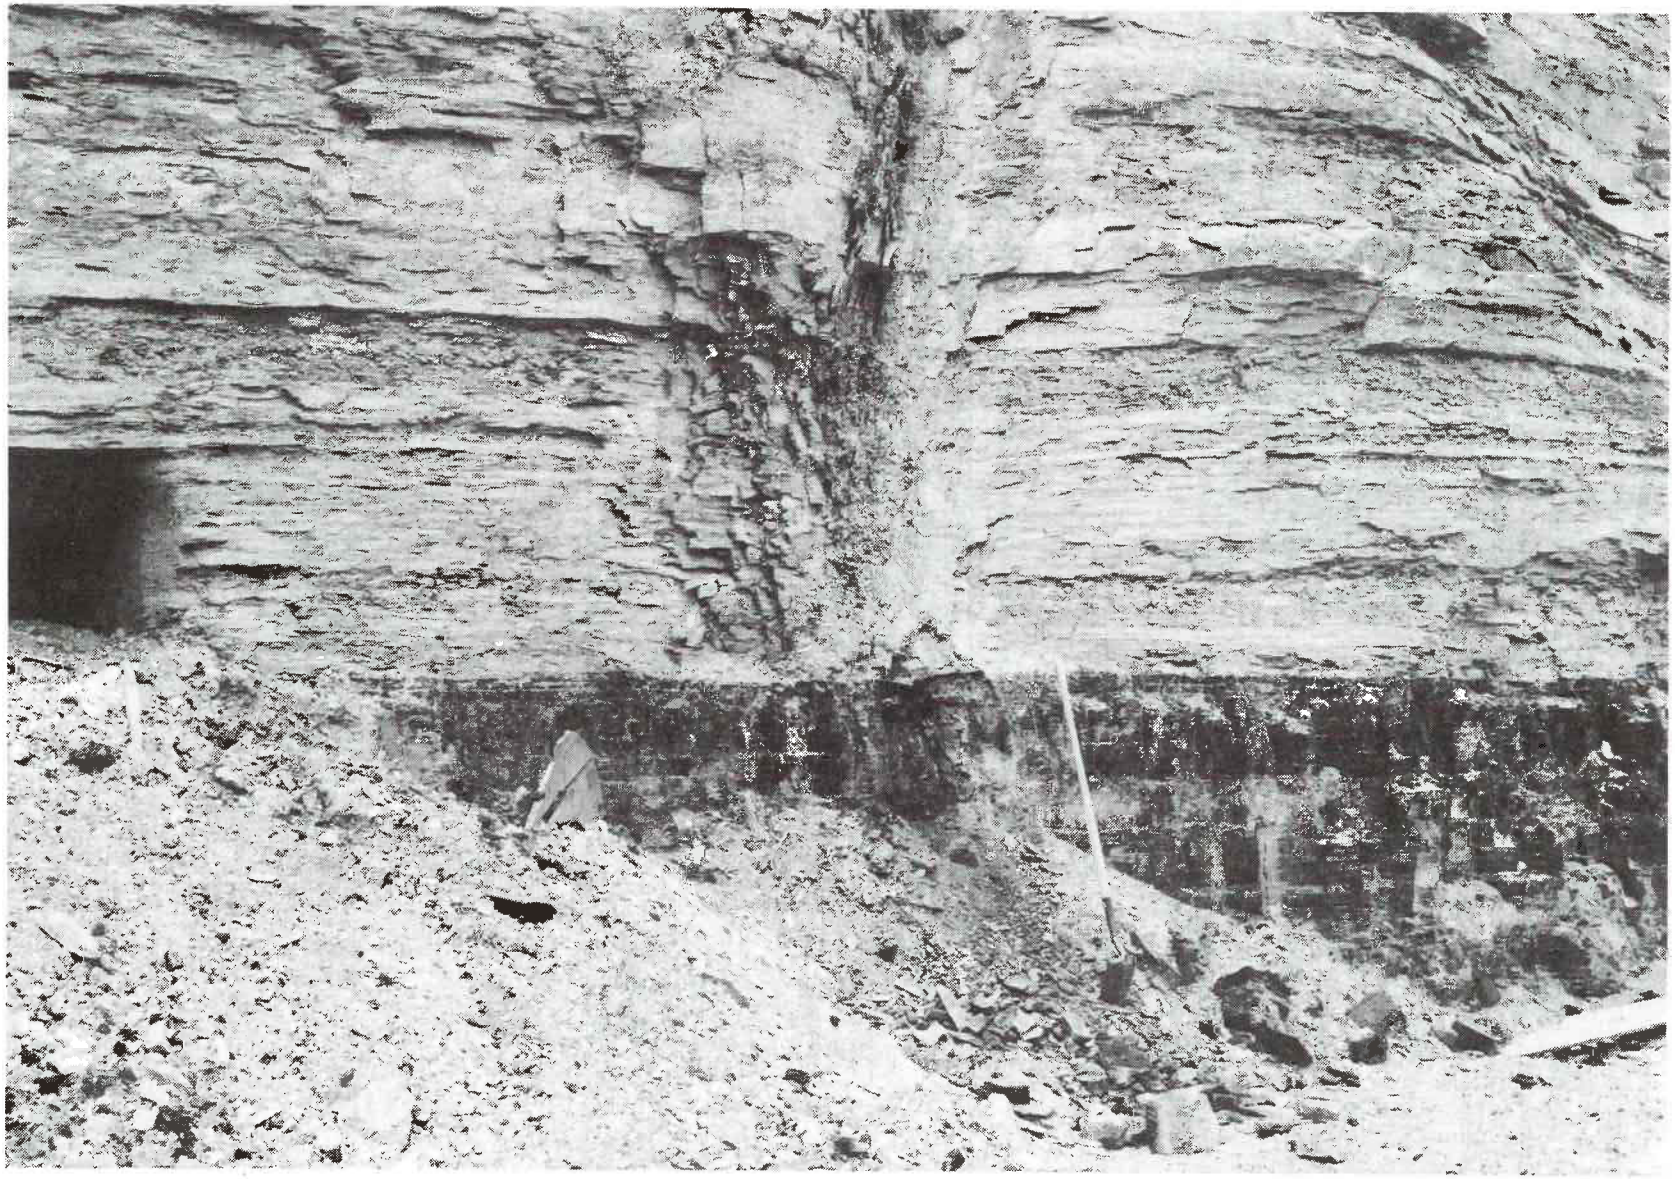
Figure 11.–Hillseams terminating at coalbed.

This is attributed to the contrast in mechanical and weathering properties between the coal and the surrounding sandstone or shale.

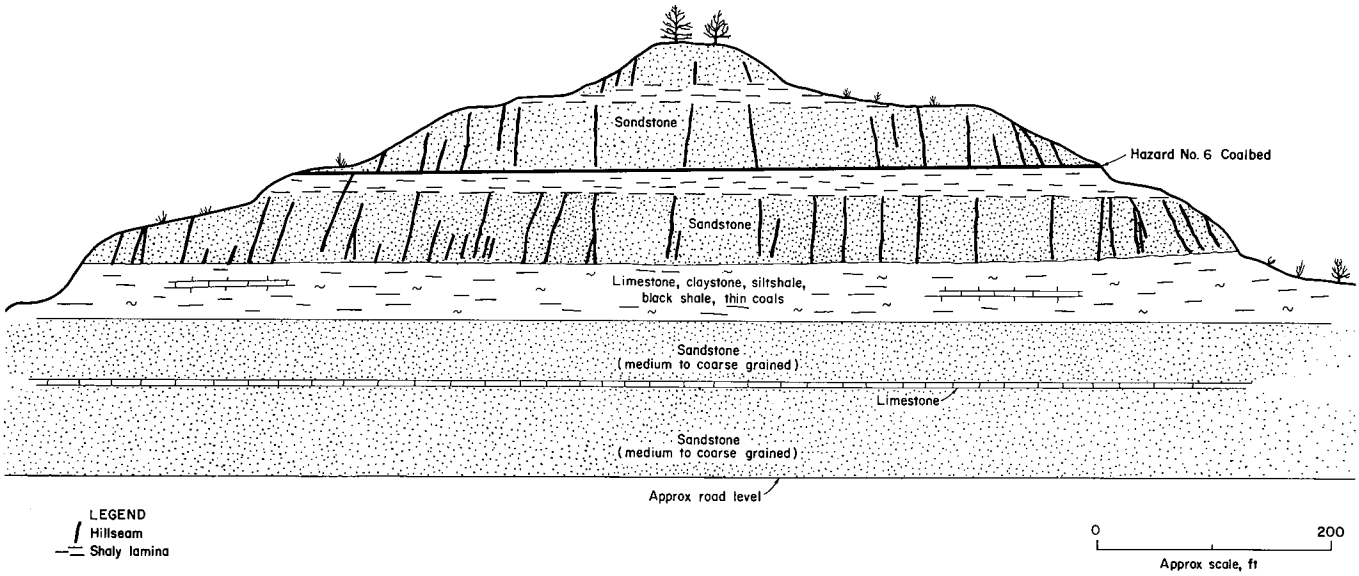
The hillseam exposures at site 3 are in a large roadcut (some 250 ft high) along Route 80 near Martin, Floyd County, in interbedded shales and sandstones (fig. 14). The trend of the roadcut, N 20° E, is generally perpendicular to the trend of the topographic ridge and

Figure 14.–Highwall exposure in Route 80 Martin roadcut.

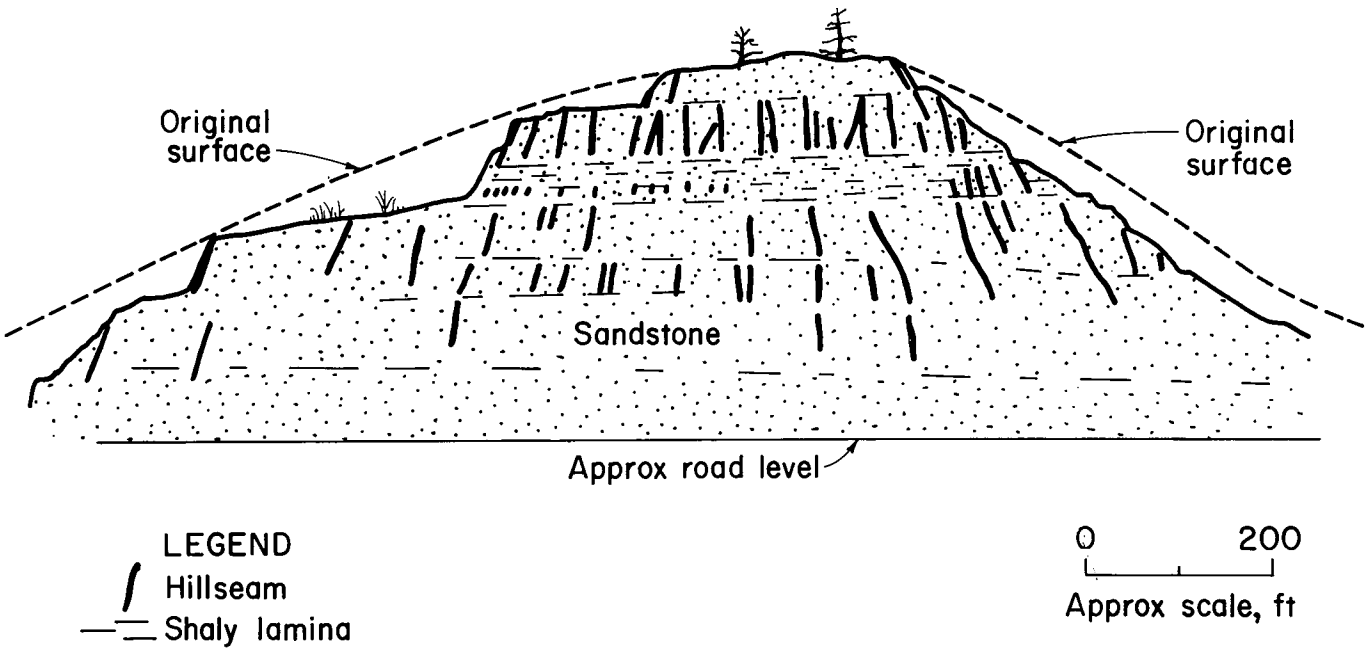
Figure 16.–Highwall exposure in Pikeville canyon roadcut.

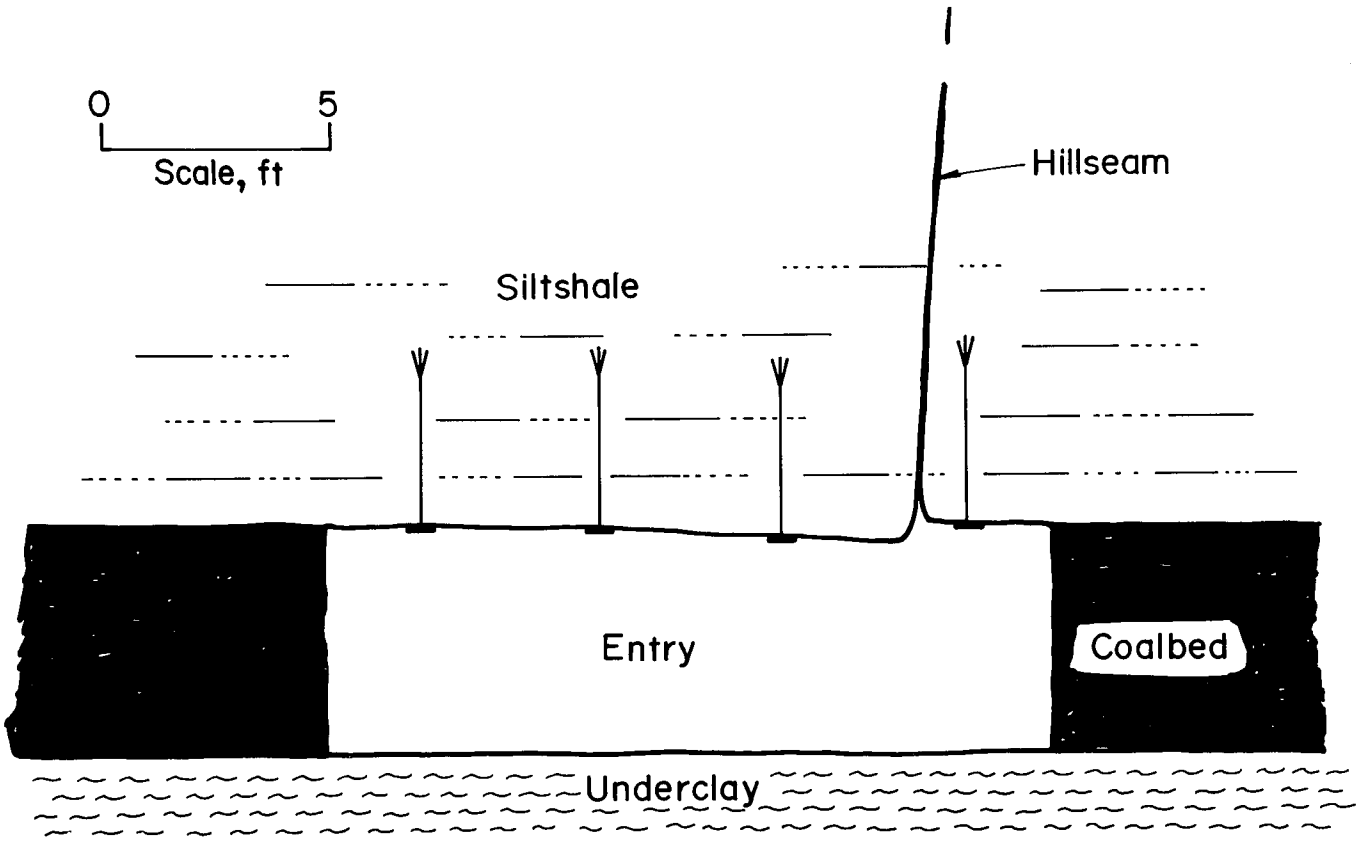
Hillseams that parallel openings create a serious hazard by interrupting the beamlike span of roof that normally supports the overlying rock, leaving a cantilever (fig. 18). This situation calls for detailed observations, immediate judgment, and remedial action in terms of supplementary support, especially when the hillseam may be heavily weathered and broken just beyond the face.

Figure 18.–Cantilevered mine roof formed by hillseam paralleling entry.

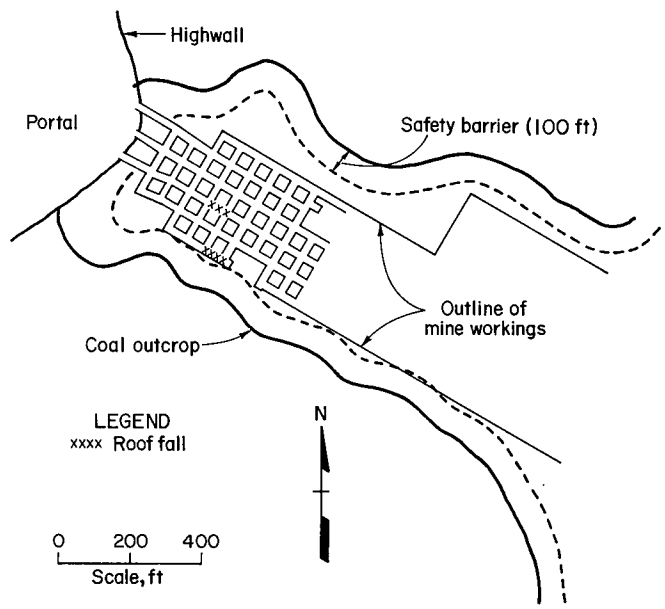
Figure 20.–Map of example 1 mine workings.

County: Martin
Coalbed: Stockton, 52 in
Overburden: At accident site, 40 ft
Mining method: Conventional room-and-pillar
Roof: Main, massive sandstone, 10 ft; immediate, silty shale, 24 in
Hillseam-related injury: Roof fall fatality
Summary: The portal of this mine was driven into the nose of a ridge and advanced for 1,500 ft parallel to the topographic contours on each side of the ridge (fig. 20). Hillseams were abundant for the first 100 ft inby the portal; however, some persisted parallel to the main entries for over 300 ft and contributed to the collapse of a large section of roof. Further inby the outcrop, the roof was largely free of hillseams because of the greater thickness of overburden.

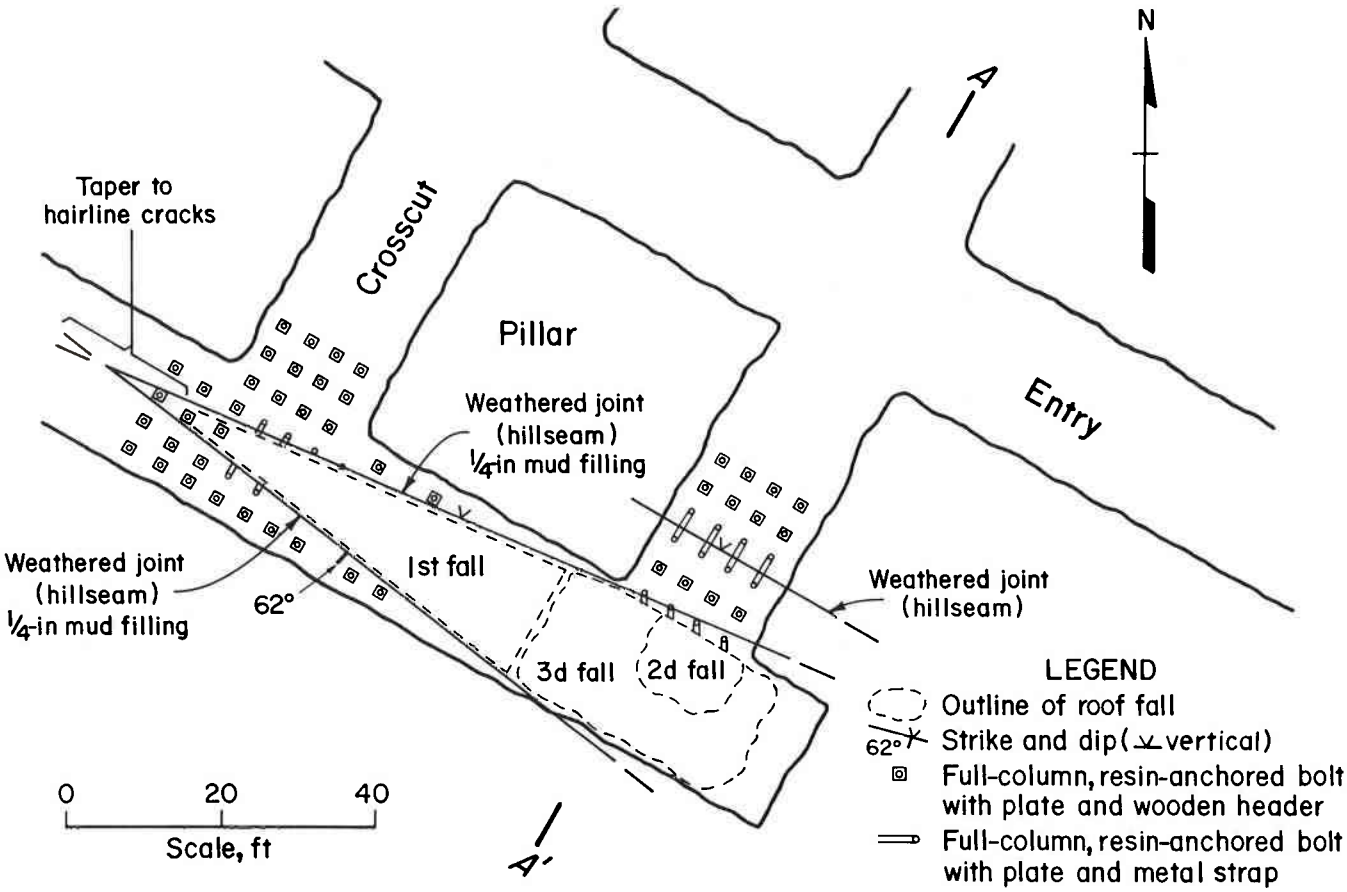
In one area of the mine, the outer entry of the mains was adjacent to the 100-ft-wide outcrop barrier. Hairline cracks in the roof were the first indication of roof support problems. As the entry was advanced, the cracks gradually increased in width and intensity of weathering until two intersecting hillseams were exposed that followed the trend of the entry and the contour of the ridge.

The entire wedge-shaped fall of roof between the intersecting hillseams was estimated to consist of 5,139 ft^3 of rock weighing 385 st. Figures 22 and 23 show two views of the fall. This weight over an entry length of 50 to 80 ft far exceeded the support capacity of the installed bolts and straps. If the magnitude of the fall could have been anticipated by a greater awareness of the roof structure, additional supplementary support could have been installed.

Figure 21.–Roof falls in example 1 mine.

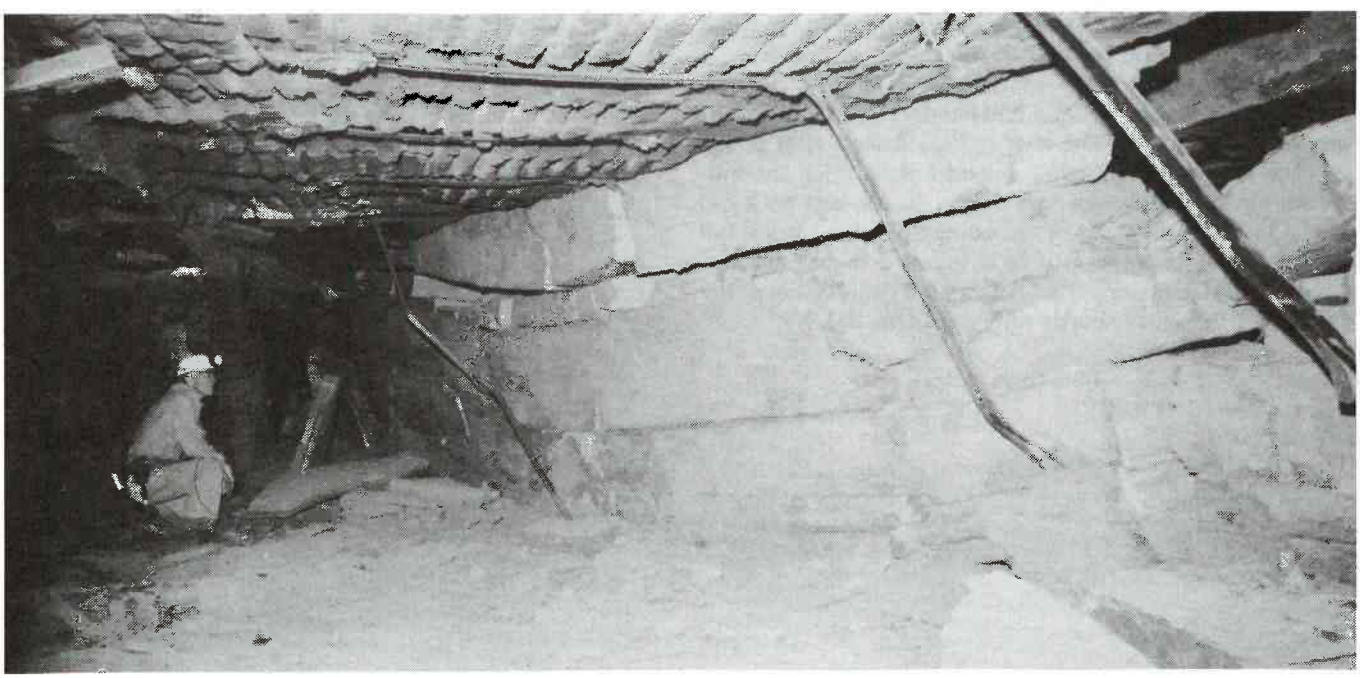
Figure 22.–North side of roof fall in example 1 mine.

Figure 23.–Apex of roof fall in example 1 mine.

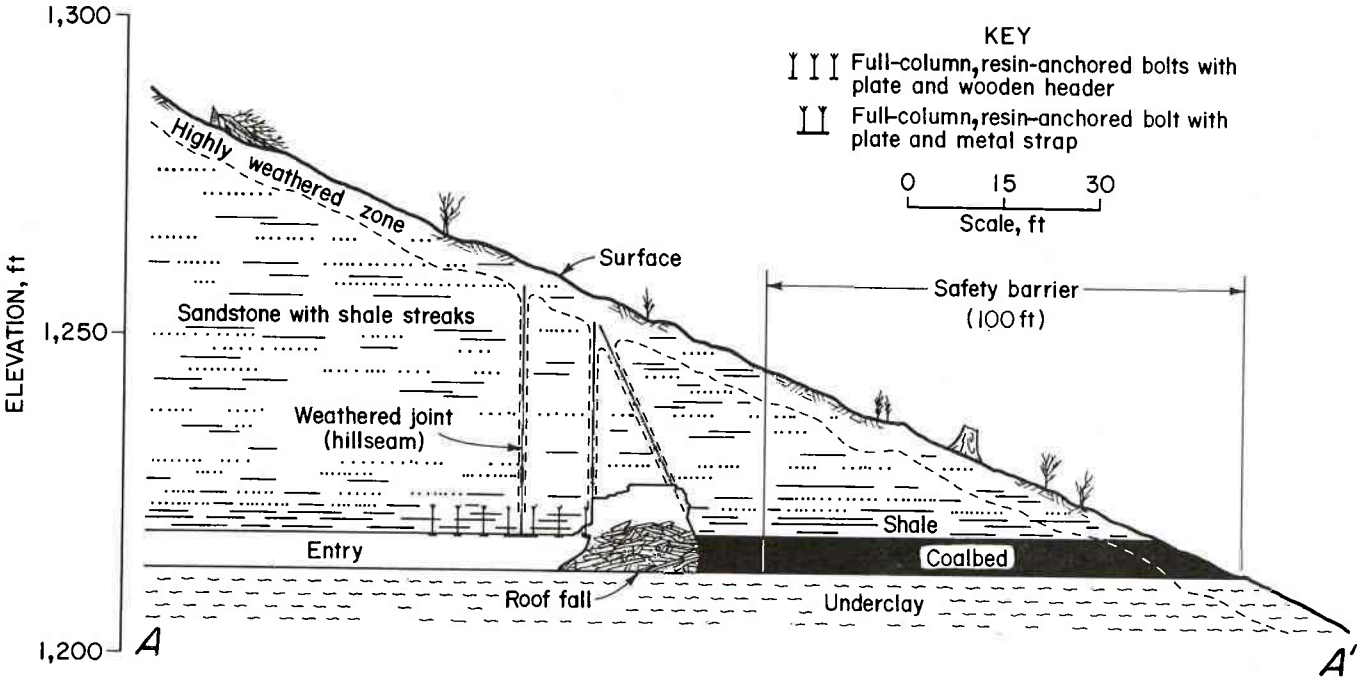
Figure 24.–Overburden profile at example 1 mine.

This example of hillseam related roof failure is common in situations where the entries tend to parallel the surface contours and failure occurs in long massive wedges of roof. The overburden at this roof fall site was about 40 ft (fig. 24).

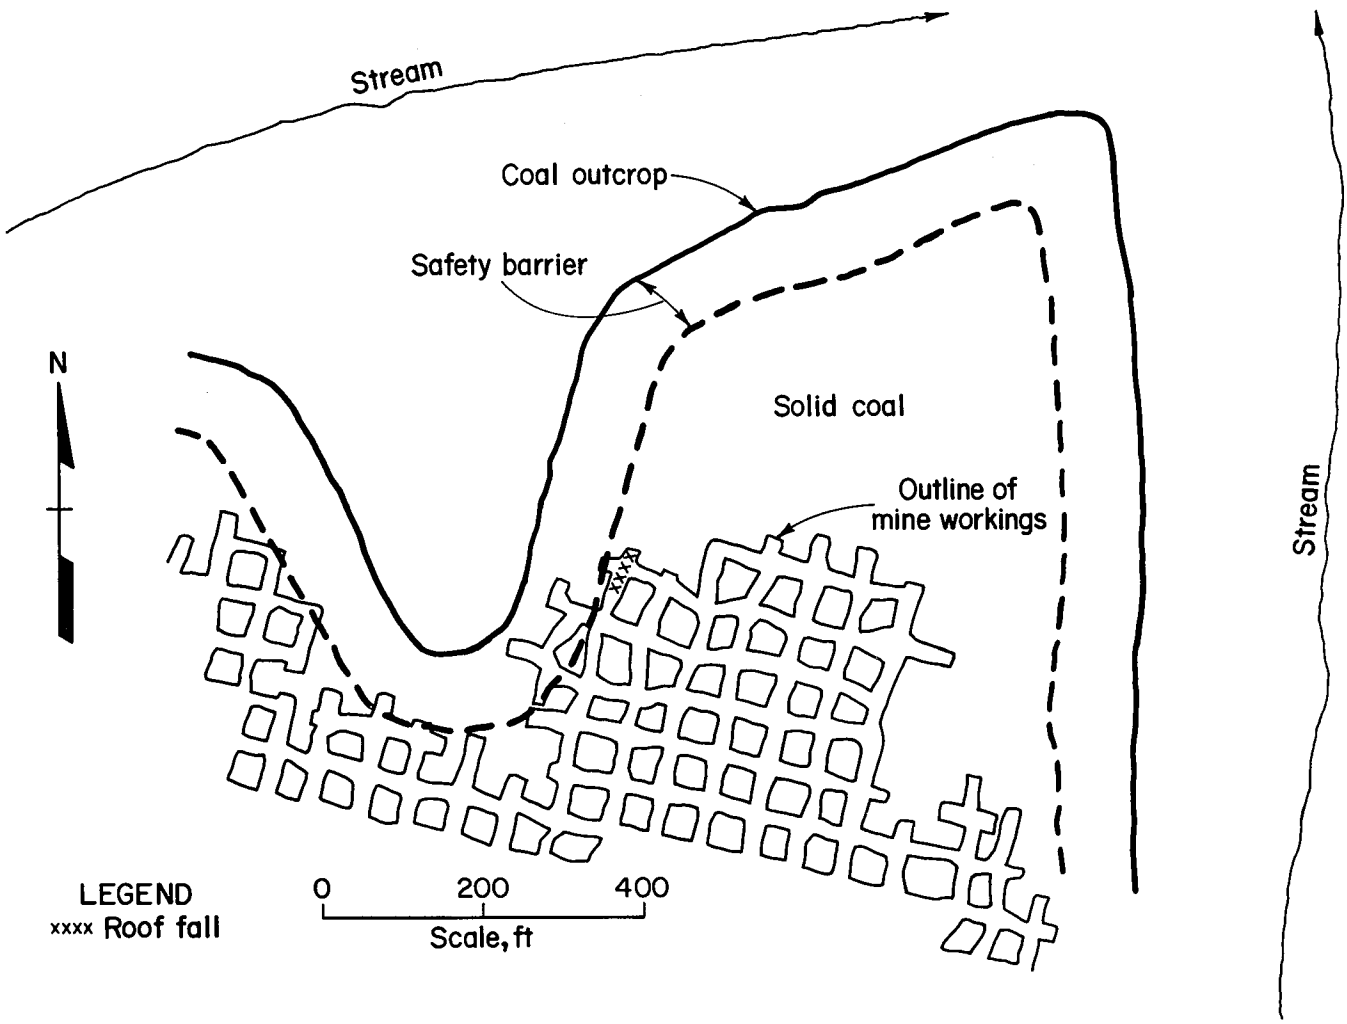
Figure 25.–Map of example 2 mine workings.

Summary: The portal of this mine was driven into a strip mine highwall 600 ft from the head of a small stream valley. The mine workings were advanced for some 1,500 ft to the safety barrier surrounding the periphery of the property (fig. 25). Hillseams were encountered in the portal area and again at two locations near the barrier 1,500 ft inby the portal. At one location, entries were stopped 70 to 100 ft short of the barrier because of hazardous roof related to hillseams. At a second location, a breakthrough was being mined when a massive block of roof collapsed into the intersection without warning, instantly killing a miner. The roof was weakened by two hillseams that ran parallel with the entry and two that cut across the entry (fig. 26) forming the boundaries of a rectangular mass of roof rock. The roof, including 3 to 4 in of headcoal, was supported by 36-in resin-anchored bolts. The hillseams were concealed by the headcoal.

The entire rectangular-shaped fall of roof between the intersecting hillseams was estimated to consist of 13,500 ft^3 of rock weighing about 1,000 st, far in excess of the support capacity of the bolts and straps.

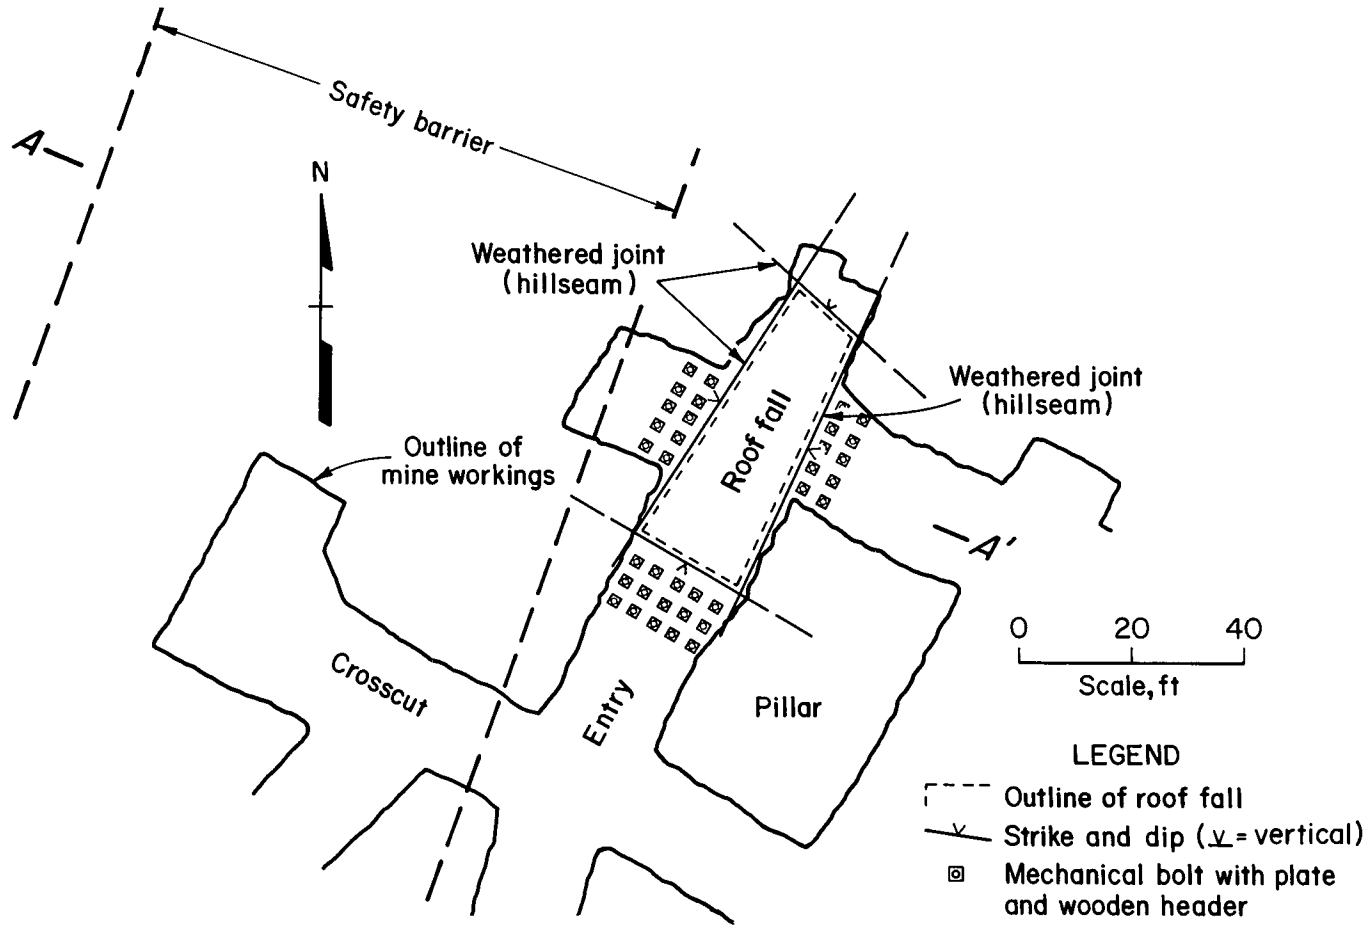
Figure 26.–Map of roof fall site in example 2 mine.

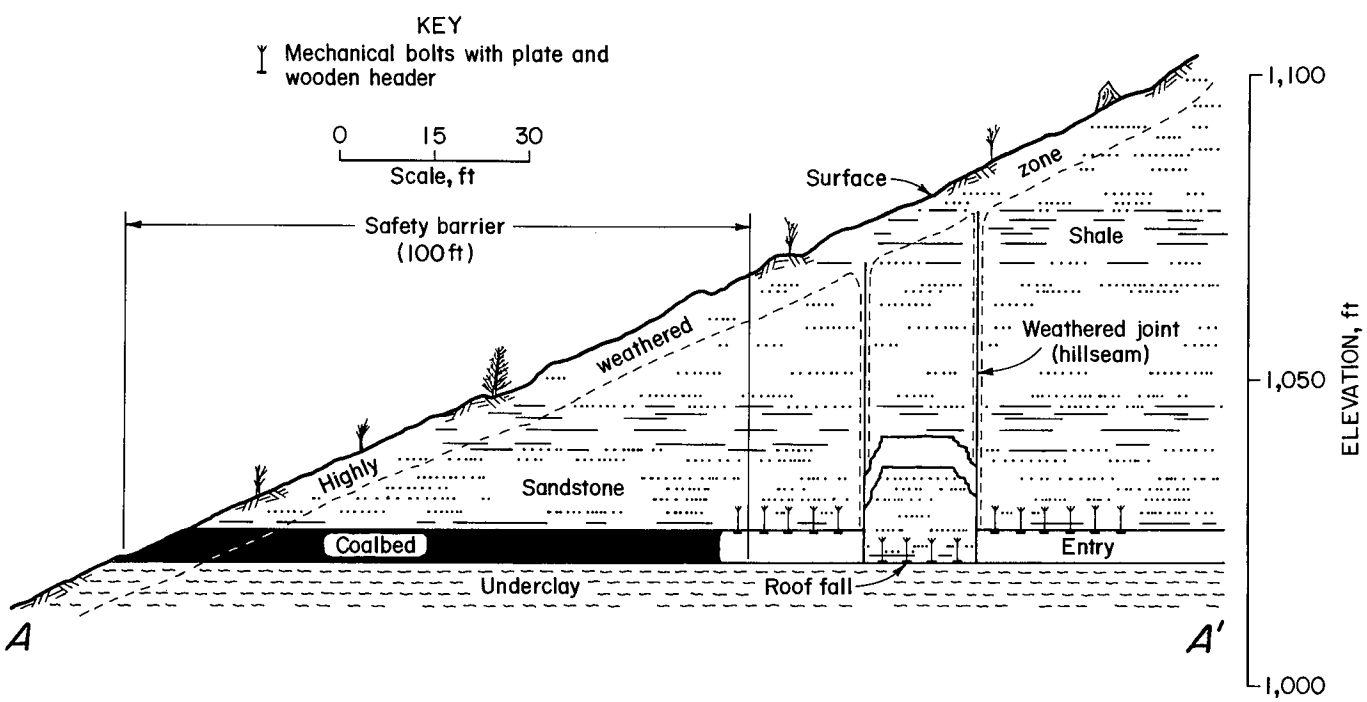
Figure 27.–Overburden profile at example 2 mine.

This example of hillseam-related roof failure is similar to that of example 1, where the problem is chiefly the failure to detect and then anticipate the inherent hazard of hillseams. In example 2, tension acting outward at both the nose and sides of the ridge resulted in intersecting hillseams. Failure in both instances occurred as the roof rock separated from overlying rock along a bedding plane (fig. 27), overcame the friction along the vertical hillseam surfaces, and dropped into the void left by removal of the supporting coal. The metal straps in each case offered little restraint.
