Report of Investigations 9267

Hillseam Geology and Roof Instability Near Outcrop in Eastern Kentucky Drift Mines

By Gary P. Sames and Noel N. Moebs

BUREAU OF MINES
T S Ary, Director

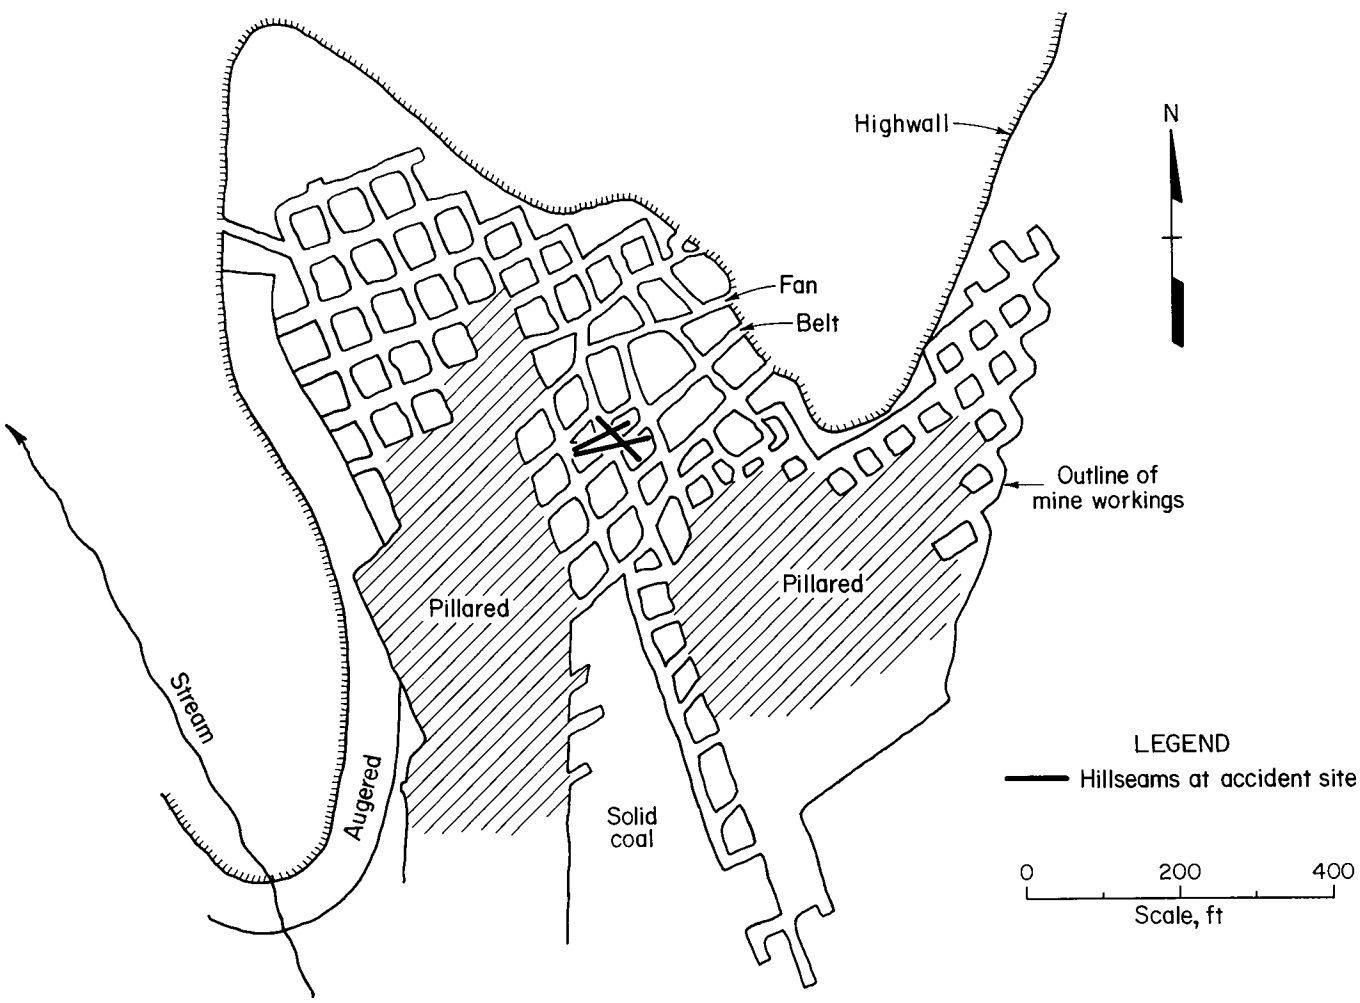
County: Harlan
Coalbed: B (Kellioka), 38 in
Overburden: At accident site, 120 ft
Mining method: Conventional room-and-pillar
Roof: Main, massive sandstone, thickness unreported; immediate, shale, thickness unreported
Hillseam-related injury: Roof fall fatality
Summary: This drift mine was opened at a highwall on the side of a ridge and developed under the nose of the ridge (fig. 28). Retreat mining with full-pillar extraction was in progress using breaker posts. The scoop was removing the last remaining coal from the punchthrough of a pillar split. A hillseam along the inby (south) rib was inspected a short time before, but it showed no movement. Small fragments of rock began to dribble from one of three hillseams located at the intersection opening into the pillar split. Immediately thereafter, the roof between the hillseams collapsed with a loud rasping noise and sparks were emitted from the ruptured metal straps that were installed across one of the hillseams.

The roof fall size was 35 by 22 by 1 to 5 ft and weighed an estimated 95 st. A scoop operator was trapped in the scoop cab by the fall for 2 h. A miner who was observing the roof while the scoop was loading coal was caught under the edge of the fall and fatally injured. The accident was attributed to the second mining being conducted under known adverse roof conditions (hillseams). The increase of load on the roof due to removal of the supporting coal dislodged the segment of roof bounded by the three hillseams.

Figure 28.–Map of example 3 mine workings.

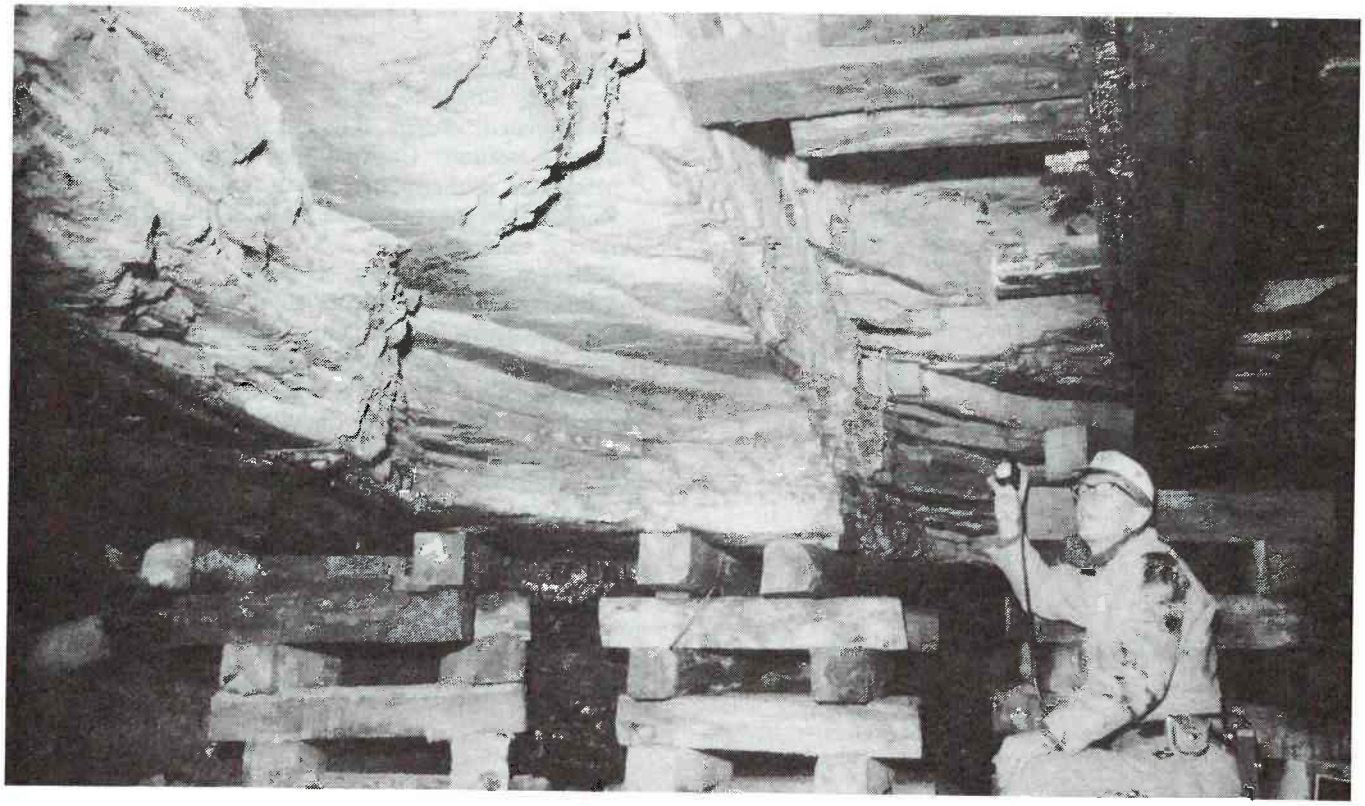
Figure 31.–Unstable roof in example 4 mine intersection.

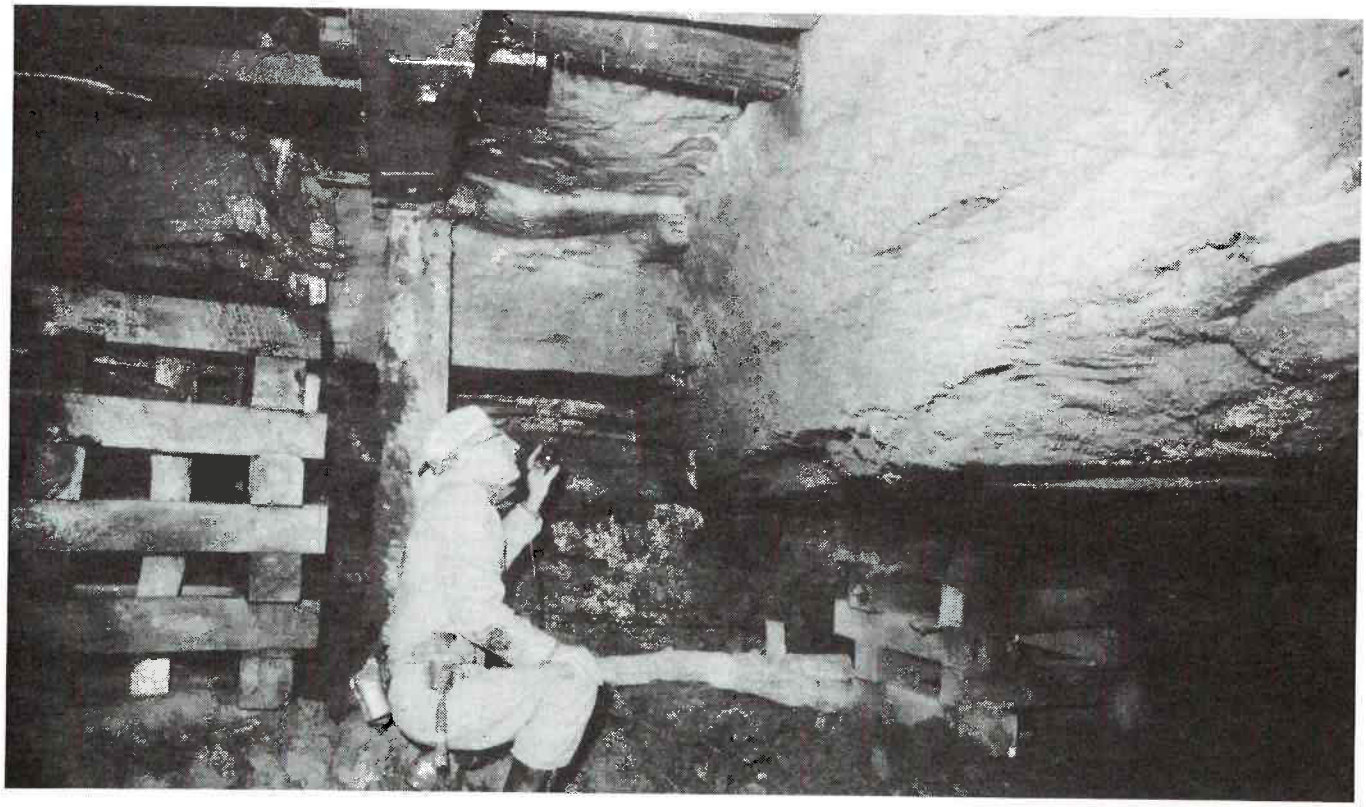
Figure 32.–Hillseam-related roof fall forming roof brow.

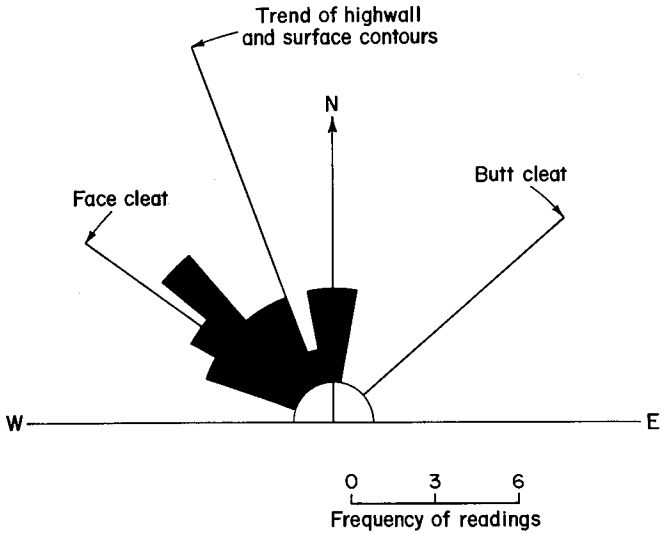
Figure 33.–Rose diagram of hillseam trends at example 4 mine.

A diagram of hillseams exposed in a highwall near the mine portals shows that the hillseams follow a preferred direction that generally parallels the trend of the surface contours (fig. 33).

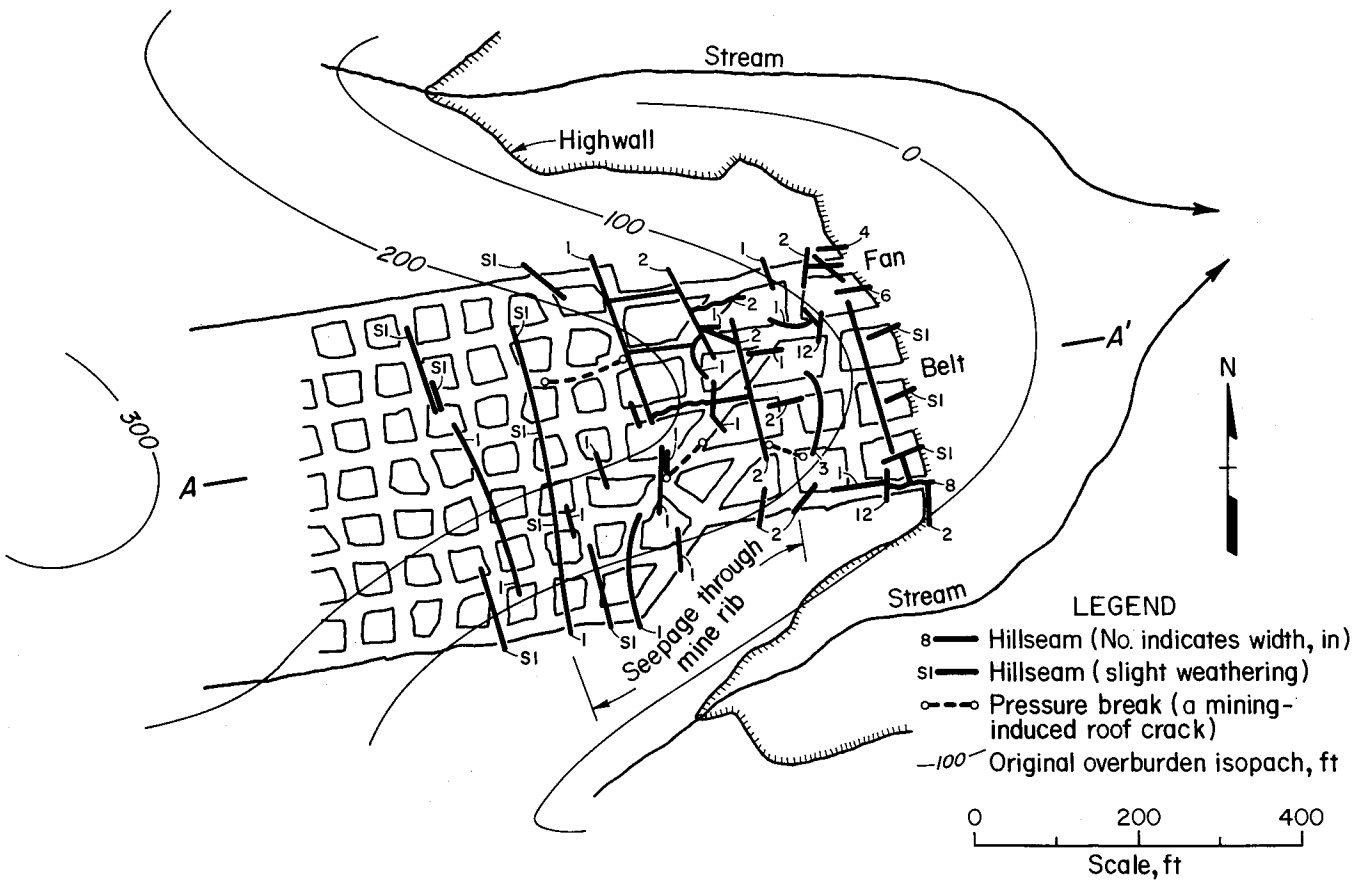
Figure 34.–Map of example 5 mine portal area.

County: Martin
Coalbed: Coalburg, 52 in
Overburden: Range, 0 to 230 ft
Mining method: Conventional room-and-pillar
Minimum roof support: 60-in bolts on 5-ft centers
Roof: Main, massive sandstone, 20 to 25 ft; immediate, laminated sandstone, 1 to 2 ft
Hillseam-related injury: None
Summary: This mine consists of a complex of portals, mains, and isolated producing sections (only one portal area was selected for study). The portals were opened in a highwall at the nose of a ridge and driven straight for more than 1,000 ft. The highwall strata consisted of a thick, massive sandstone with a few hillseams 1 to 8 in wide. Hillseams were encountered for some 550 ft inby the portals, or 715 ft inby the original coal outcrop (fig. 34). The most severe problem with hillseams occurred within 415 ft of the original coal outcrop (fig. 35).

A rose diagram of hillseam orientations in the study area inby the portals (fig. 36) indicates that the hillseams tend to follow a narrow preferred orientation that lies about midway in the broad range of surface contour directions around the nose of the ridge. Actual underground mapping in figure 34 shows the intersecting nature of the hillseams in the most outby portion of the development entries directly under the nose of the ridge.

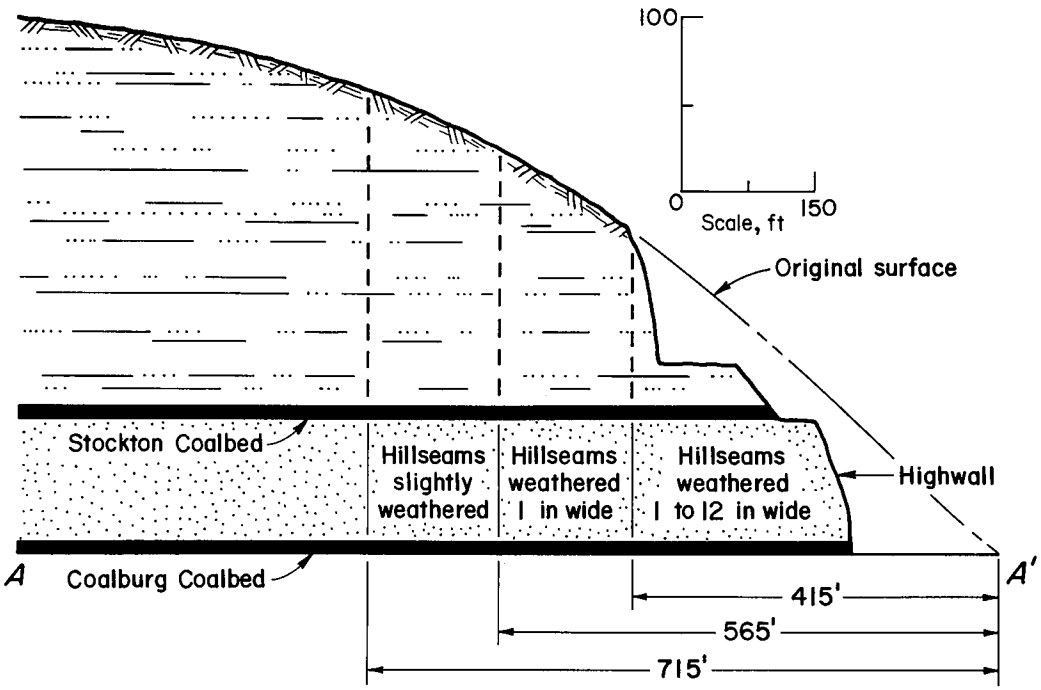
Figure 35.–Overburden profile at example 5 mine.

Generally, roof conditions in the area studied were very good with a minimum of supplementary support required at wide hillseams. No roof falls have occurred although at least two pressure breaks (long, mining-induced tension

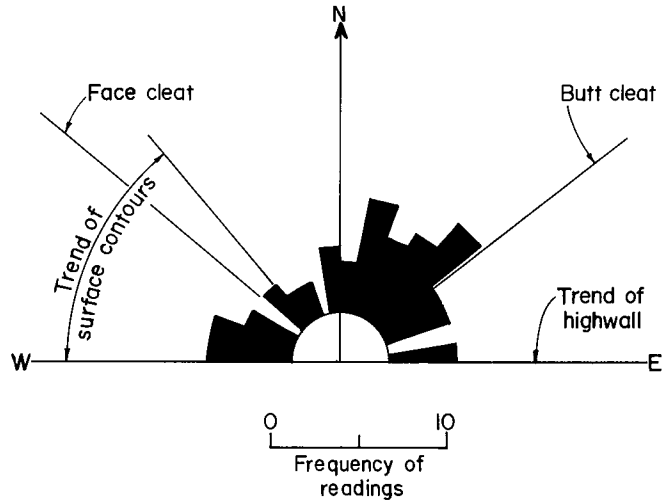
Figure 39.–Rose diagram of hillseam trends at example 6 mine.

A diagram of the hillseams exposed in the highwall at the portals indicates that most parallel the general east-west trend of an irregular highwall and the surface contours (fig. 39). Many of the hillseams in the highwall did not penetrate down to the coalbed and were not observed in the mine roof, suggesting that the main roof may be weakened by hillseams that cannot be detected in exposed mine roof.
