Coal Mine Impoundment Safety

D. E. Stump Jr. PE
Office of Surface Mining
Appalachian Region,
Pittsburgh, PA

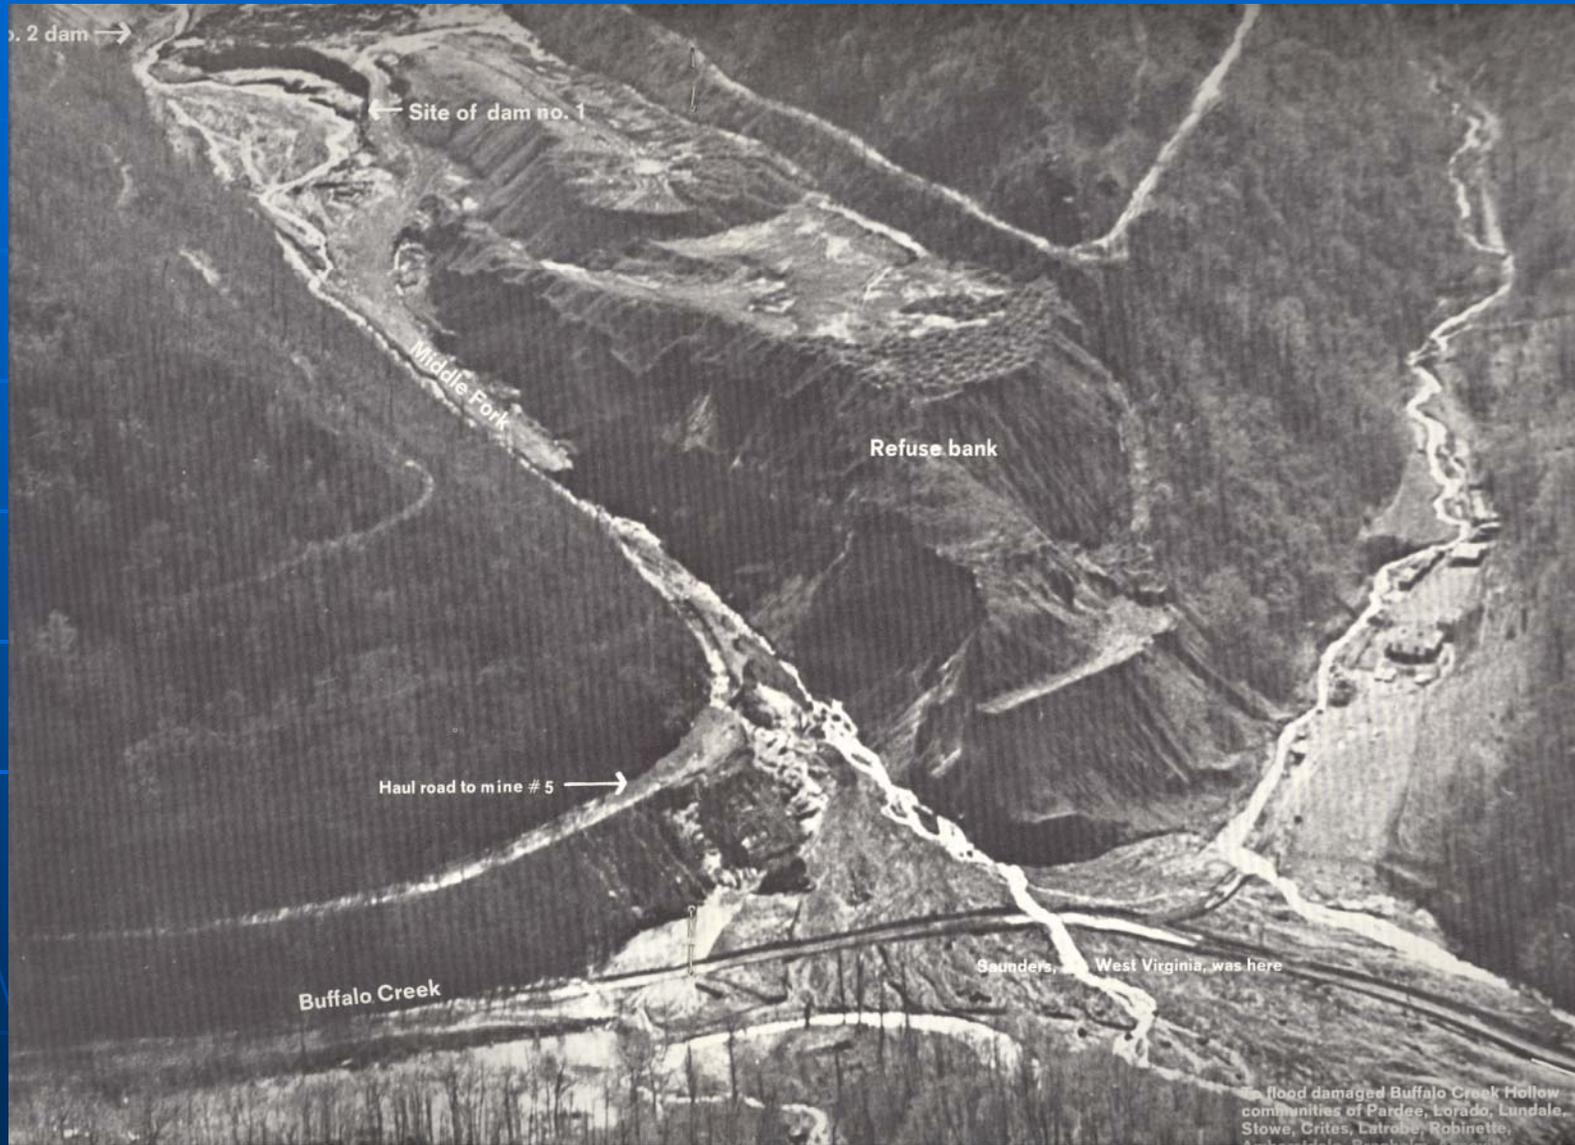
A series of coal
waste embankment
dams failed releasing
132 million gallons of
water and fine coal
waste

Flood damaged Buffalo Creek Hollow communities of Pardee, Lorado, Lundale, Stowe, Crites, Latrobe, Robinette, and...

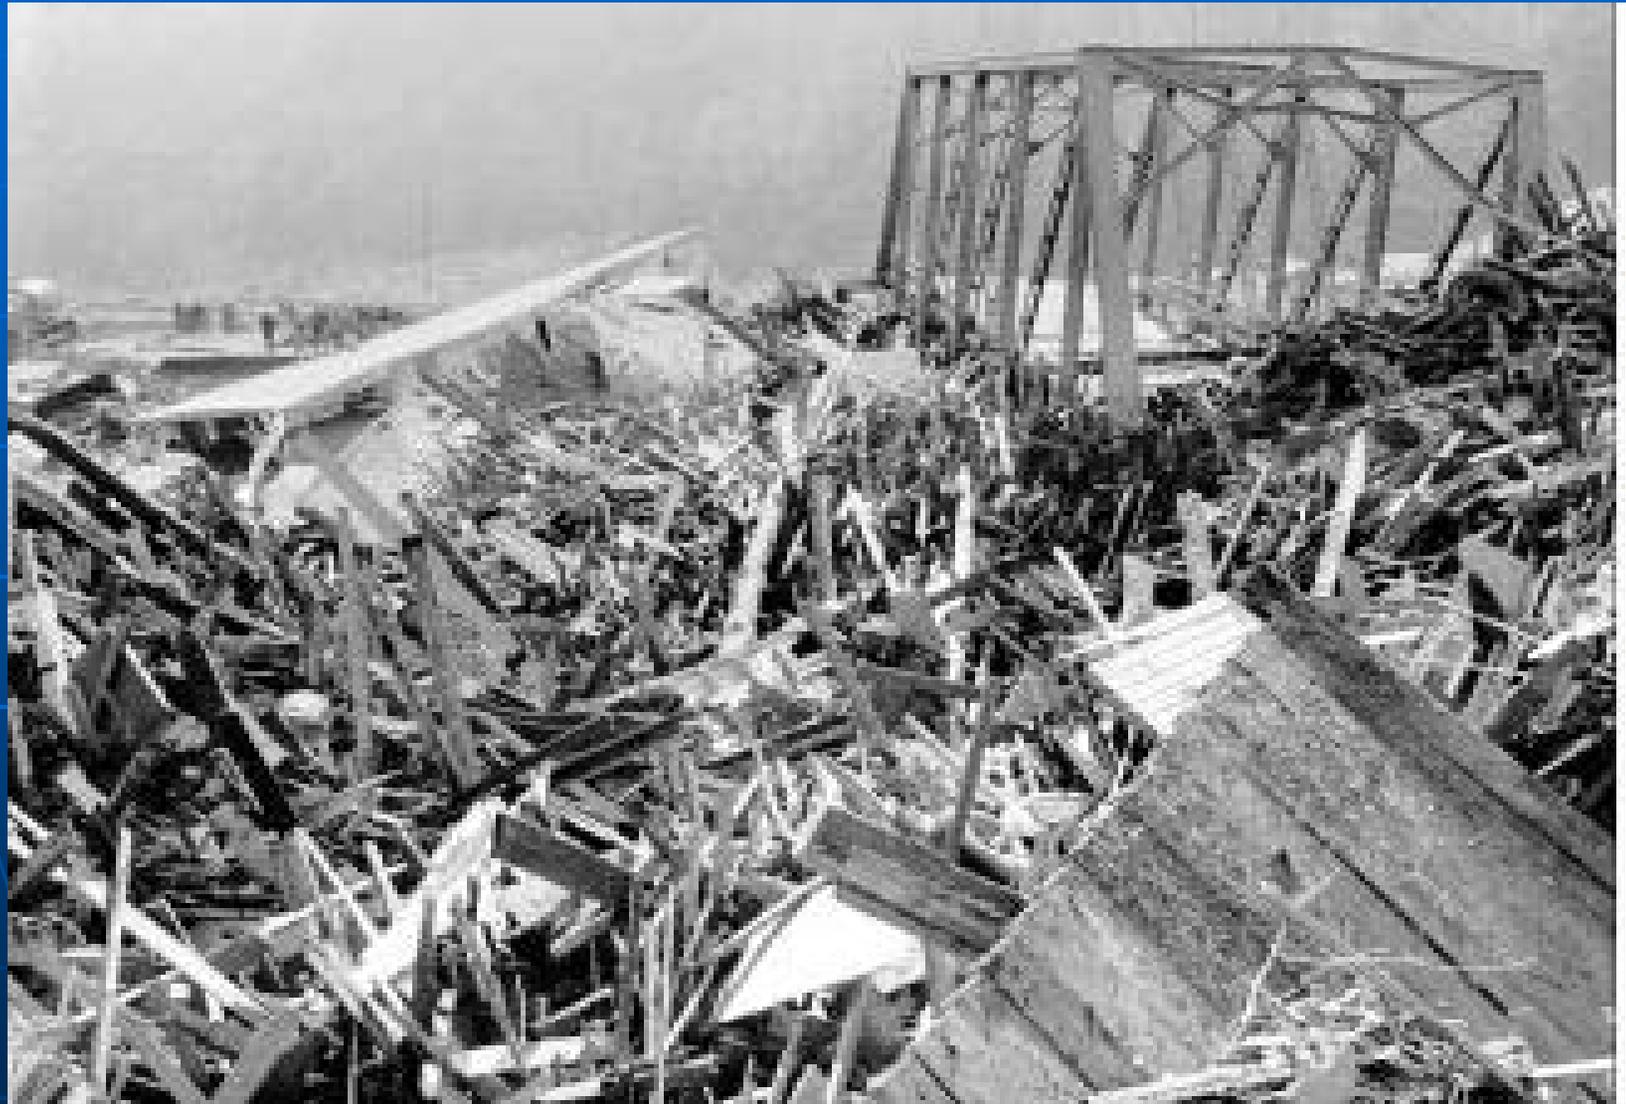
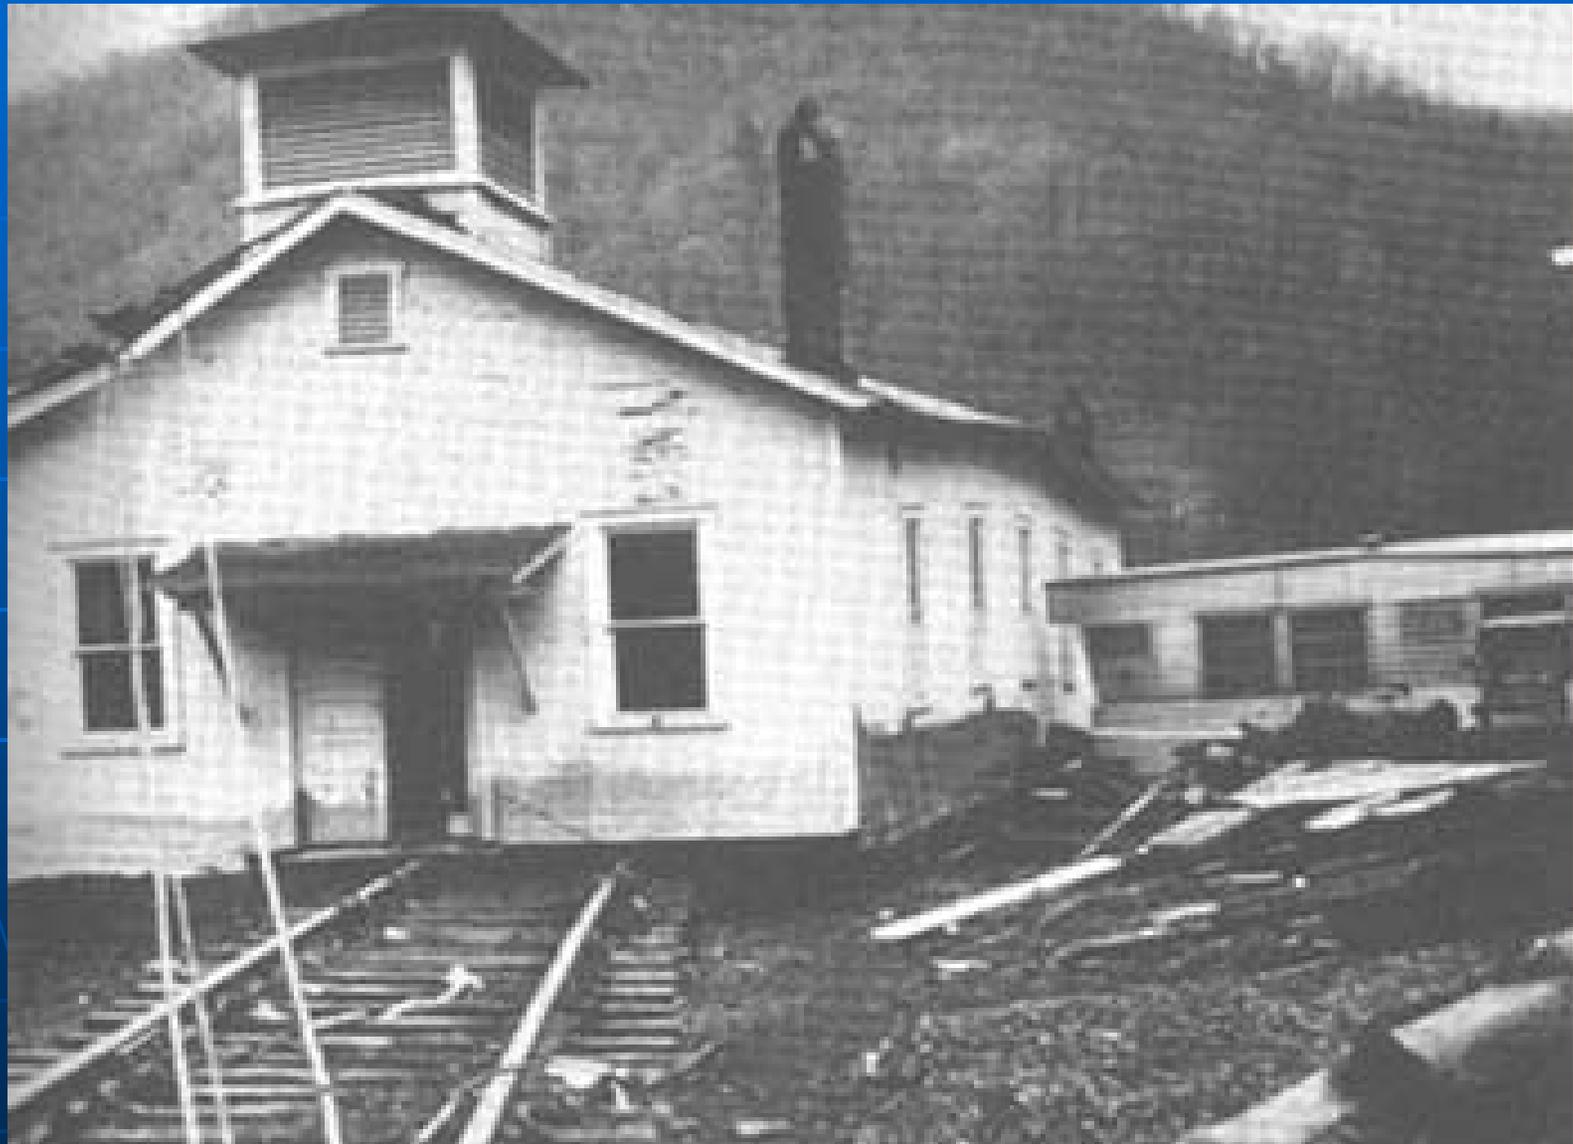
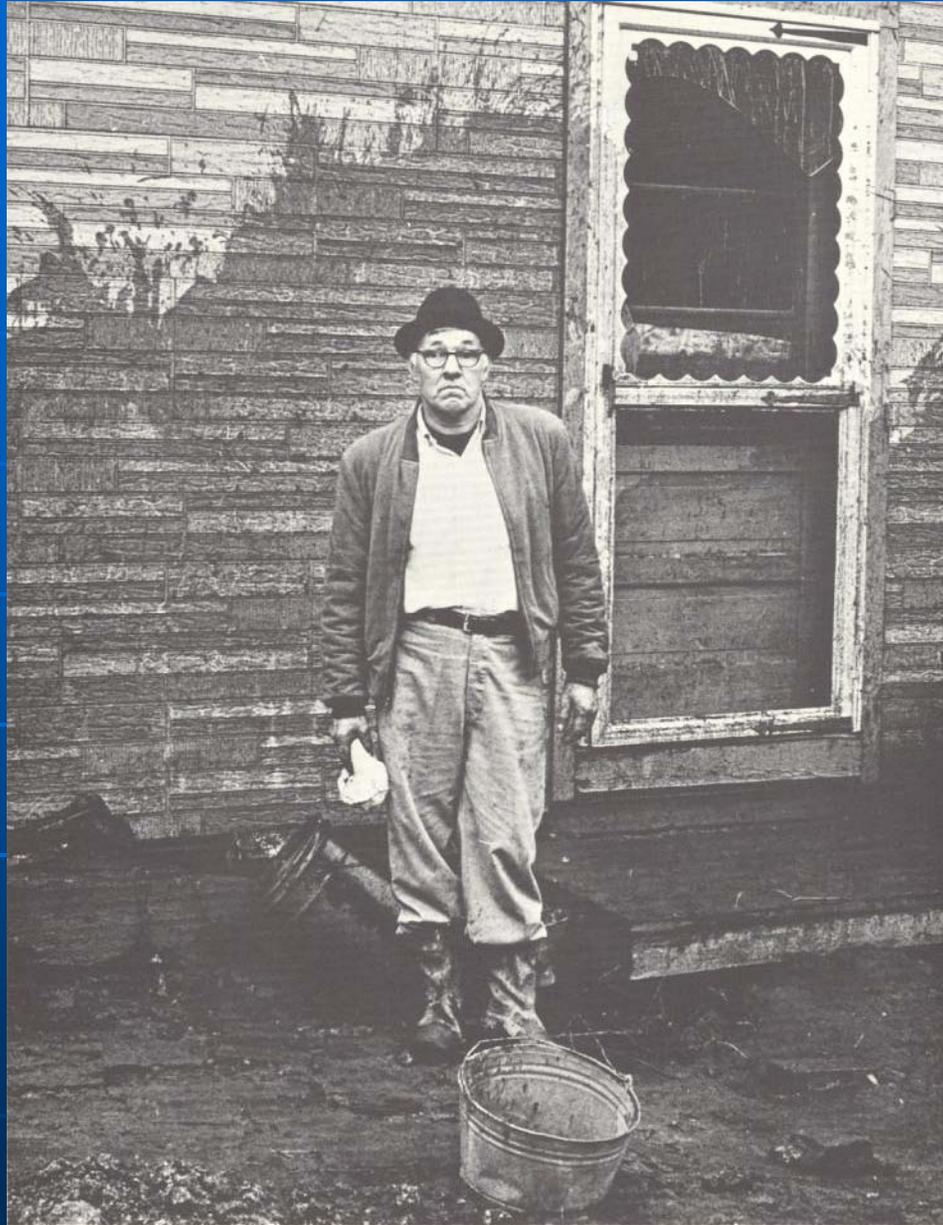
124 dead, 4,000
homeless, an estimated
\$50 million in property
damage

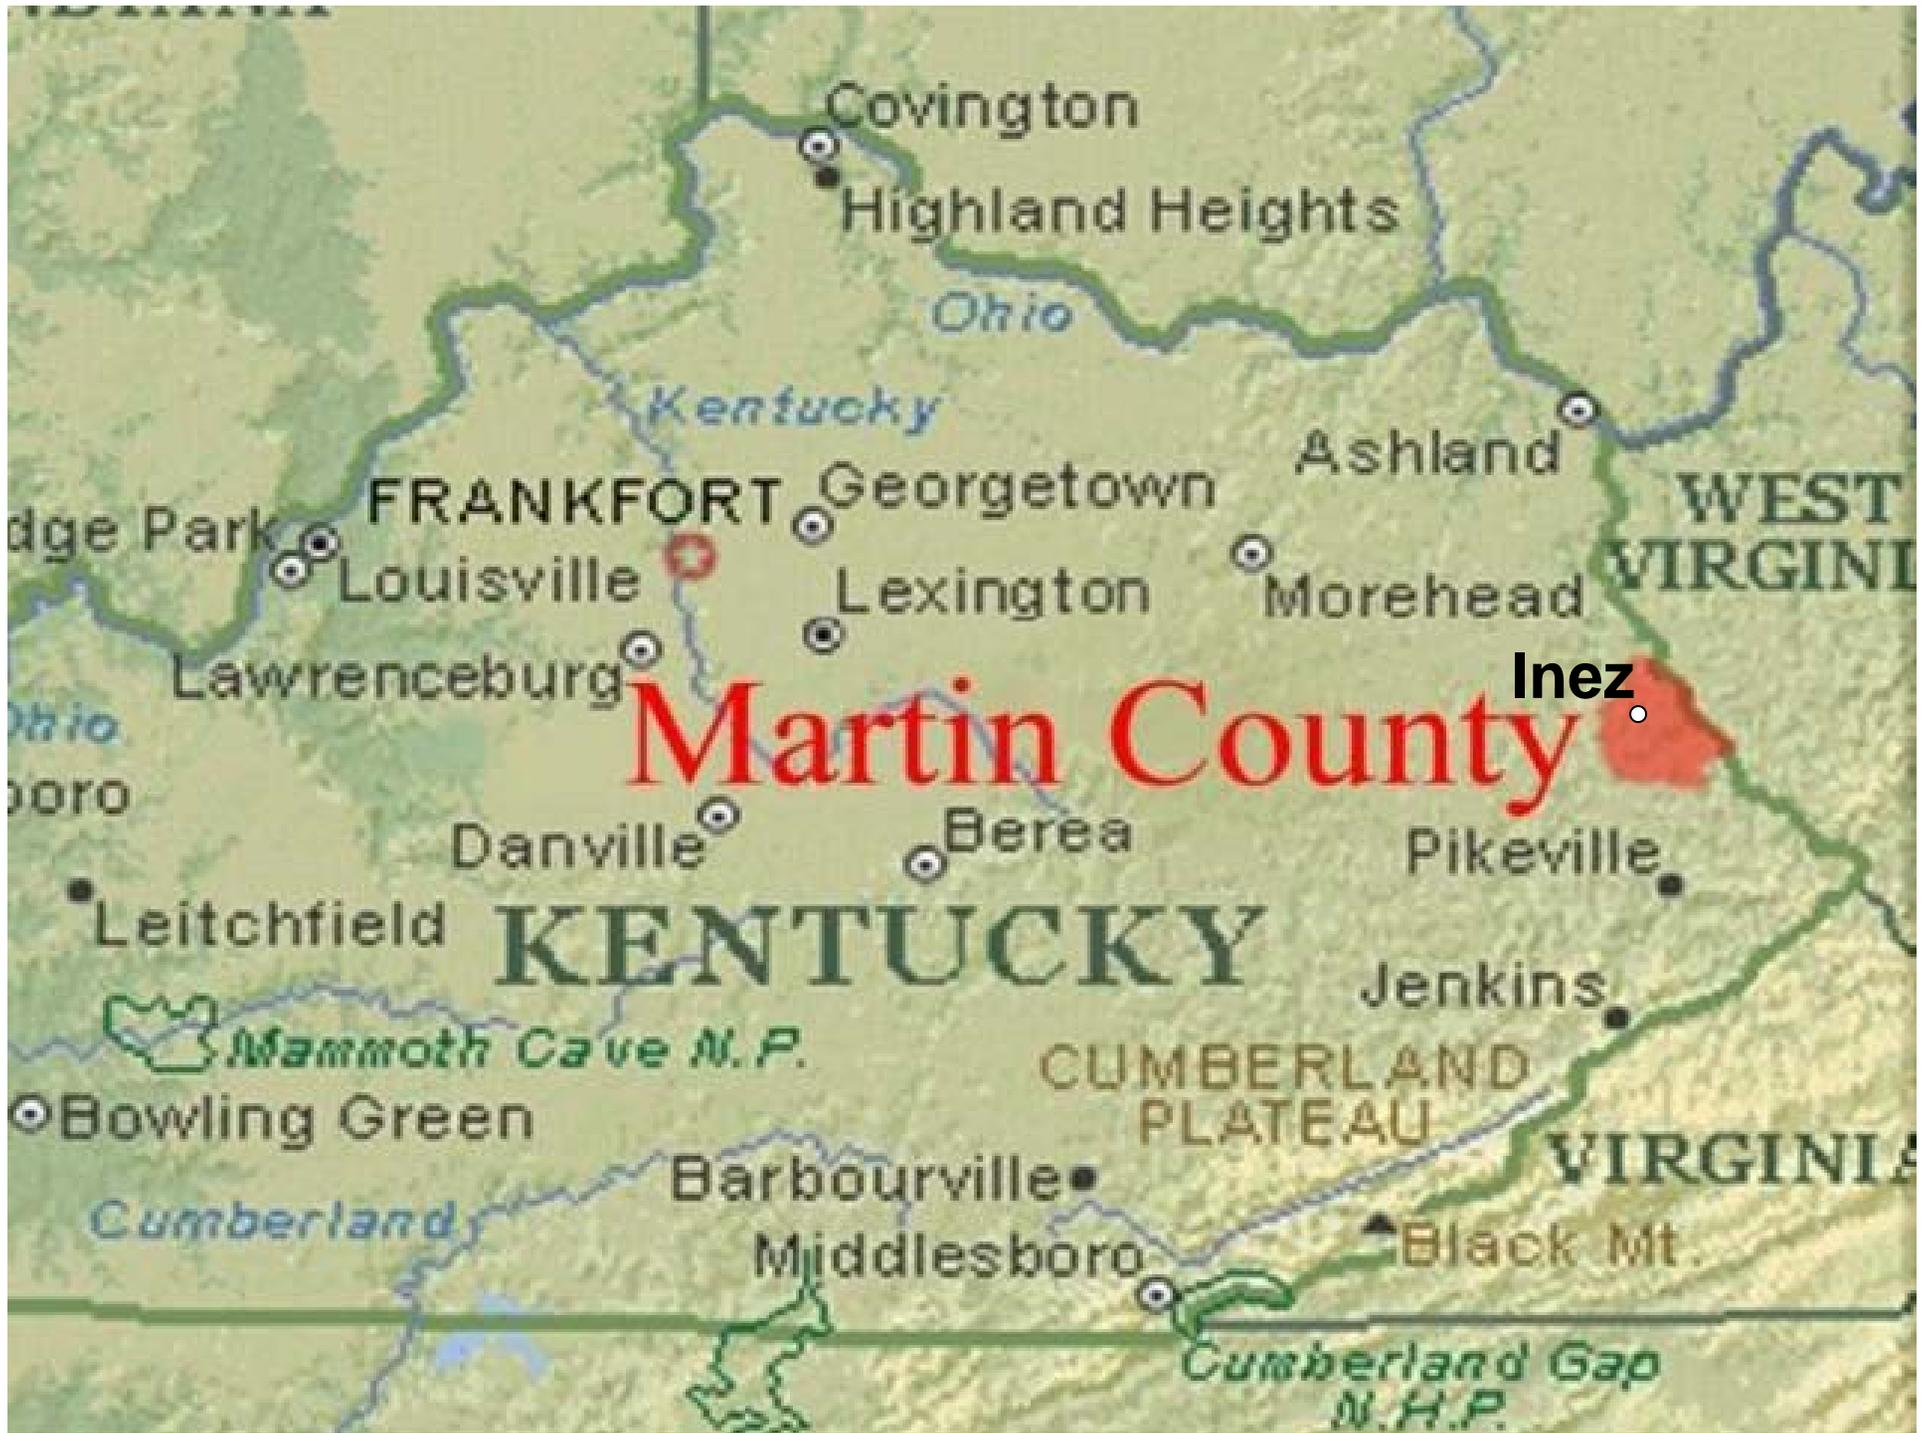
- 250 million gallons of coal waste slurry are released from an impoundment, October 2000

The embankment did not fail

The coal waste slurry flowed
through underground mine
workings

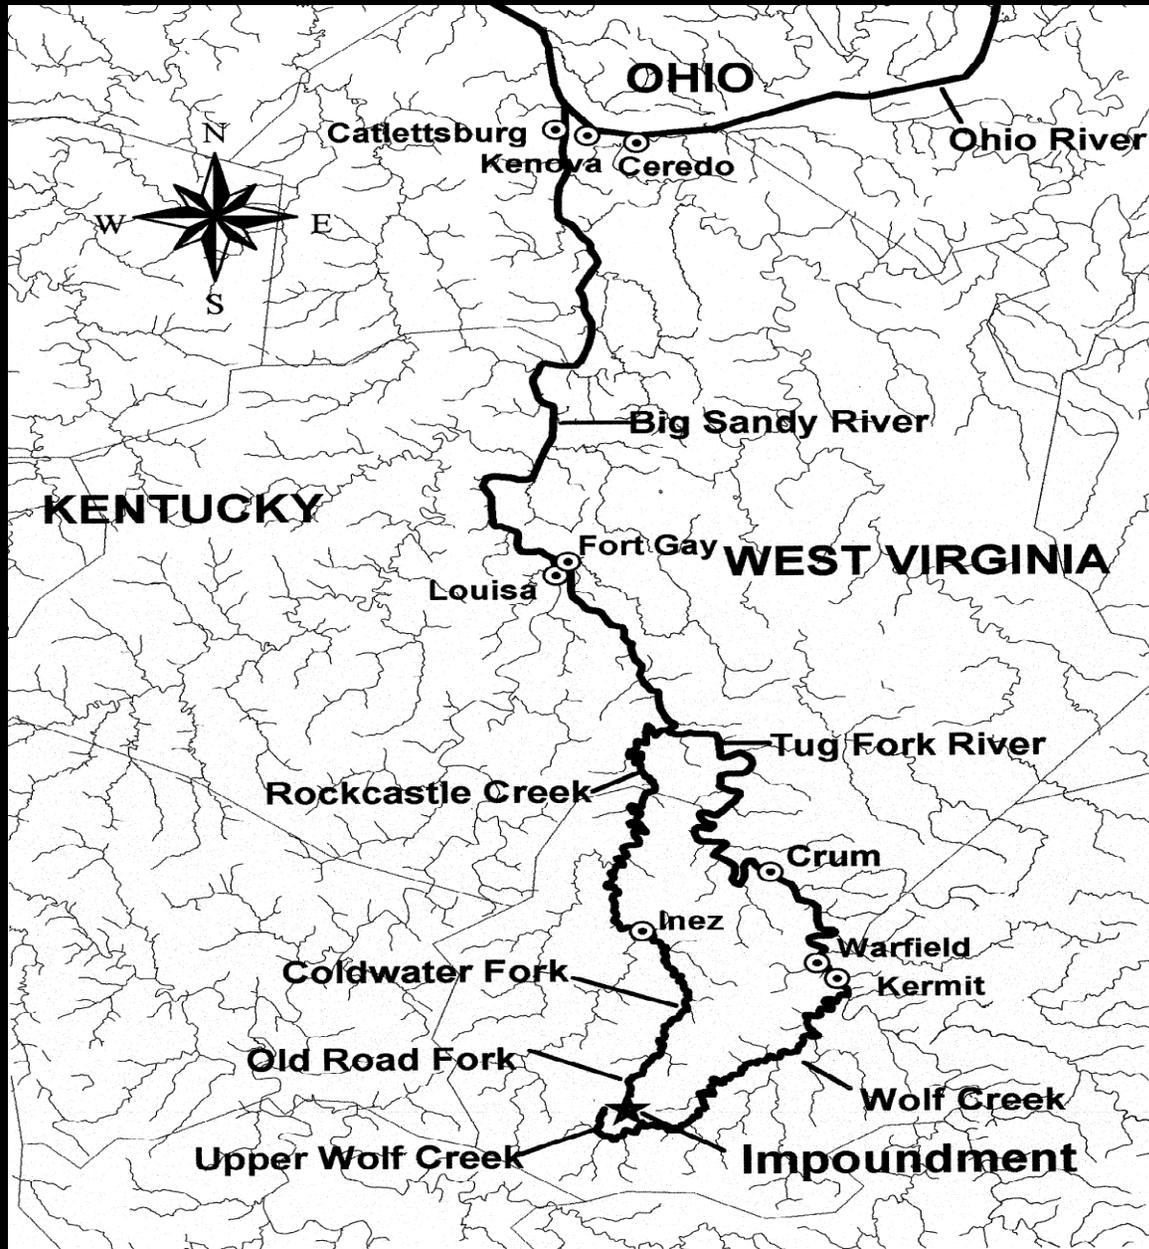
No lives were lost but
environmental damage was
significant
