Egg-Crate Mine Subsidence – Adding LiDAR

Mike Dunn, OSMRE, Pittsburgh

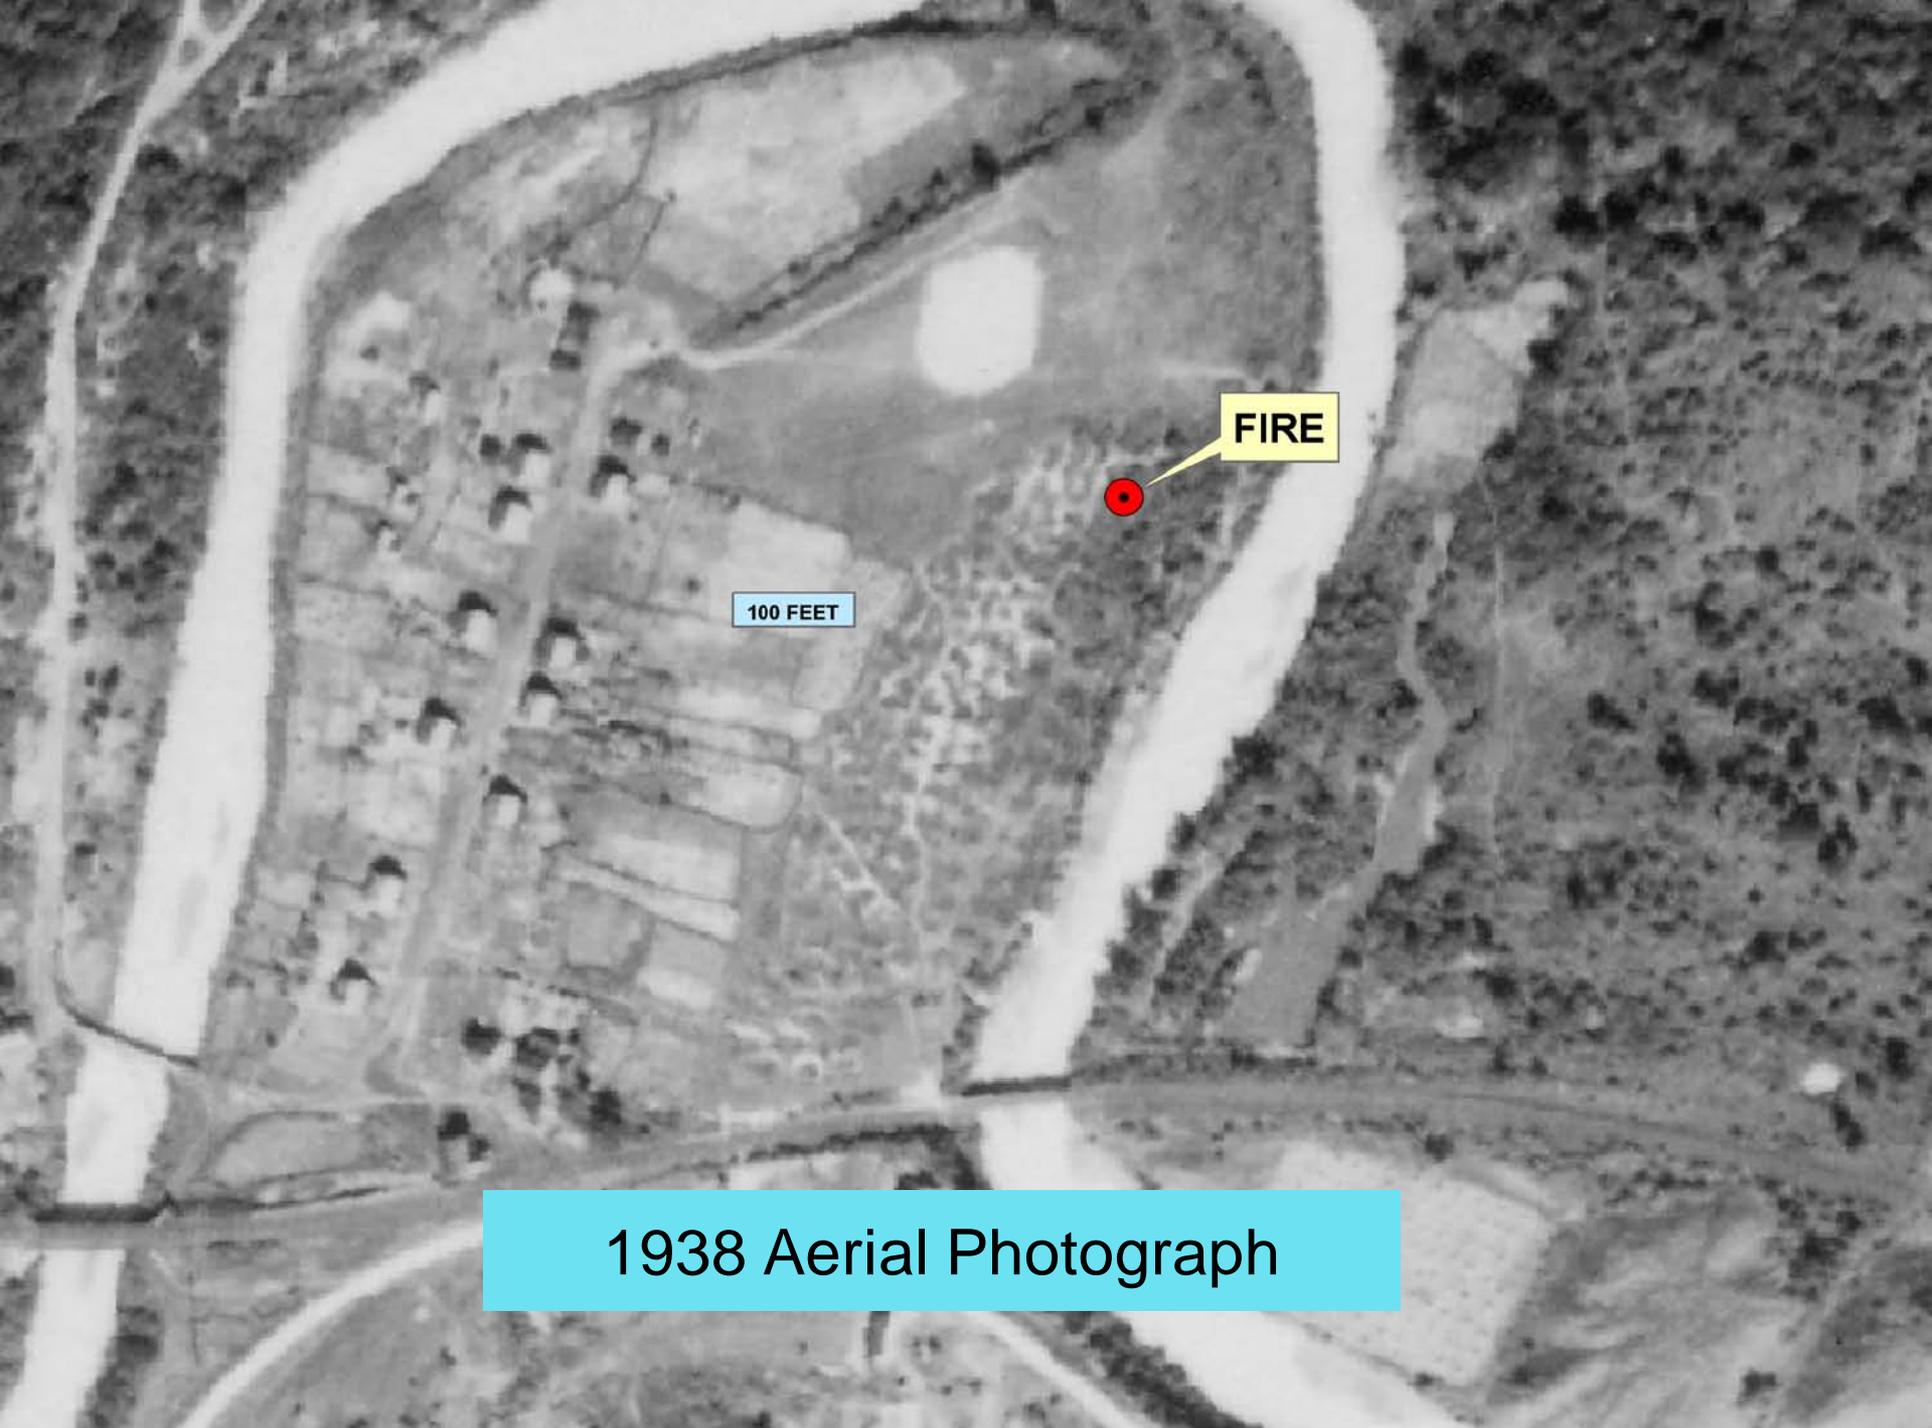
1938 Aerial Photograph

- Site characterization used all available maps and photographs for the worst-case scenario.
- Modern topo maps and aerial photos lack detail and don't show mining effects.
- 1973 Soil Survey maps area as "mine spoil."
- 1938 aerial photo show geometric pattern in the fire area.
- 1914 mine workings mirror this pattern, indicating water stress and/or almost complete subsidence.

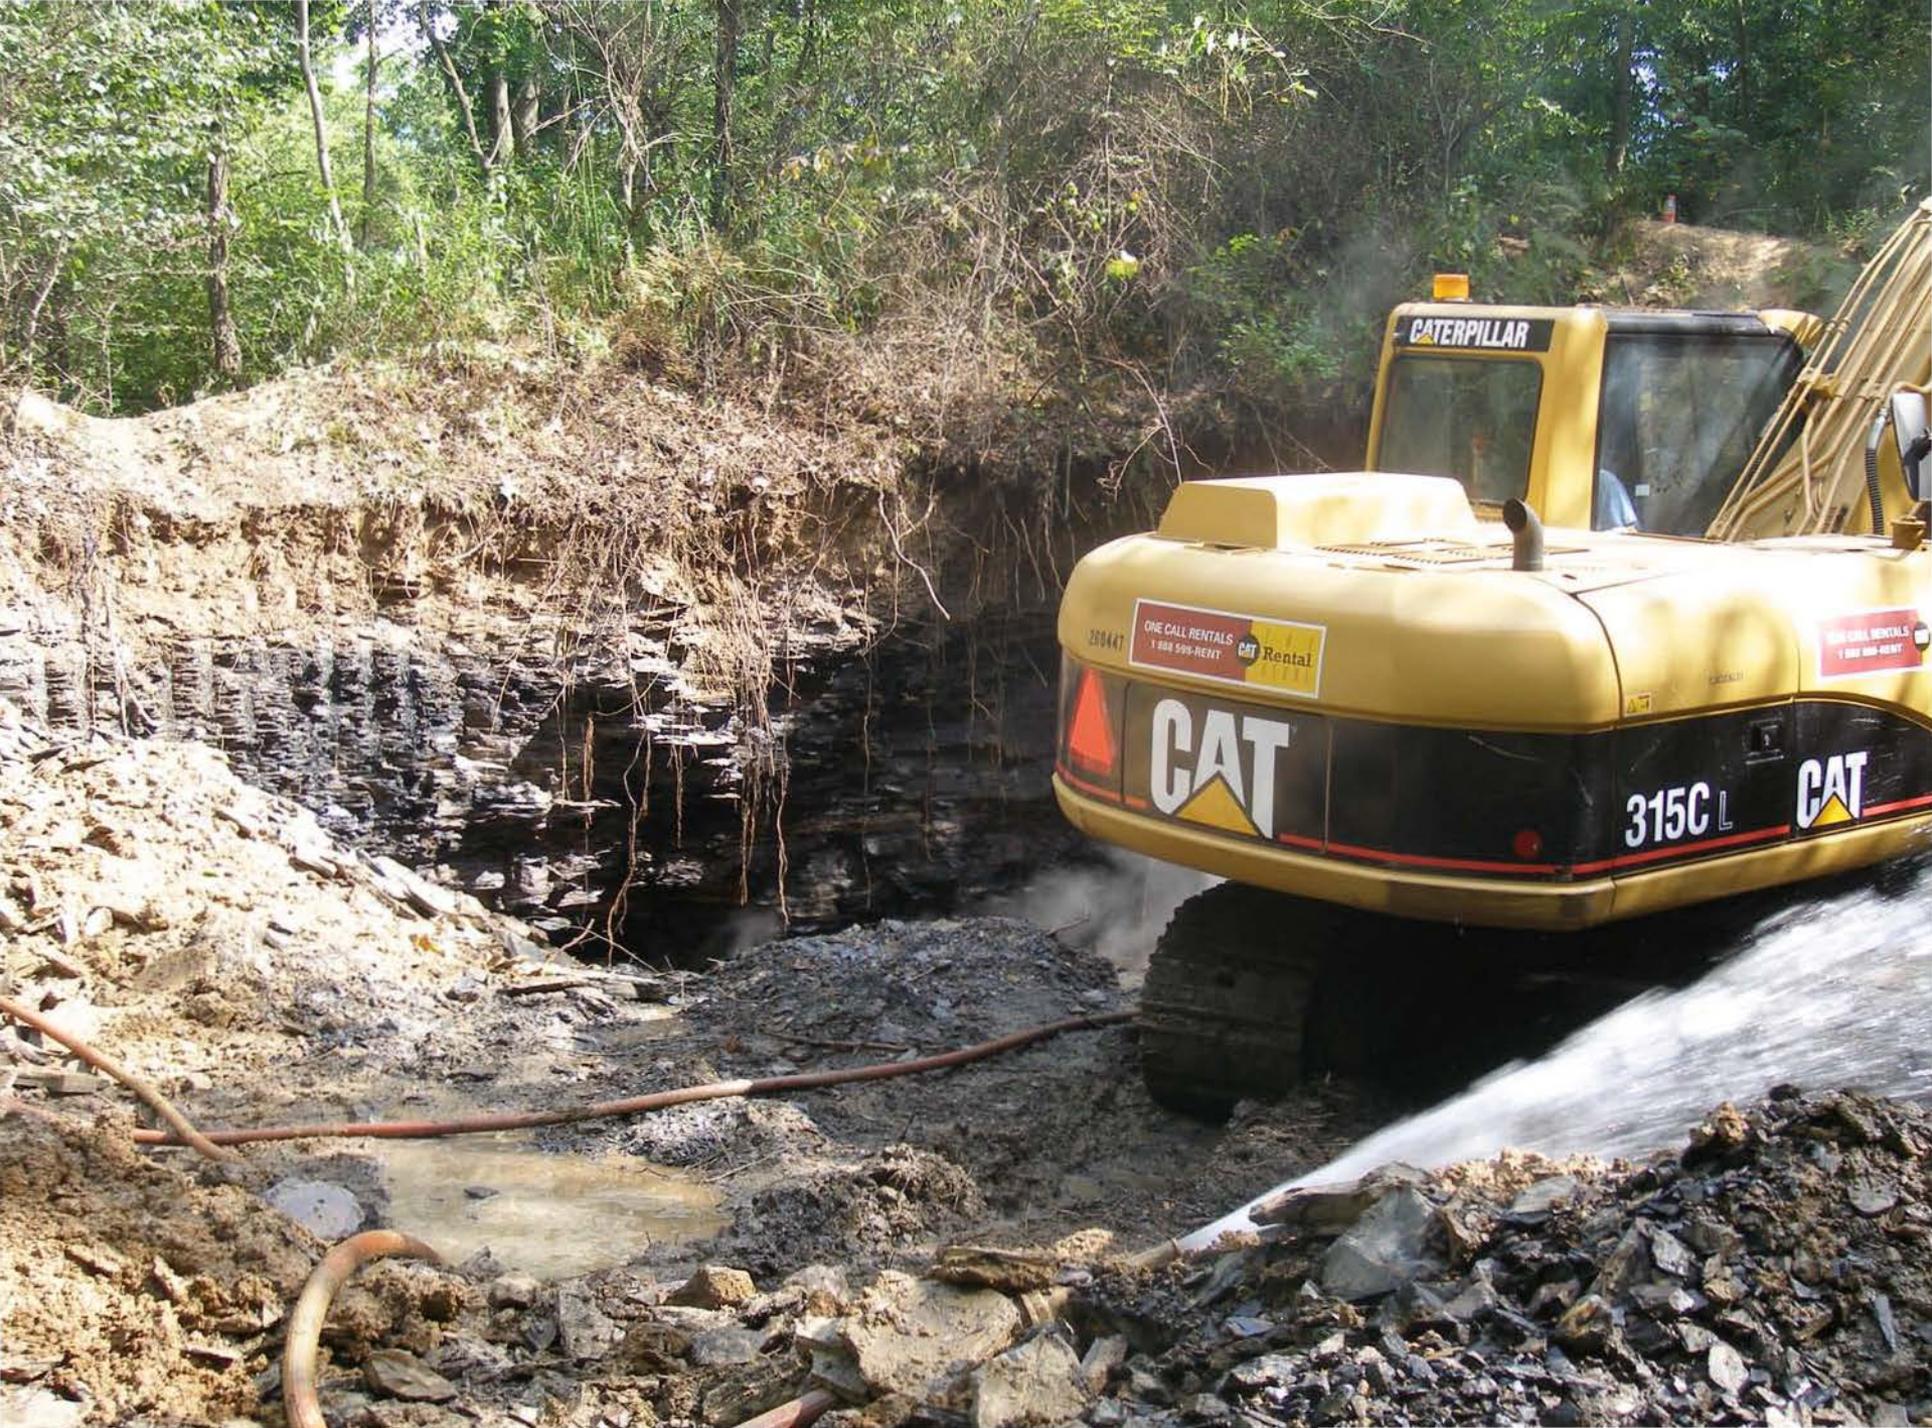
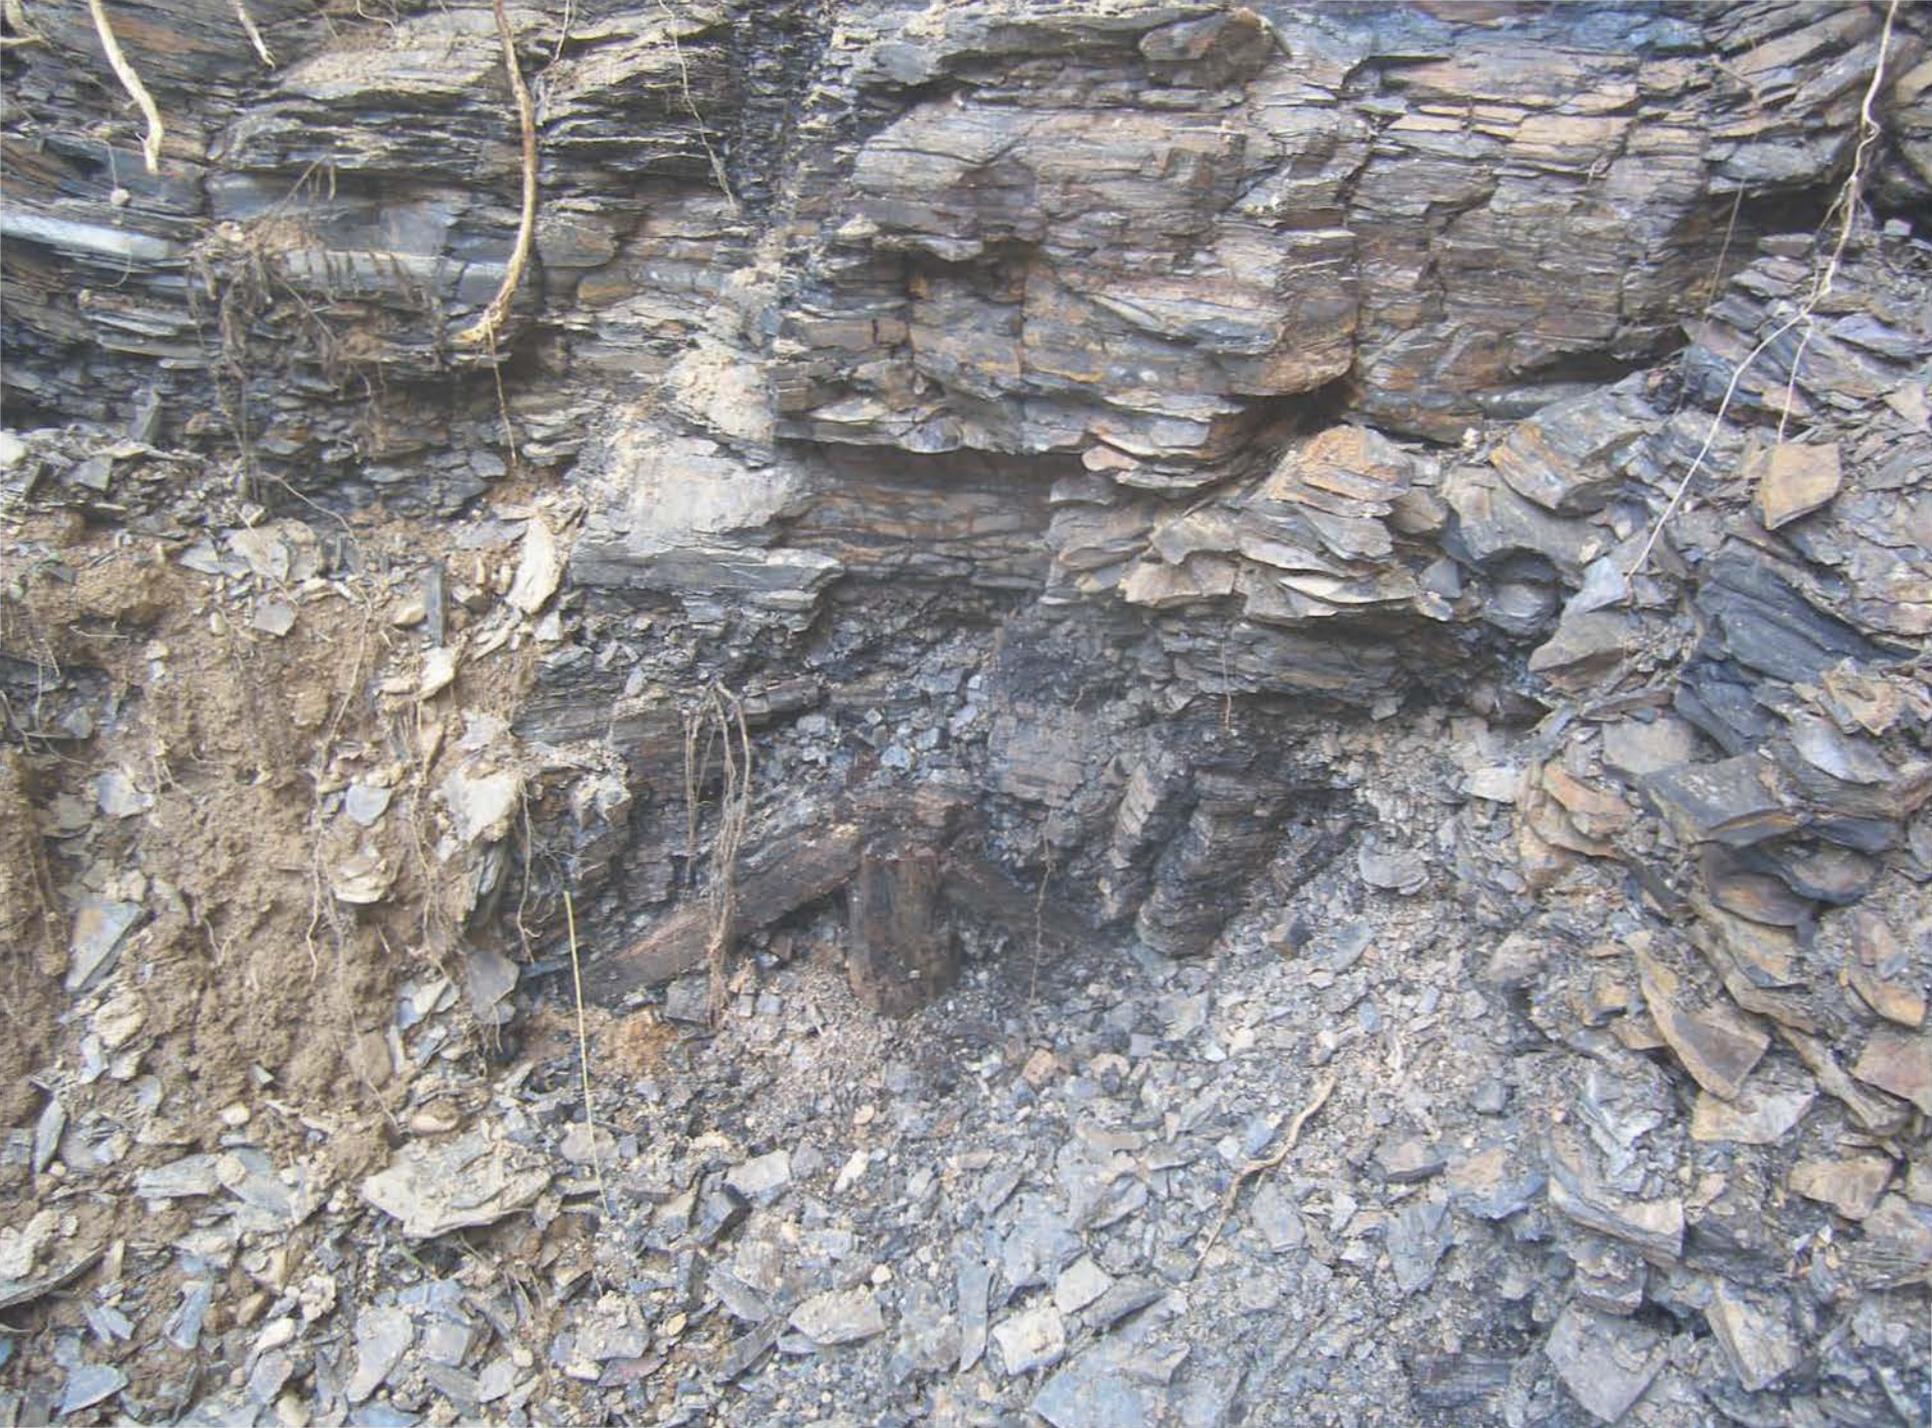
- At mine level, the cutoff trench and maps show that all mining was:
 - Advance only, no retreat.
 - Long rooms and long pillars; few crosscuts.
 - Shallow - less than 20 feet of cover.
 - In the weathered zone and often in the rooting zone.
 - Without any outcrop barrier.
- The trench also confirmed that near total subsidence had occurred.

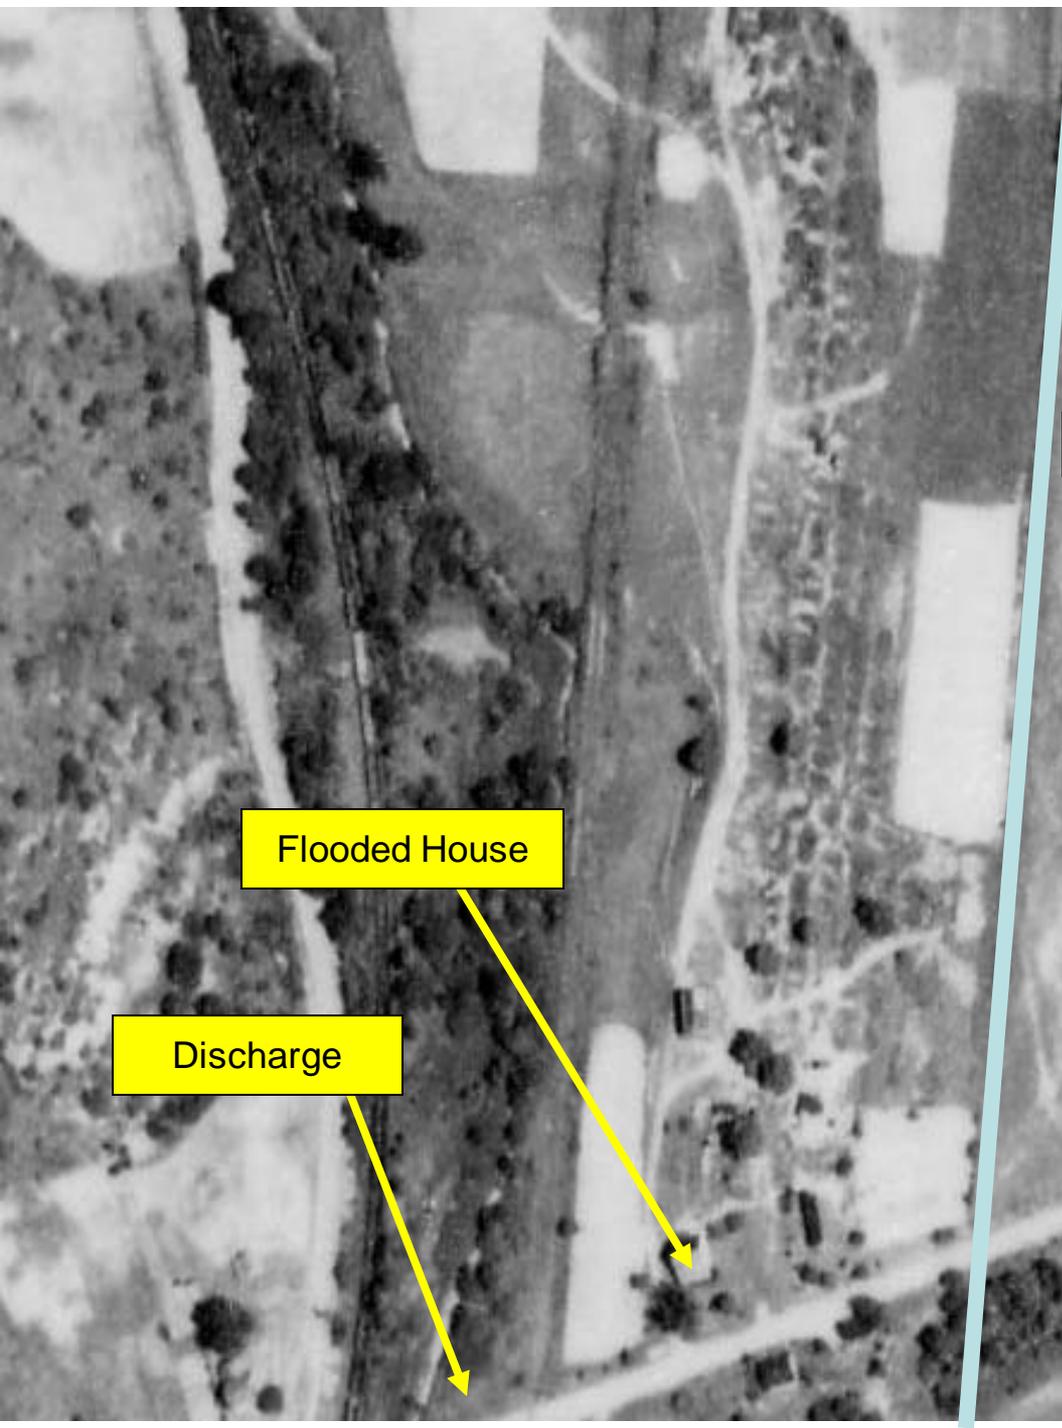
- Mine water flooding a house has been controlled but degrades the receiving stream.
- There's no mine map but adjacent maps and drilling indicate very shallow (<30 feet) mining from the outcrop to a property line. A 1939 aerial photo shows patterns similar to those over the mine fire.
- In the 1950's, an adjacent mine broke into the old works along the property line. The later mine is now part of a major mine pool that periodically discharges through the old mine directly toward the house.

Flooded House

Discharge

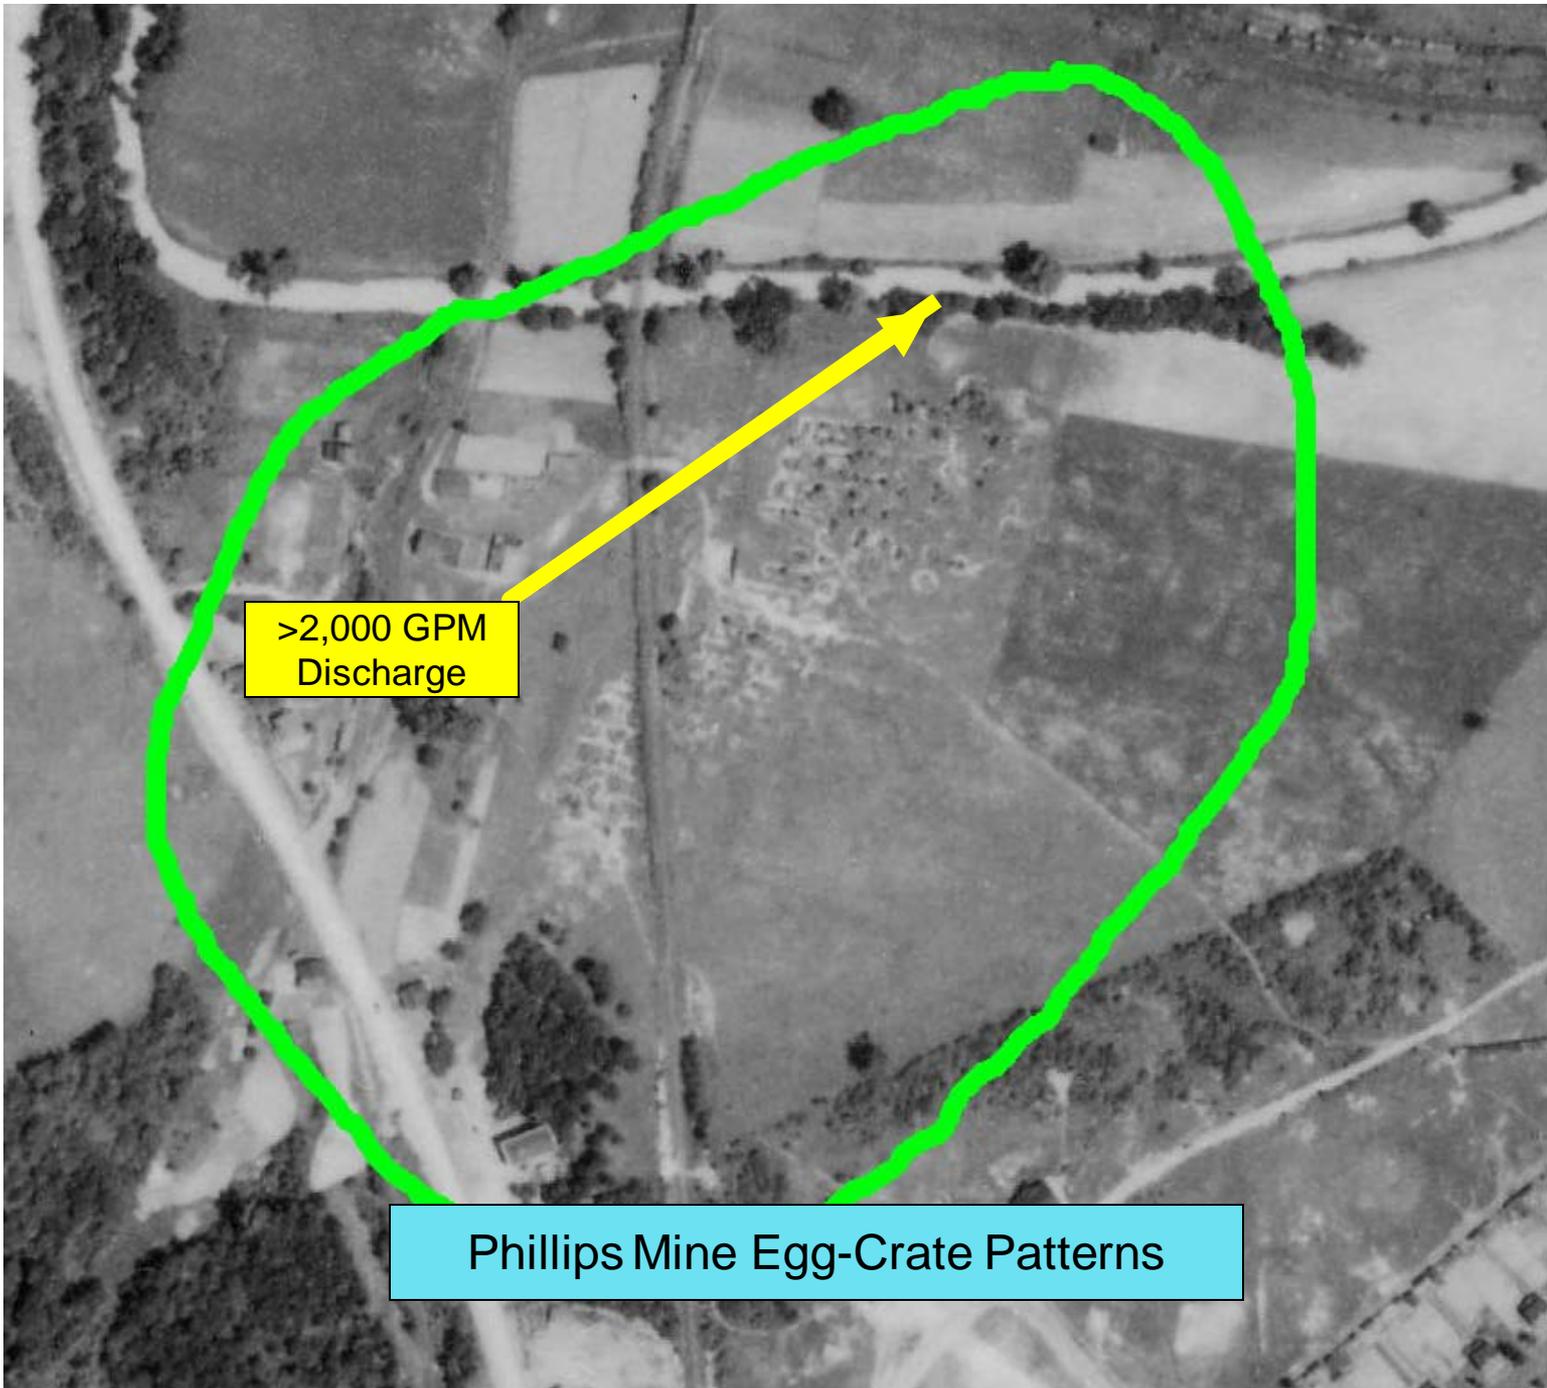
- Elsewhere on the same mine pool, shallow mining nearer the deepest part of the coal basin is allowing perpetual discharges of several thousand GPM.
- Control and treatment are unlikely in the near future. The outlets cover a large area, precluding consolidation; the sole discharge is just above stream level.

>2,000 GPM
Discharge

Phillips Mine Egg-Crate Patterns

Phillips Mine Discharge

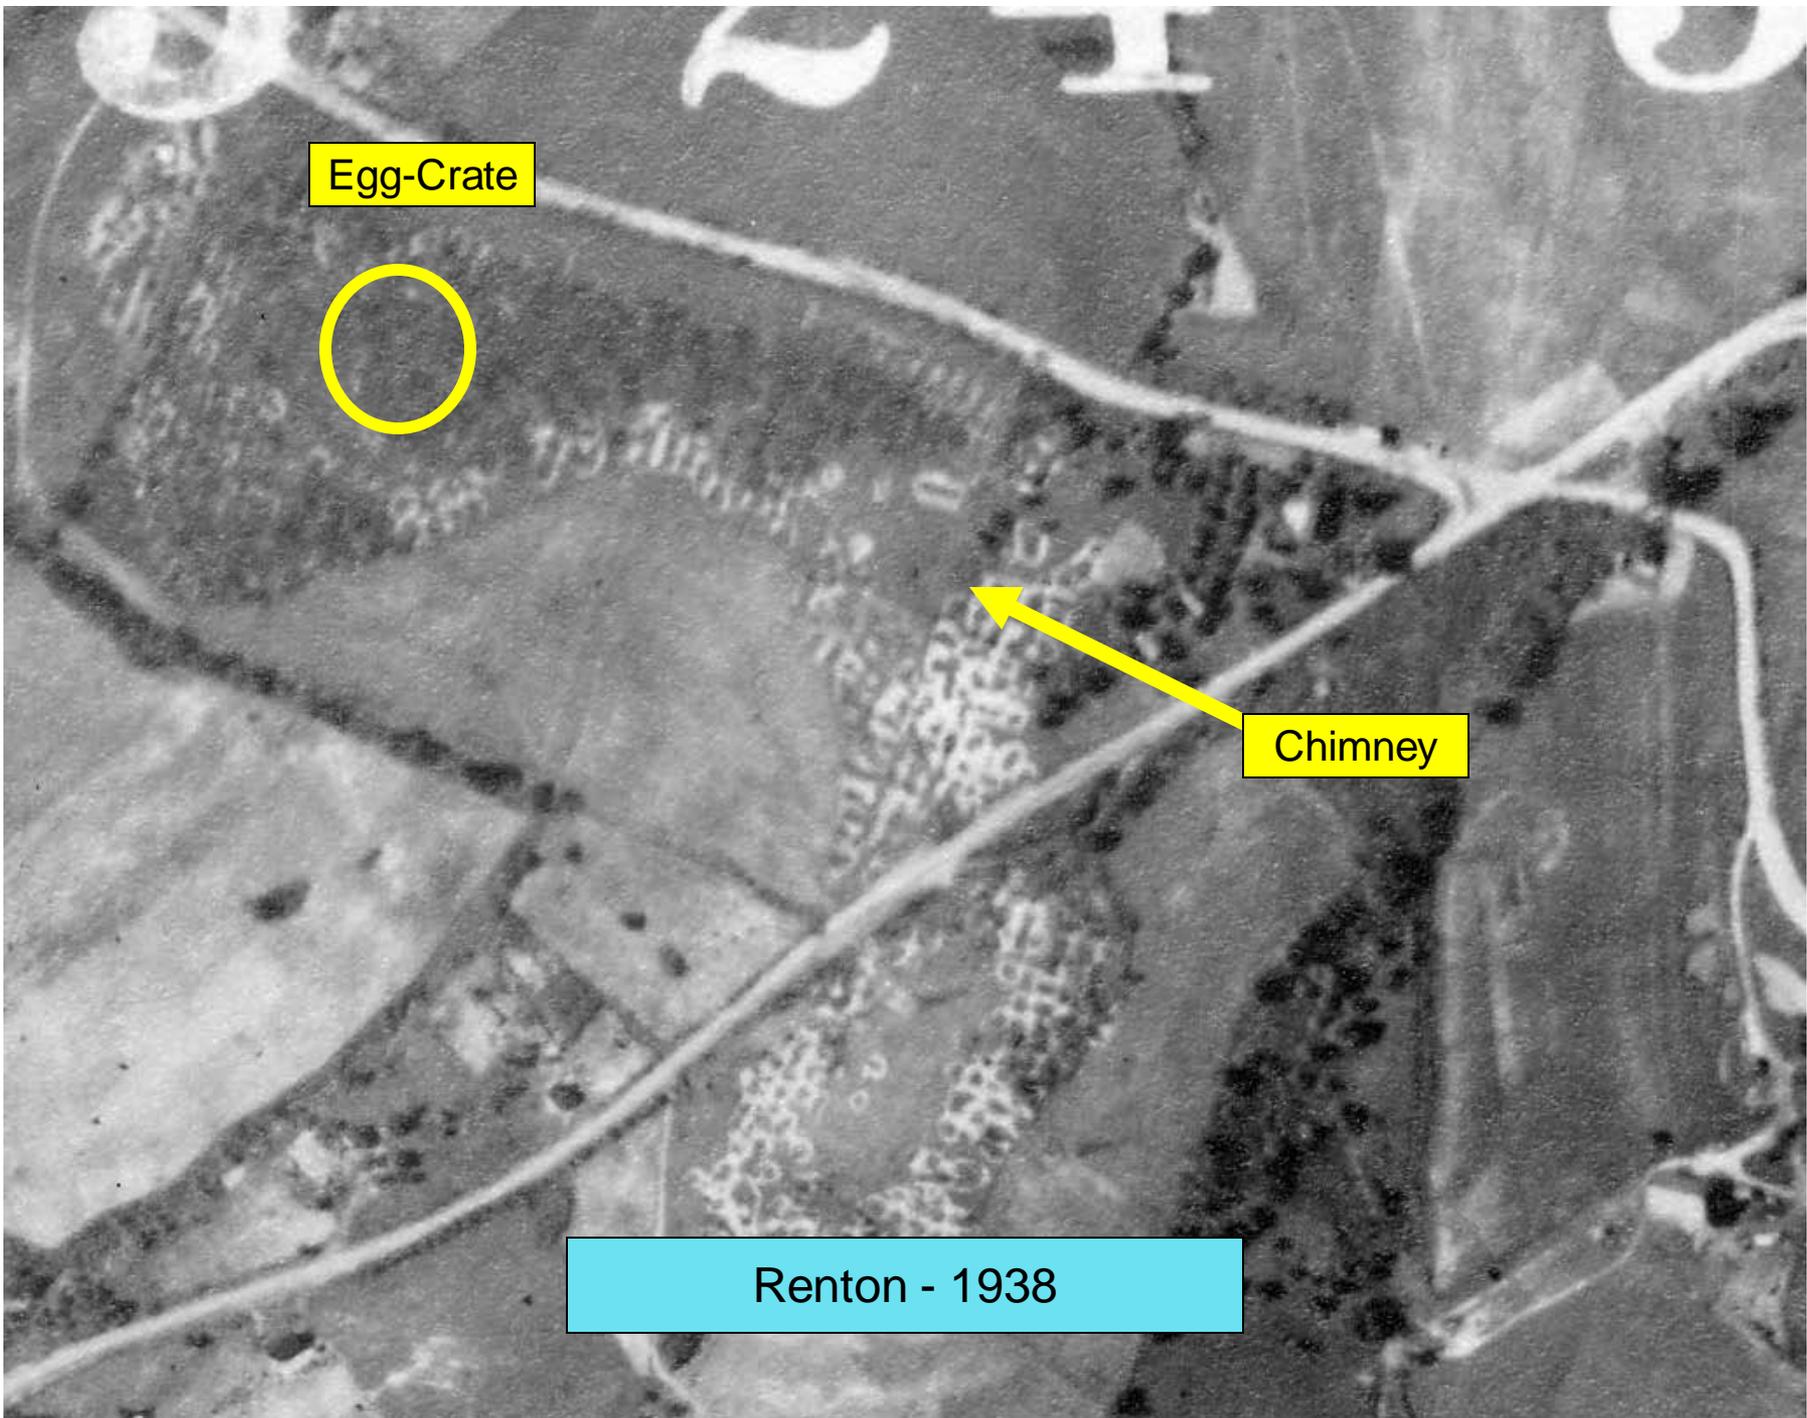
Renton - 2005

Egg-Crate

Chimney

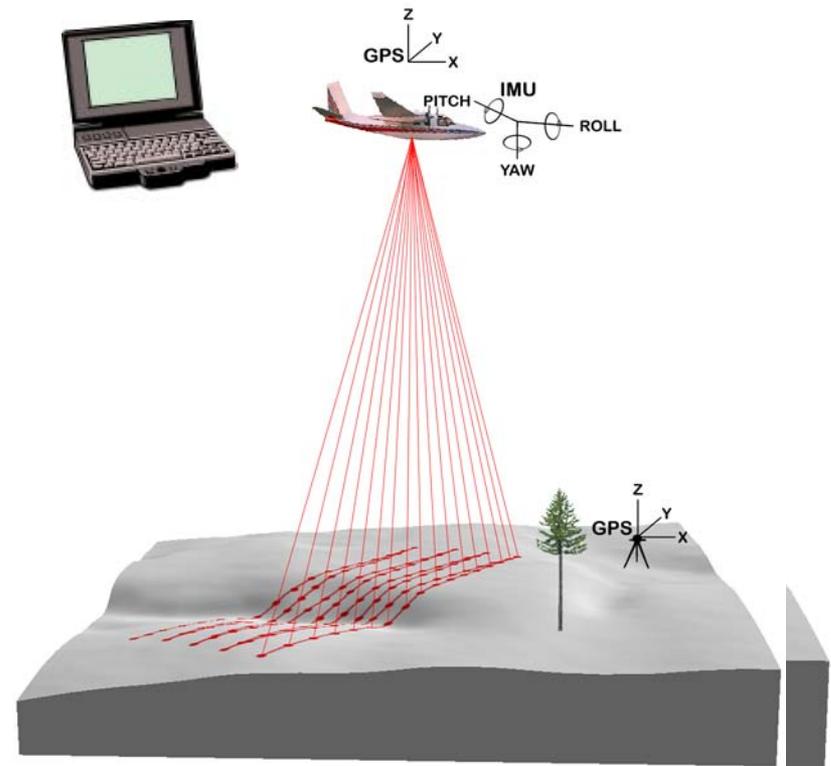
Airborne Laser Scanning (LIDAR) System Components

- Active sensor emits 40,000 – 150,000 infrared laser pulses per second
- Differentially-corrected GPS
- Inertial measurement unit (IMU)
- Computer to control the system monitor mission progress
- Interesting targets

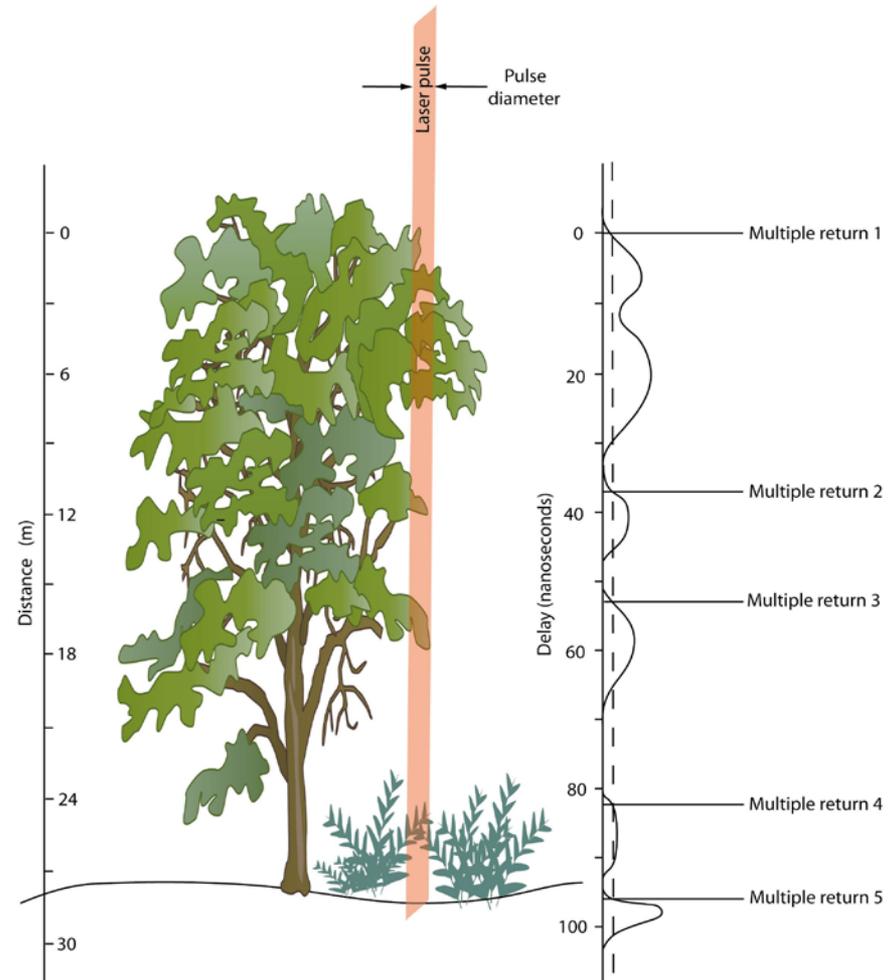
Airborne Laser Scanning (LIDAR) Technology

- Acquires 1-5 reflections (returns) per pulse
- Typically 1 -10 measurements per m² or 4,000 – 40,000 measurements per acre
- Data delivered as XYZ points in a “data cloud”
- **Direct measurement of 3-D structure**
 - Terrain
 - Forest vegetation
 - Infrastructure

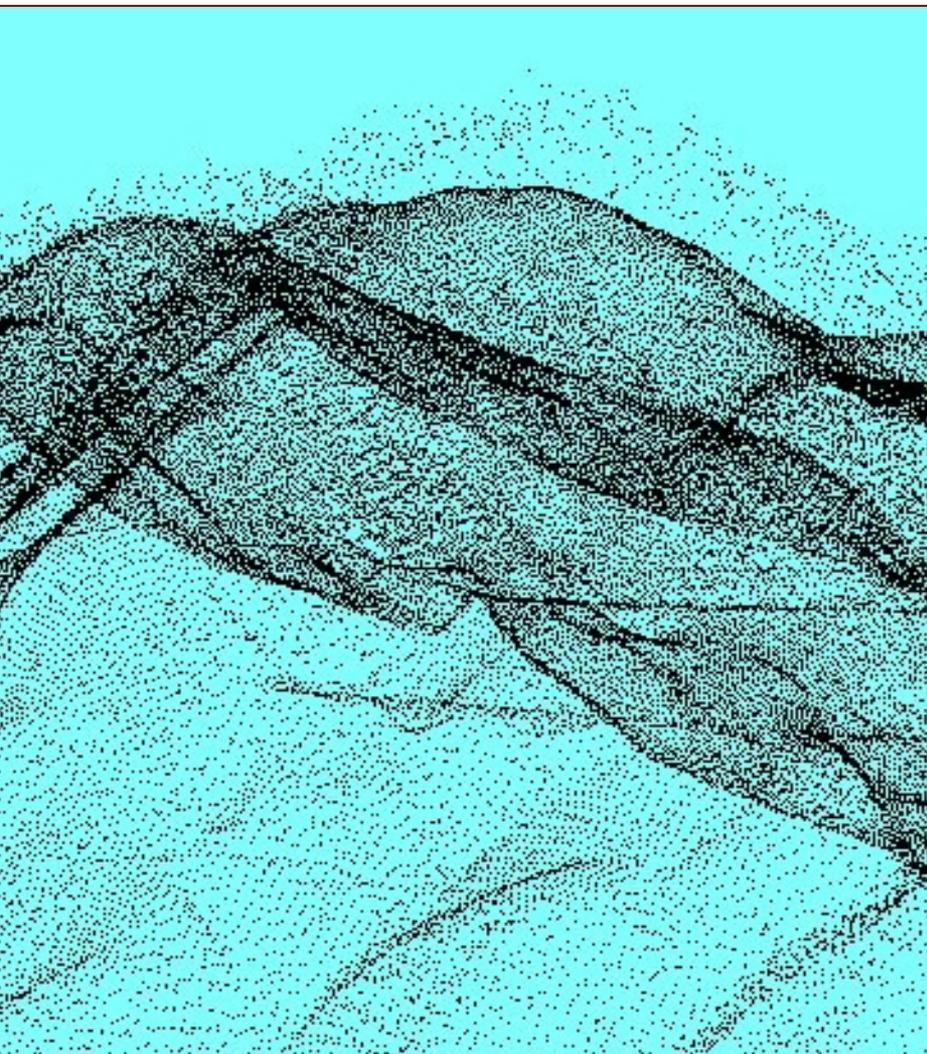
Raw Point Cloud

Typical DTM from USFS Tools

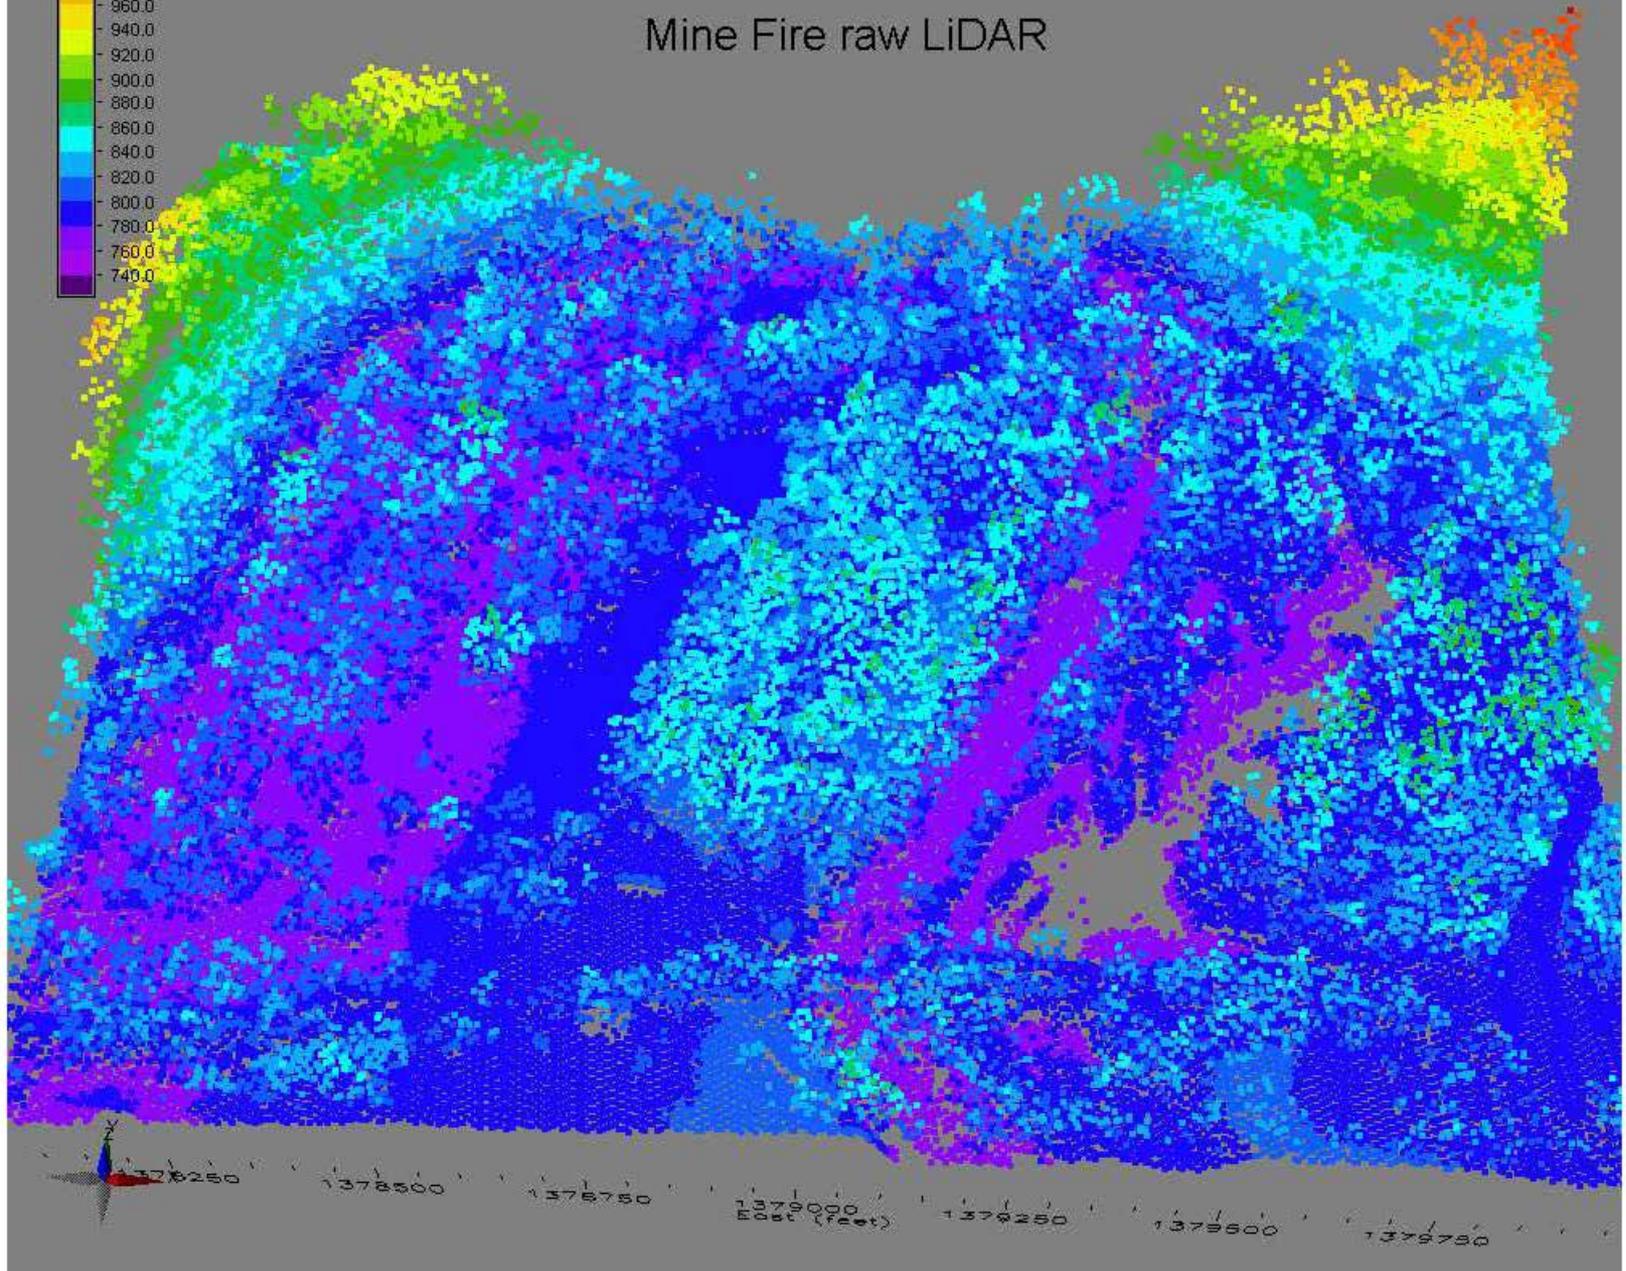
Mine Fire raw LiDAR

- The following slides revisit 3 of the sites presented earlier
- LiDAR raw data are extremely noisy and the derived DEMs rarely capture true bare ground.
- With careful editing to remove every non-earth point, far more detail survives

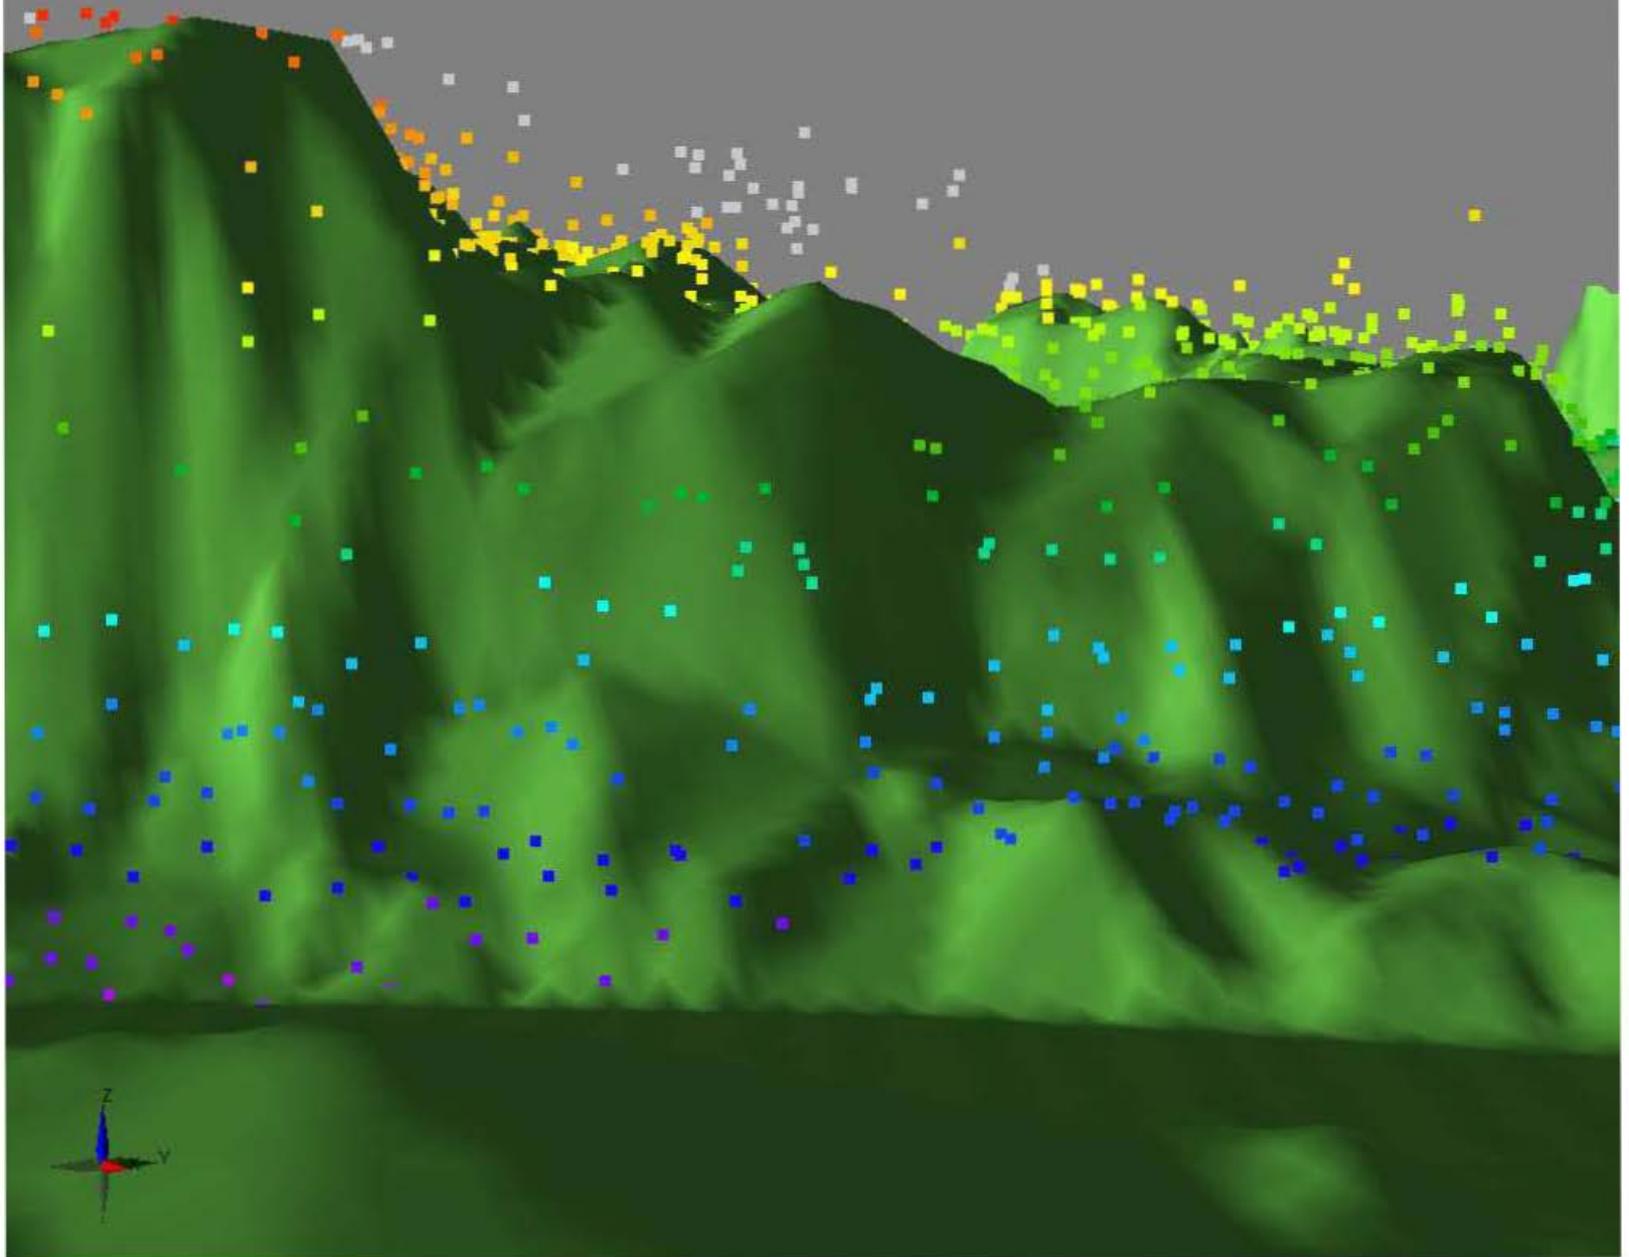
Manual Editing of Above Ground Returns

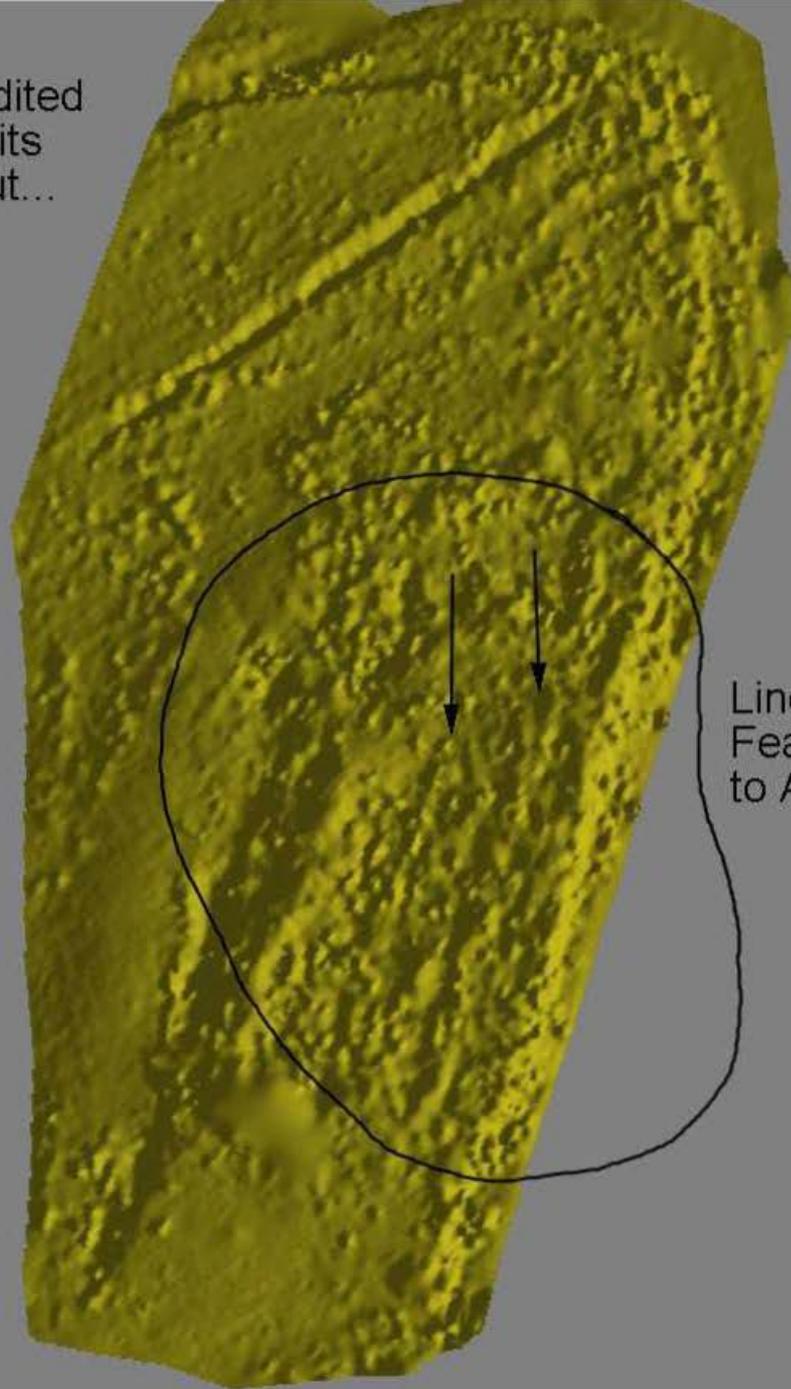
EV Grid from Edited
Data - More Edits
Still Needed, but...

Linear Egg Crate
Features Starting
to Appear!
